# Building Assessments

Duluth Airport Authority

Duluth, Minnesota

DULAI 150733 | September 13, 2021

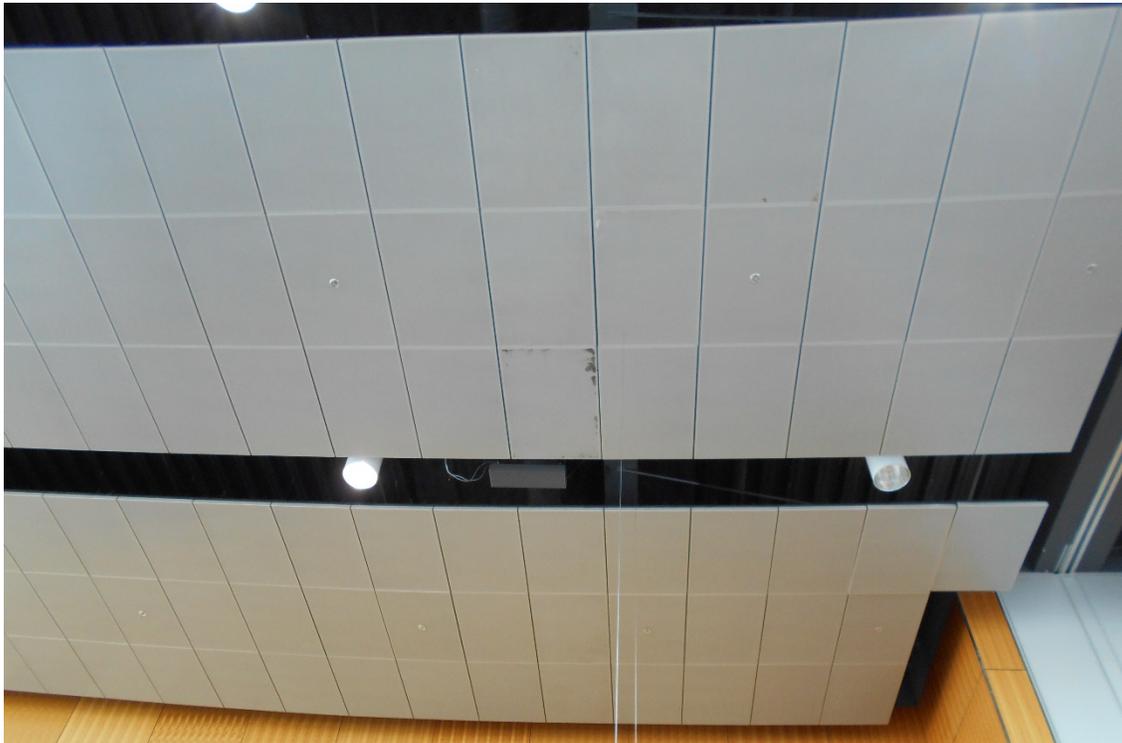
**Photo 3** Damage to ceiling panels due to water infiltration

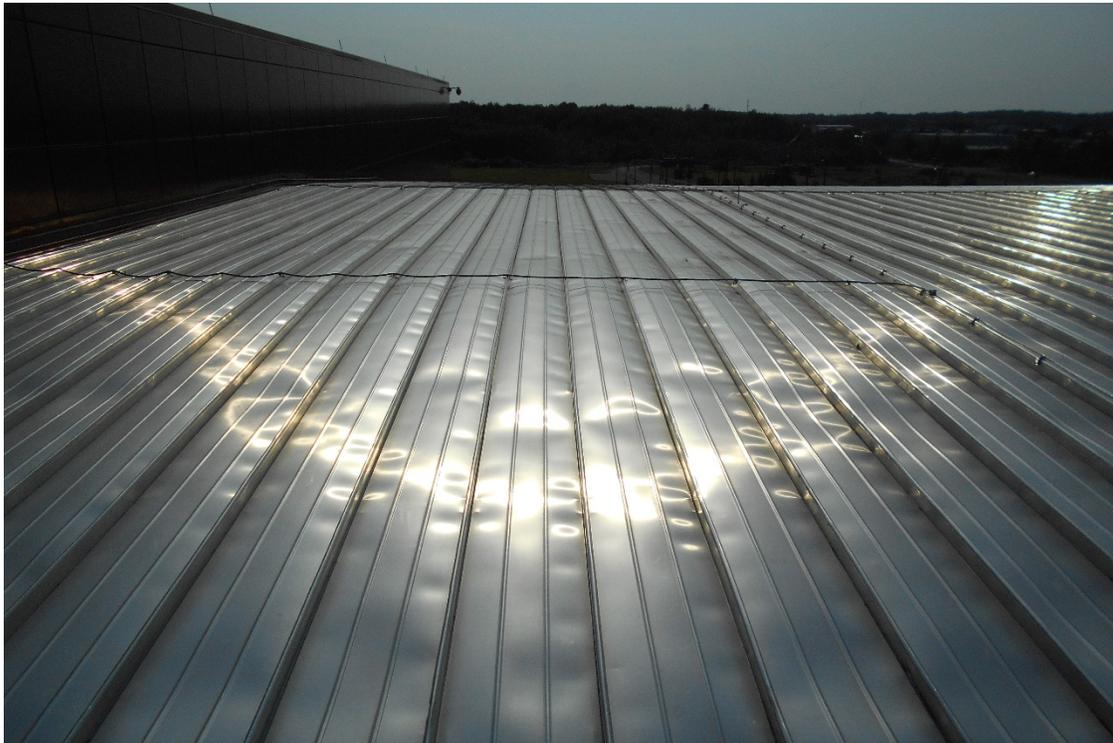
**Photo 5** Oil canning in standing seam metal roof system

- Replace the existing standing seam metal roof system due to level of existing repairs/ patches completed along with the constant maintenance required, estimated \$1.3M for replacement with standing seam metal roof system /or \$1M for replacement with fully adhered EPDM roof membrane.

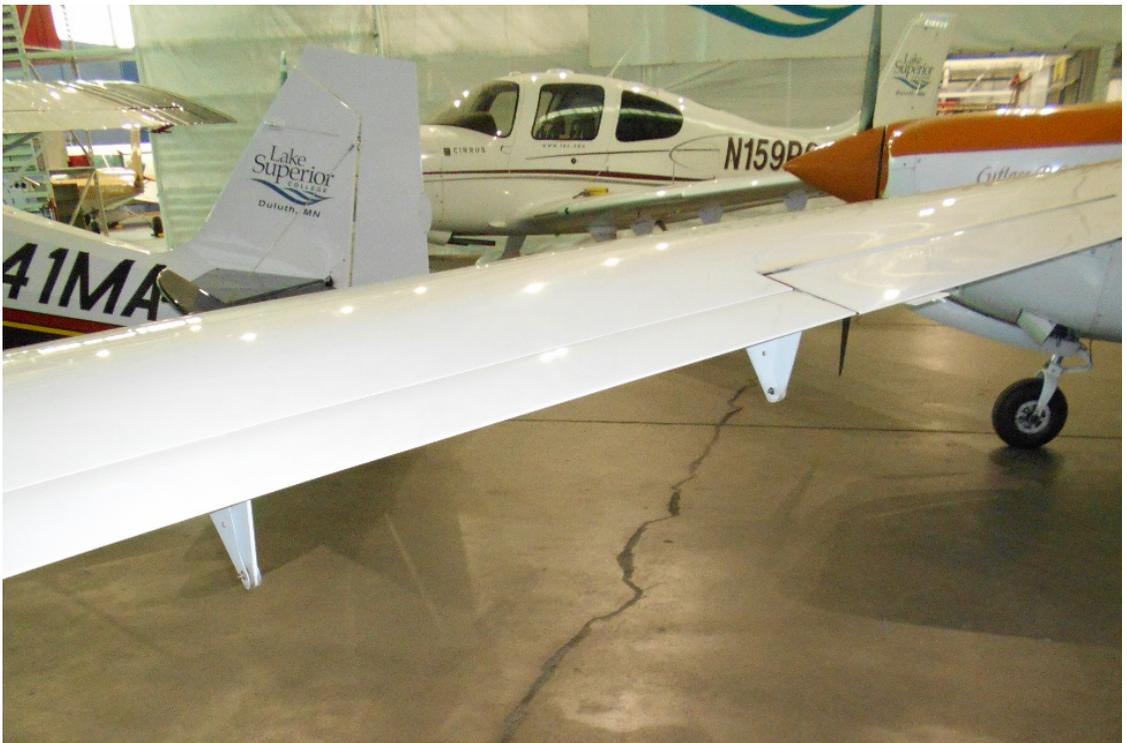
No structural deficiencies were observed with the building. There are cracks in the hangar floor at the midpoint of slab joints, likely a result of the control joints being placed too far apart and a natural crack formed at the high stress locations. This is not a structural issue; it is noted as unsightly from an aesthetic perspective.

**Photo 4** Cracks in hangar floor slab

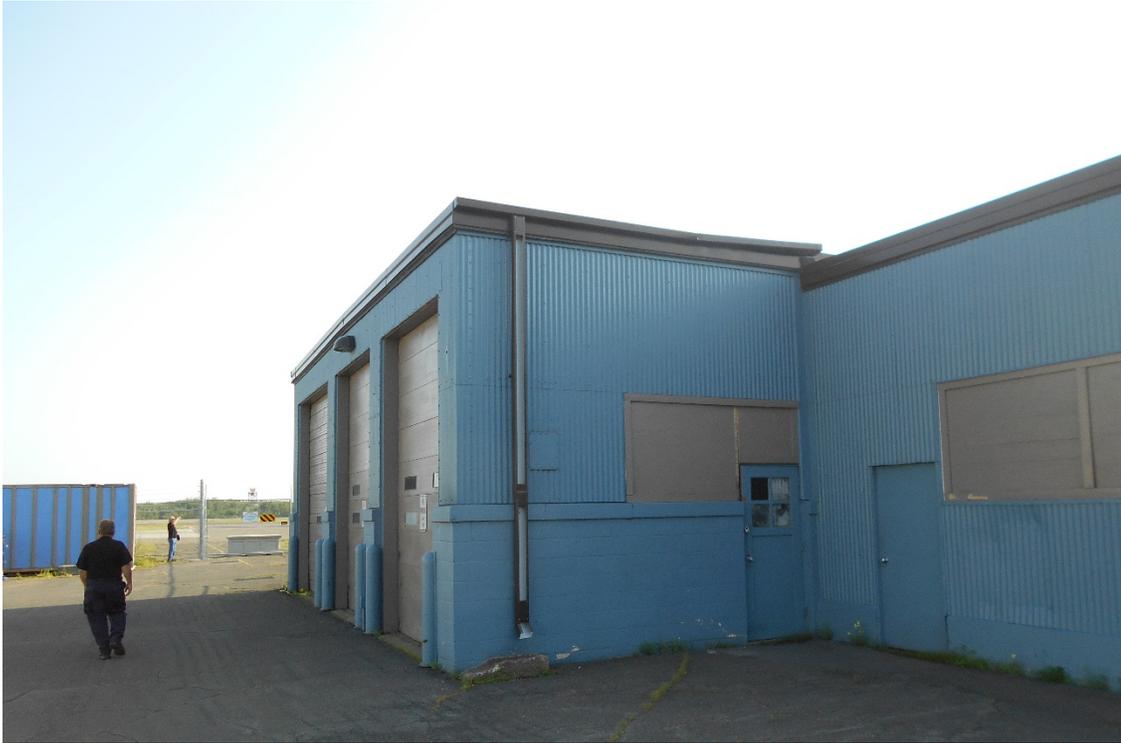
**Photo 5** Wood door and frame at Service Garage

Exterior pedestrian doors consist of a combination of pre-finished aluminum entrance framing systems and painted steel frames and doors, of which both systems appear in good condition. It is recommended that exterior painted steel doors and frames be cleaned and painted in the near future as maintenance. There were a couple of assumed original wood doors and frames at the service garage area and appeared in fair condition. These doors are showing some signs of wear and deterioration beginning to form. It is recommended that these doors get replaced with hollow metal door and frame units in the near future.

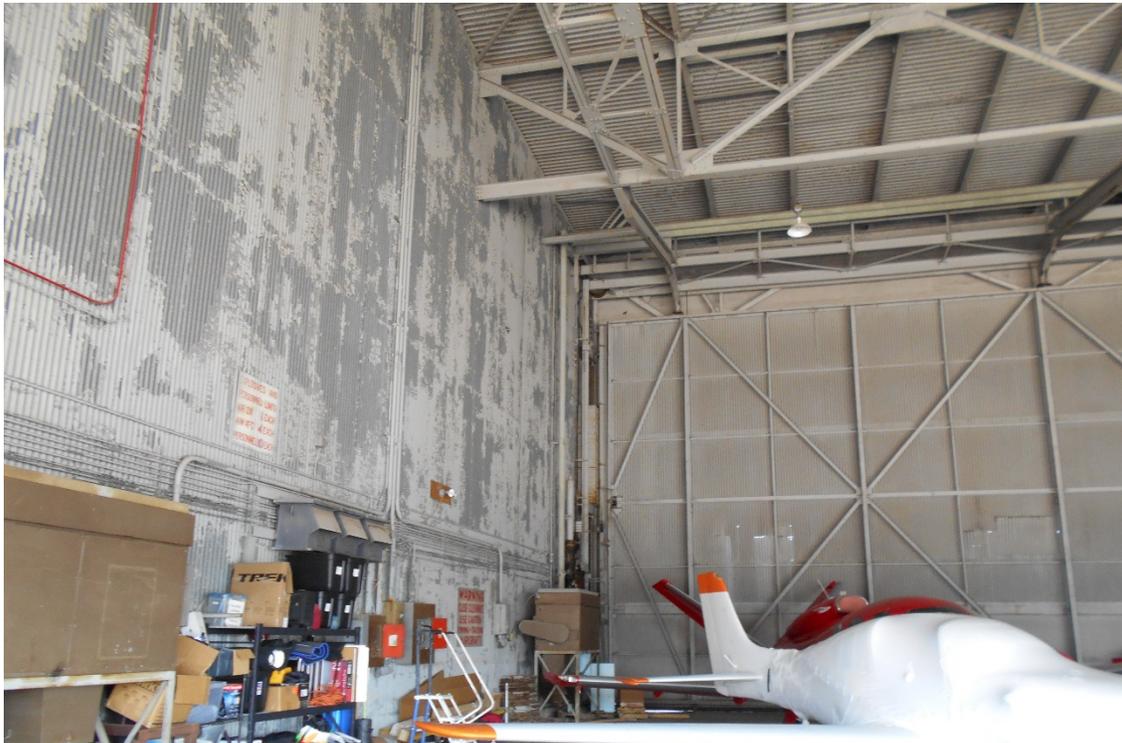
**Photo 3** Damage at North Side Hangar Door / Peeling Paint at Interior Metal Liner Panel

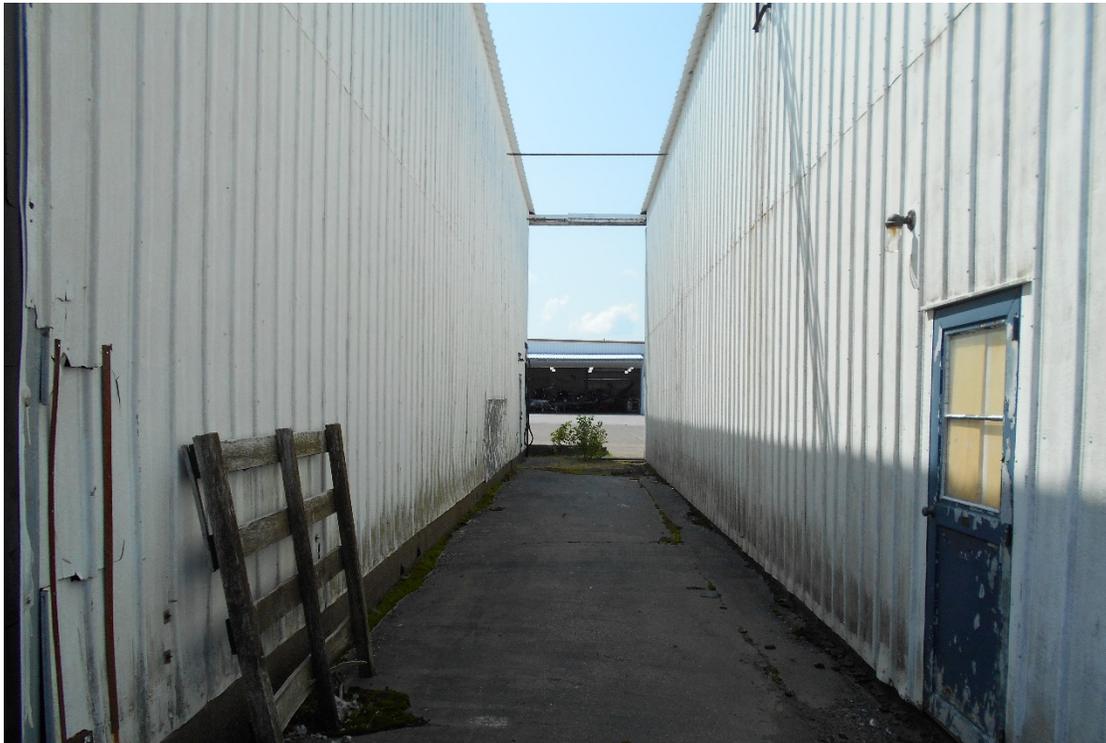
**Photo 3** Damaged Exterior Metal Wall Panels / Wood Service Door

- Patch and repair any punctured or damaged exterior wall and hangar door metal panels, estimated \$15,000 (each bldg.).
- Clean and re-paint exposed metal wall panels on exterior of building, estimated \$16,500 (each bldg.).
- Replace exterior wood doors and frames, estimated \$3,000 (2 thus, each bldg.).
- Service existing sliding hangar doors and guide rail system.
- Clean surface rust present on interior steel roof framing structure and touch-up paint, estimated \$13,750.
- Replace existing metal roof panels, estimated \$190,000.
- Replace existing electrical distribution system, including panels and distribution transformers
- Replace interior lighting with LED high bay fixtures
- Replace exterior lighting with LED fixtures

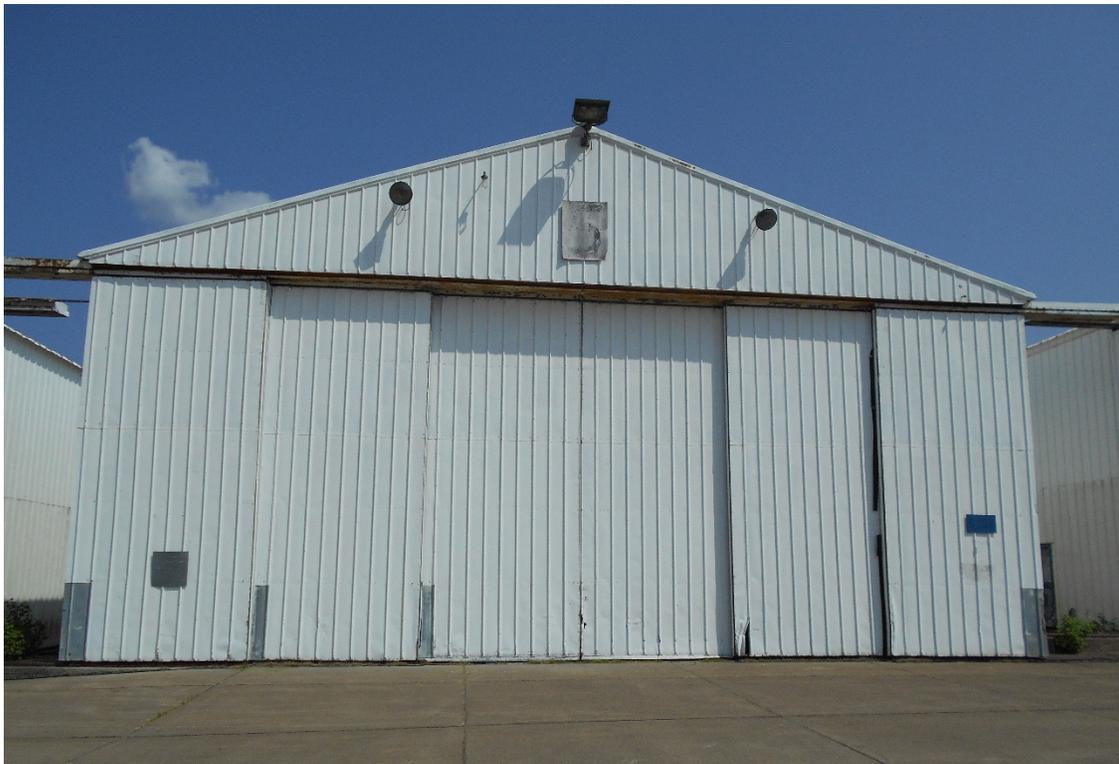
**Photo 4** Sliding Hangar Door Damage

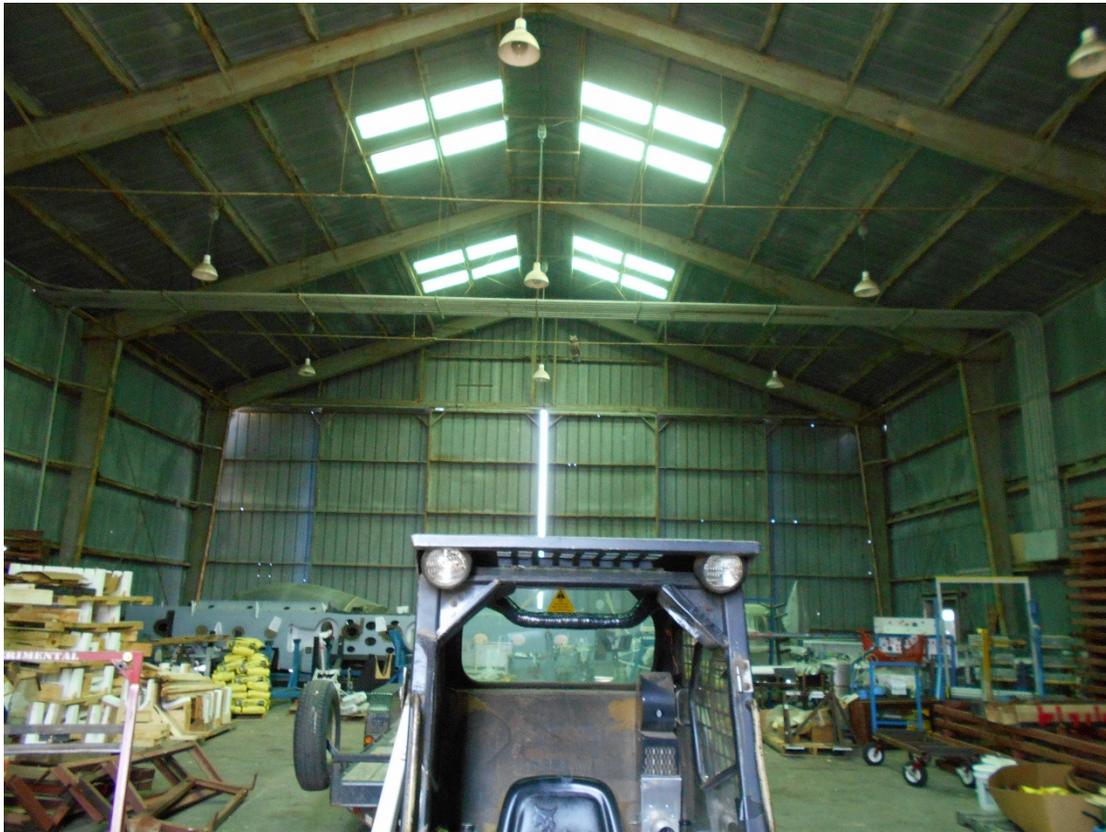
**Photo 5** Surface Rust on Interior Structural Steel Framing

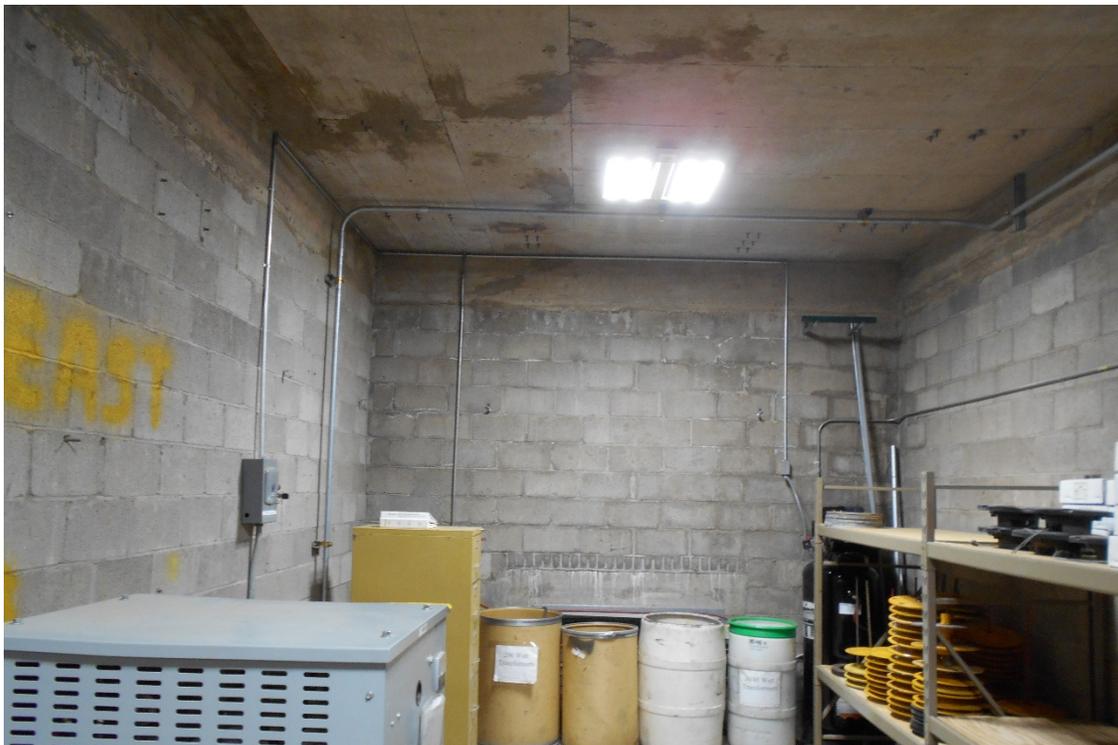
**Photo 5** Locations of Efflorescence Beginning to Form on Interior Masonry Surfaces (back wall)

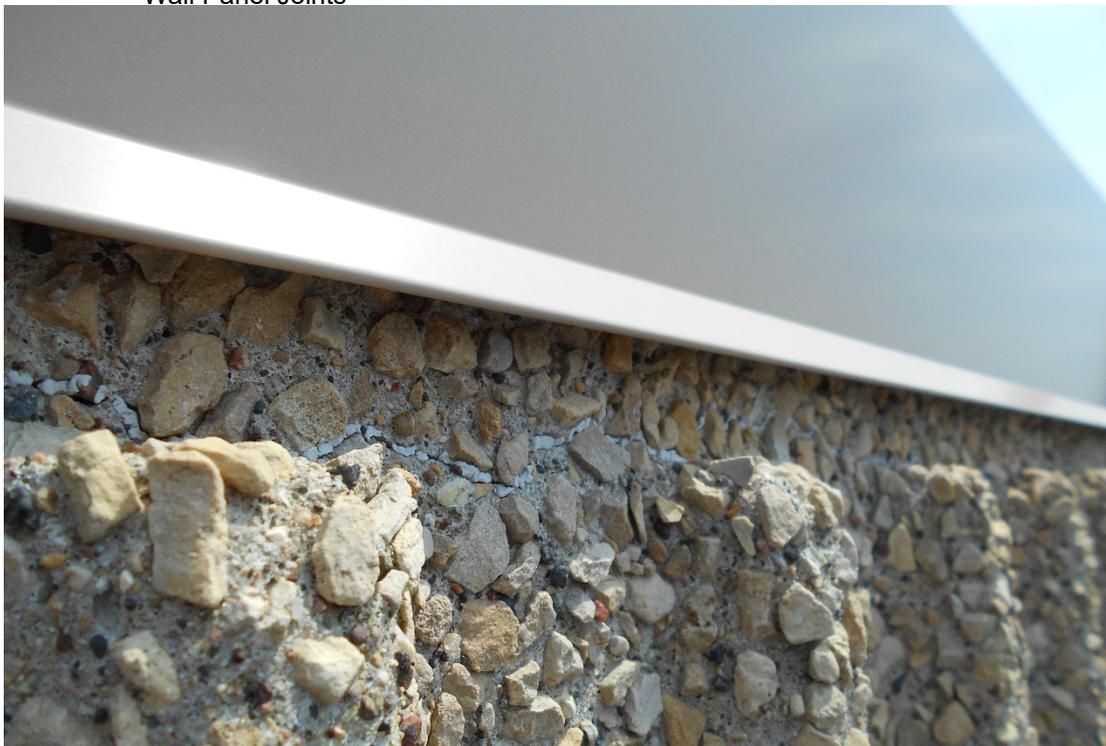
**Photo 3** Hairline Cracks in Precast Concrete Exterior Wall Panels (high roof)

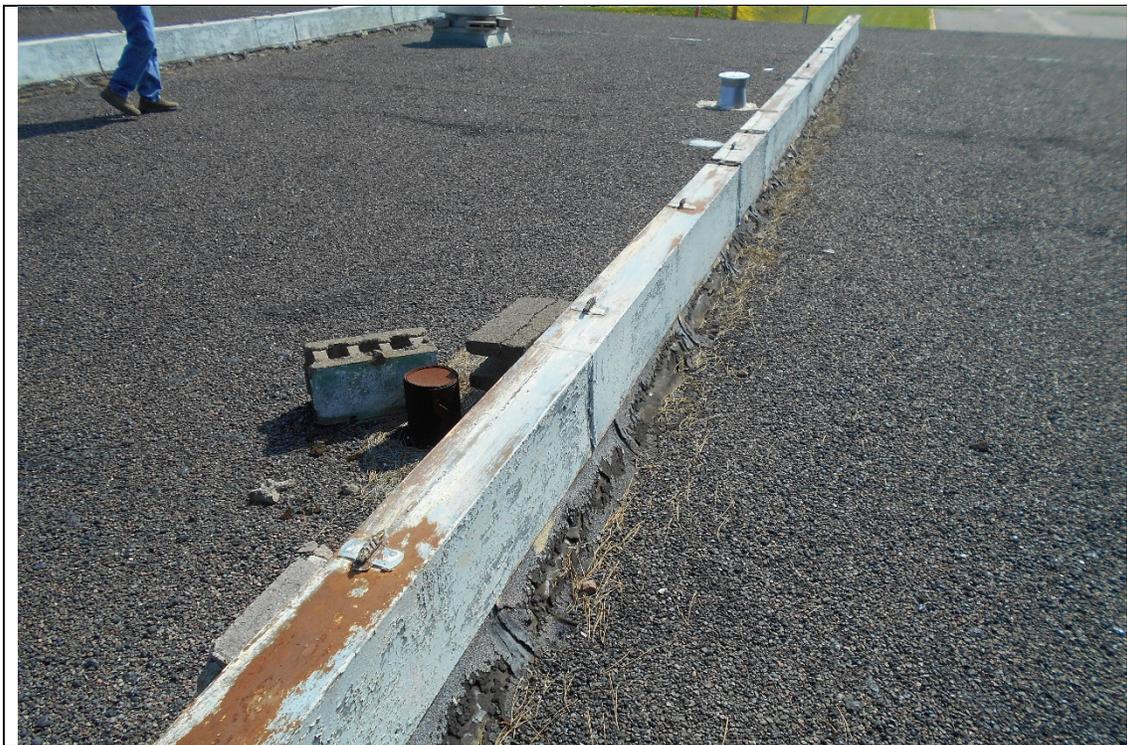
**Photo 7** Original Built-up Roof System Deteriorating/ Failing

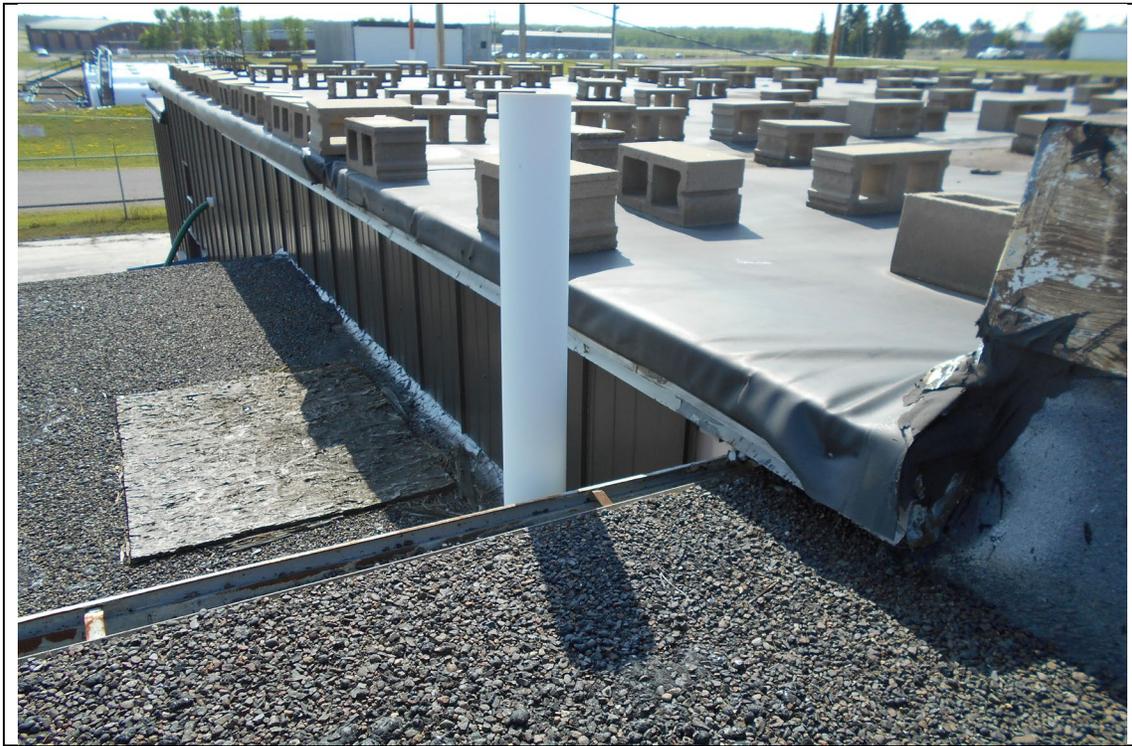
**Photo 9** Roof Edge Condition Not Properly Flashing/ Secured

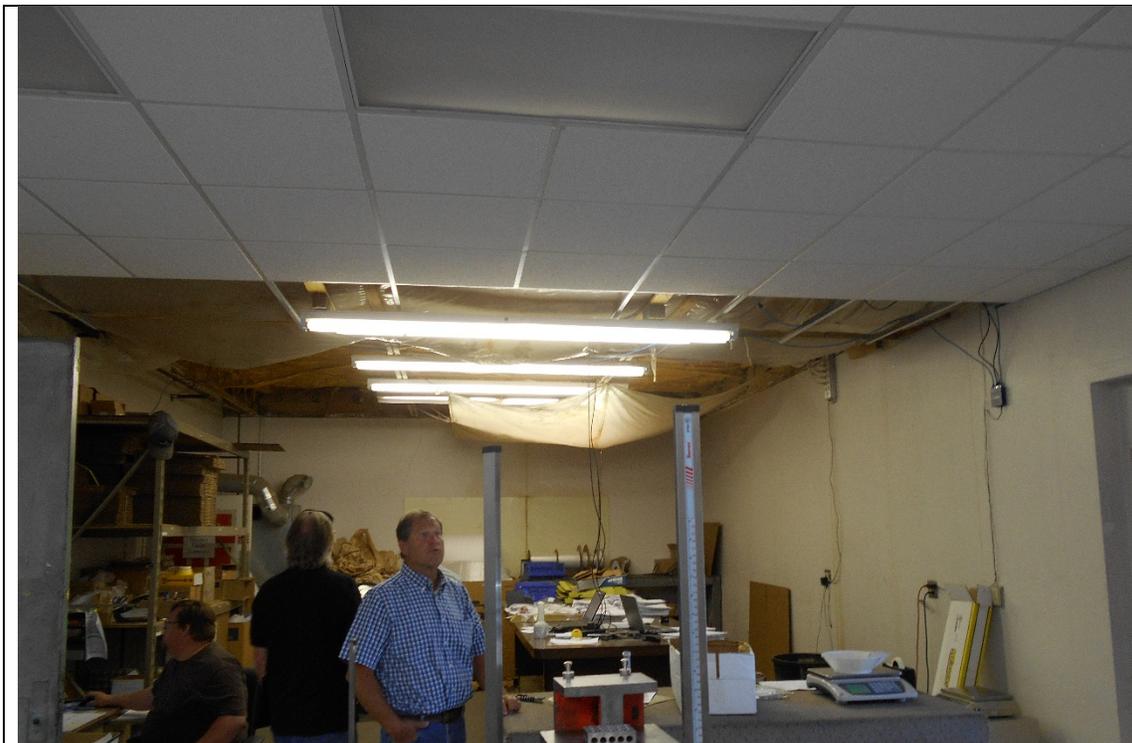
**Photo 11** Water Intrusion at Ceiling / Plastic Drip Curtains Placed to Catch and Divert Water into Plastic Buckets (multiple locations)

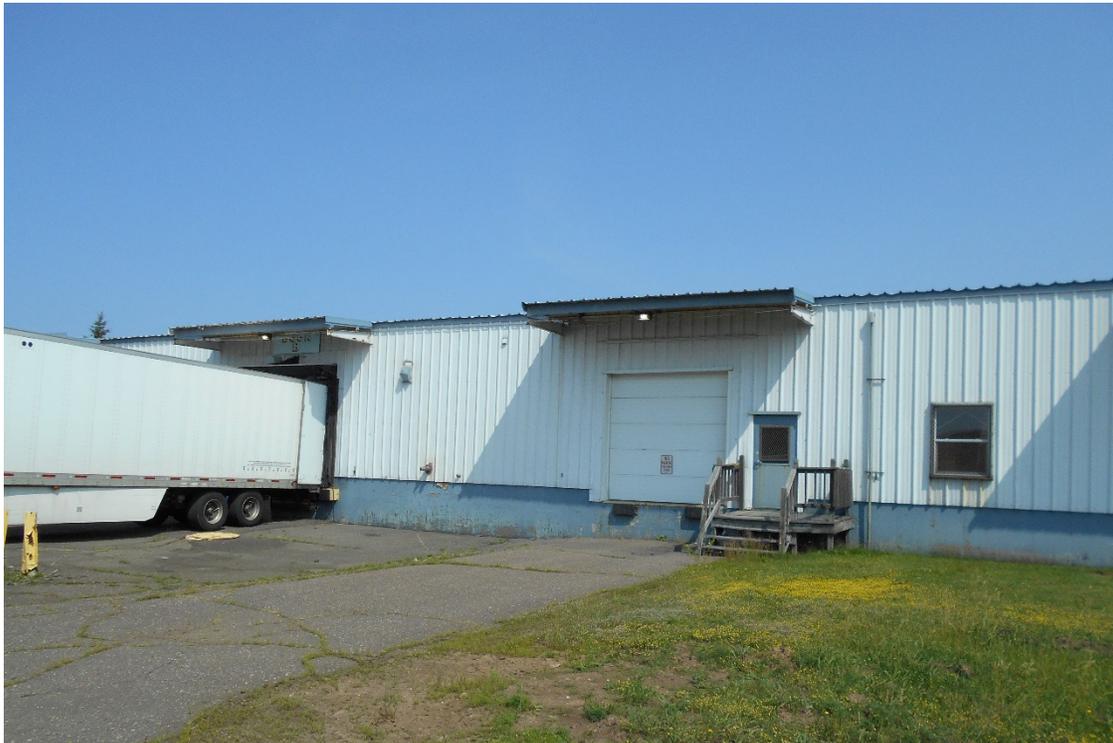
**Photo 3** Loading Dock Seals/ Pads Damaged or Missing

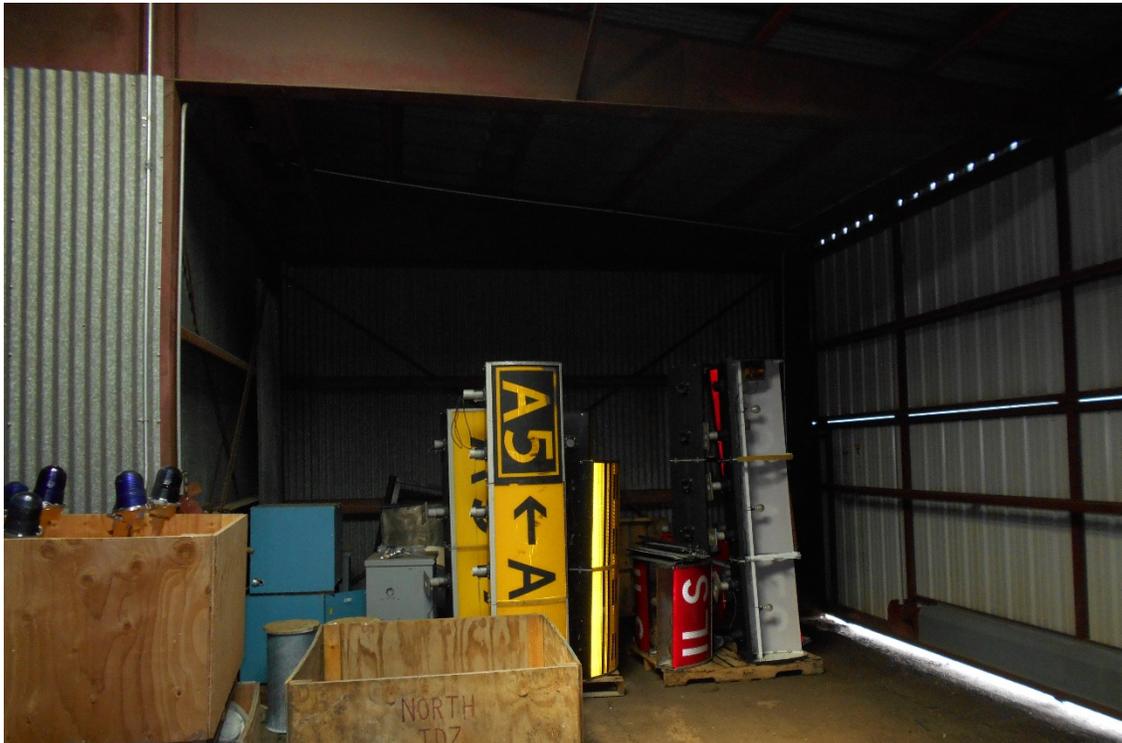
**Photo 5** Interior steel framing / hangar door seals missing

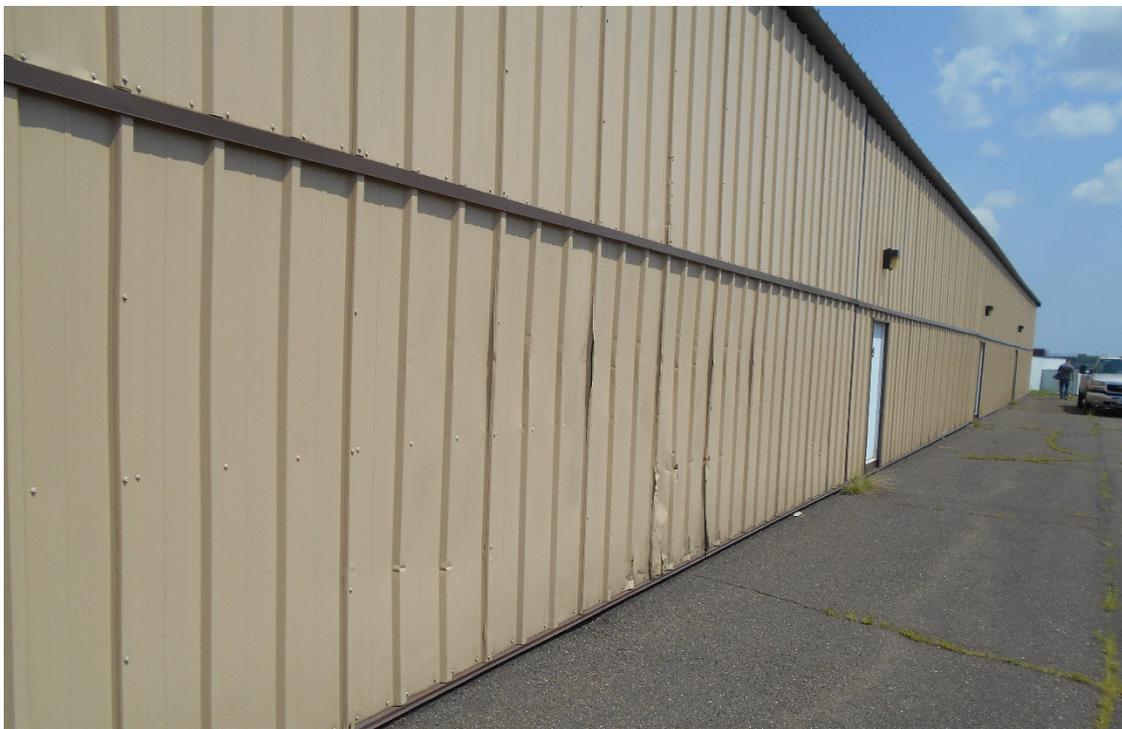
**Photo 2** Damaged exterior metal wall panels

- Patch and repair any punctured or damaged exterior metal wall and hangar door panels, estimated \$30,000.
- Clean and re-paint exterior wood frames and hollow metal doors, estimated \$7,000.
- Service the existing hangar doors and operator, along with replacing bottom seals, estimated \$7,000.
- Replace existing wood framed window located on east end of building, estimated \$600.

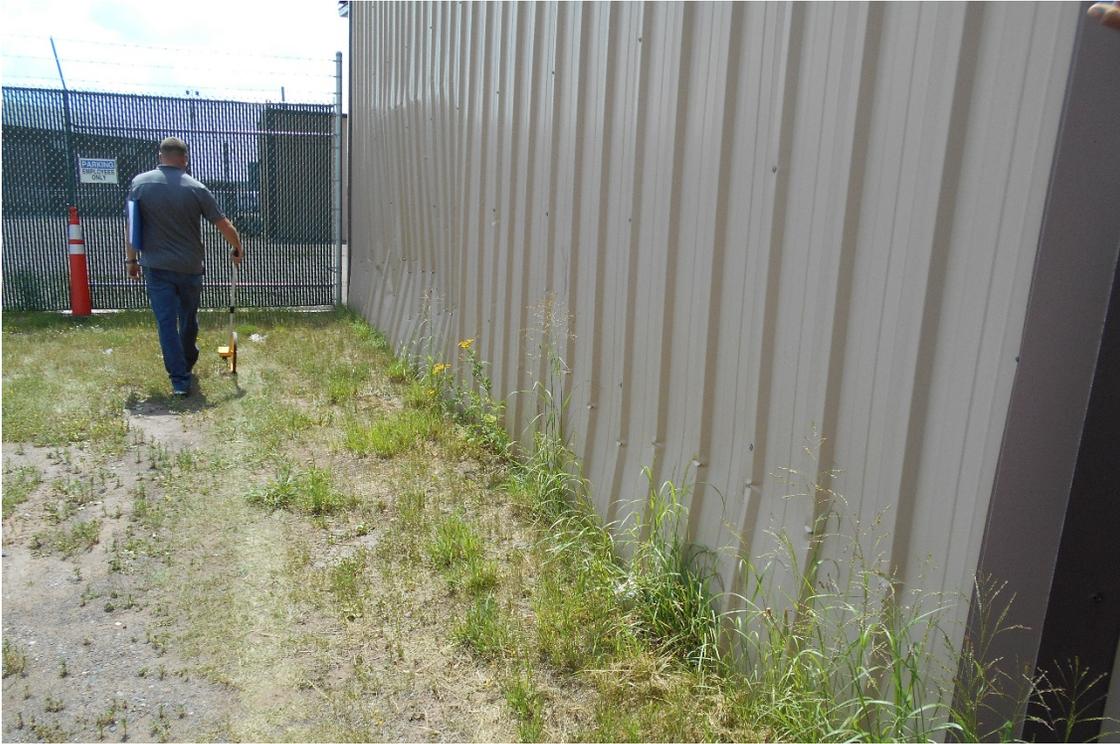
**Photo 3** Damaged exterior metal wall panels

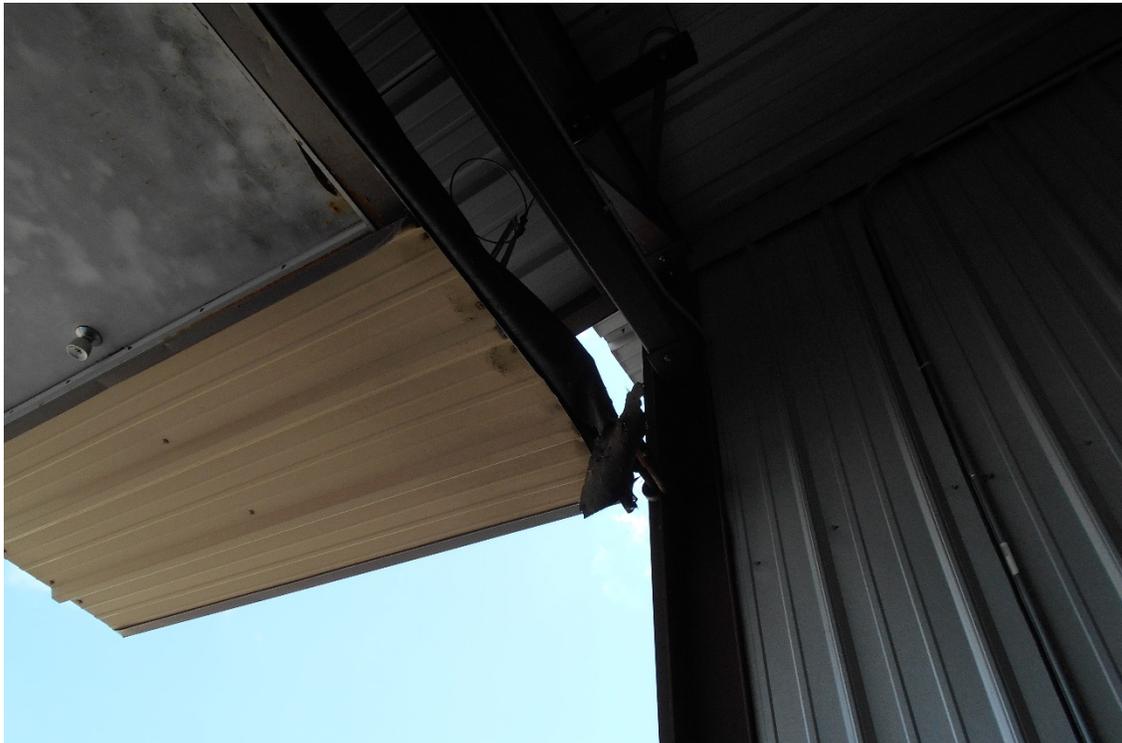
**Photo 5** Hangar door bottom seal ripped and torn

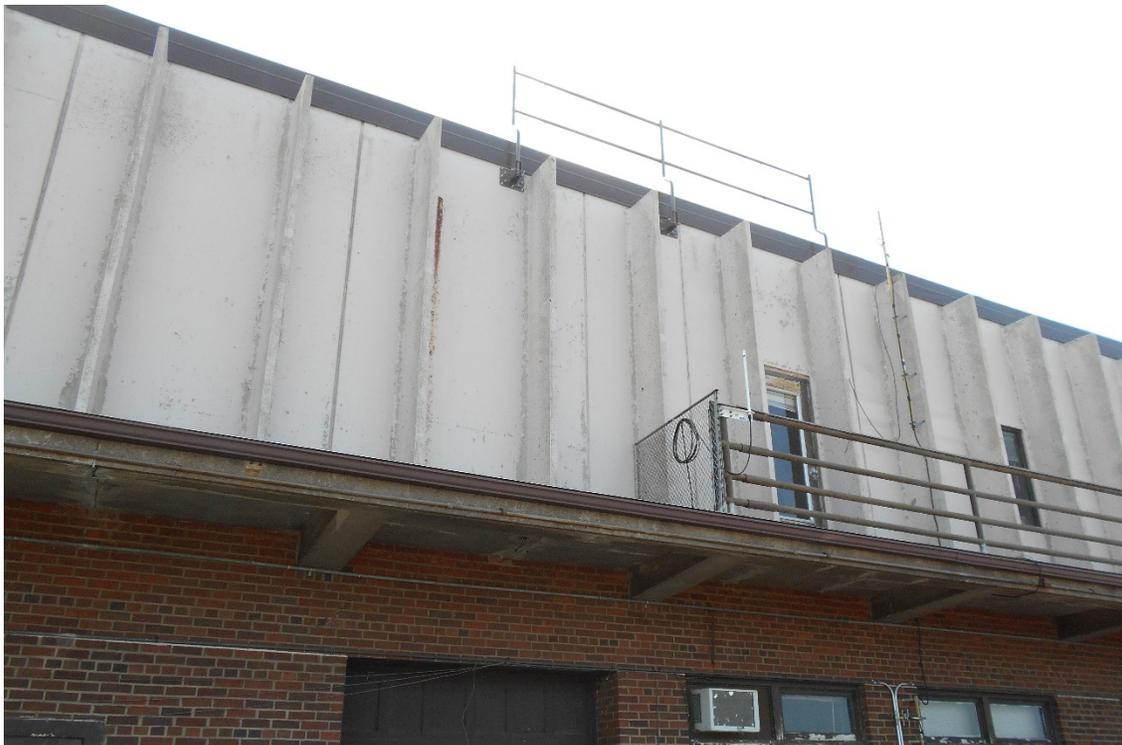
**Photo 3** Upper precast concrete wall panels paint finish peeling

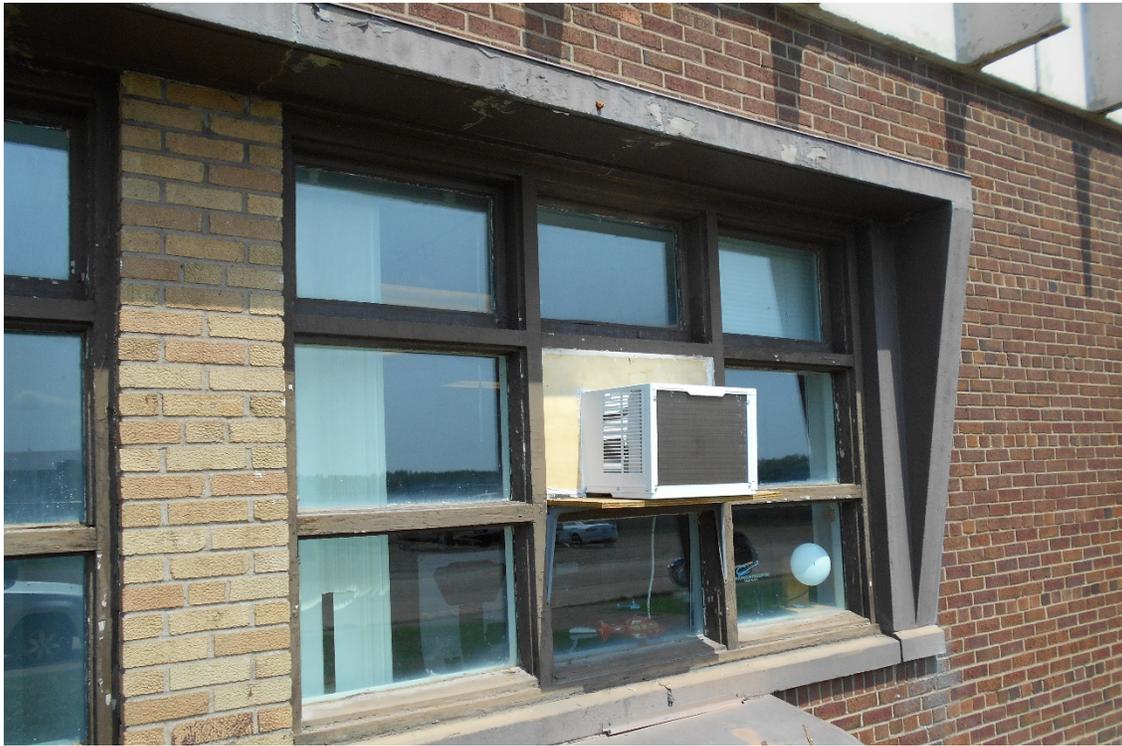
**Photo 7** Exterior painted wood framed windows in need of replacement

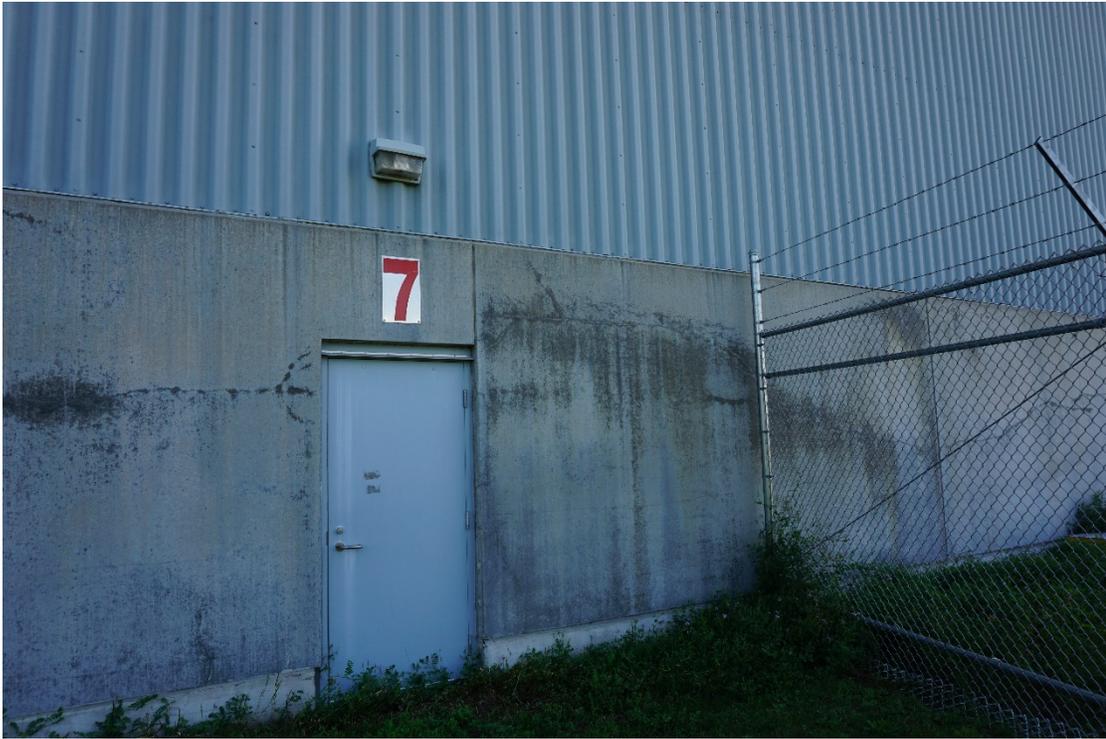
**Photo 3** Crack in exterior cast-in-place concrete wall

- Continue with recommended maintenance schedule for building components and utilities.
- Repair/ fill any cracks in concrete at lower portion of wall to prevent further deterioration and maintain weather tight enclosure.

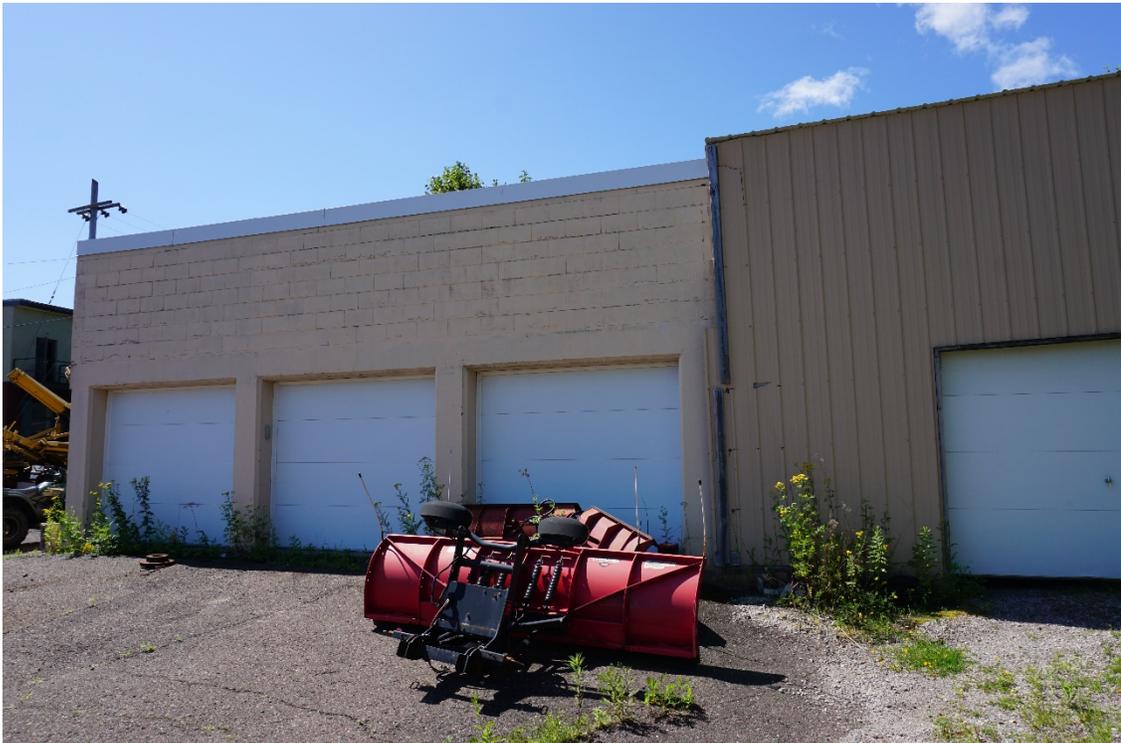
**Photo 3** Masonry block (CMU) and grout joints in need of tuck-pointing

- Extensive restorative work would be required to maintain building.
- Replace damaged masonry face shells. Locations of masonry and mortar joints in need of tuck-pointing at original building.
- Replace existing doors and windows (paint), along with replacing sealant joints along exterior openings/ frames.
- Thoroughly clean and remove any peeling paint, and provide new painted finish at exterior masonry walls.
- Repair/ replace weather stripping at overhead service doors.
- Evaluate construction type and condition at post frame addition. Re-position, properly flash and secure post frame addition to original masonry building to provide weathertight enclosure (if feasible).
- Assess existing roof conditions and make necessary repairs/ replacement.

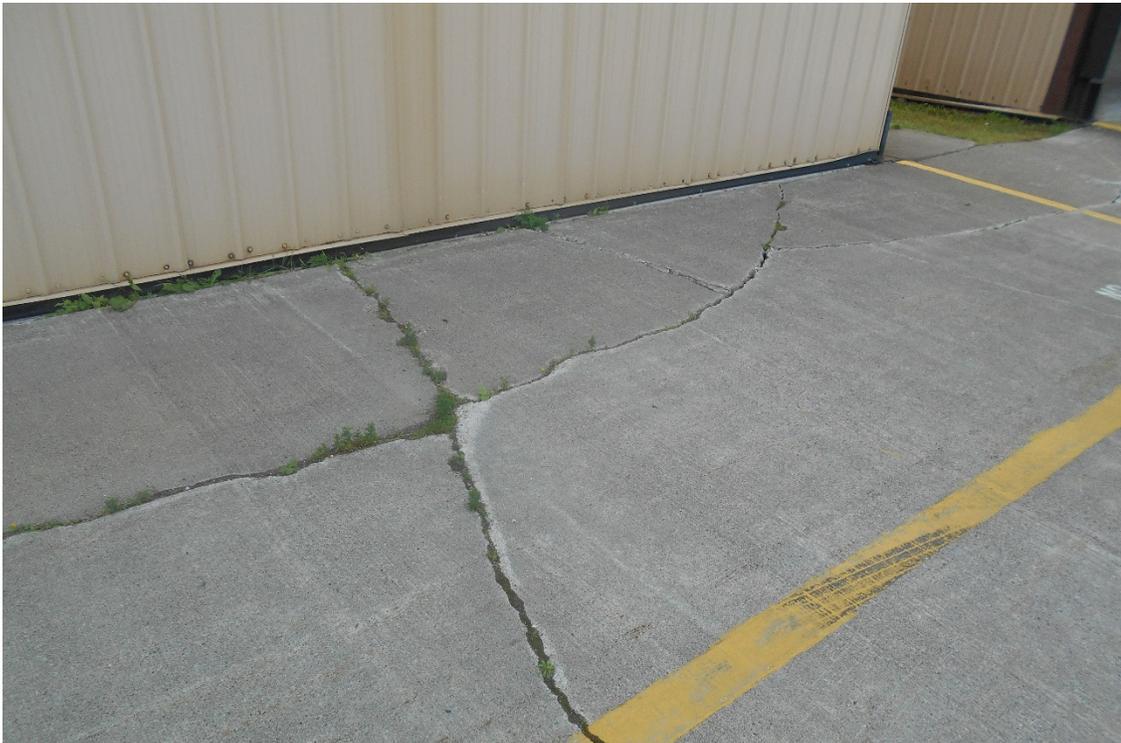
**Photo 3** Cracks in exterior concrete apron

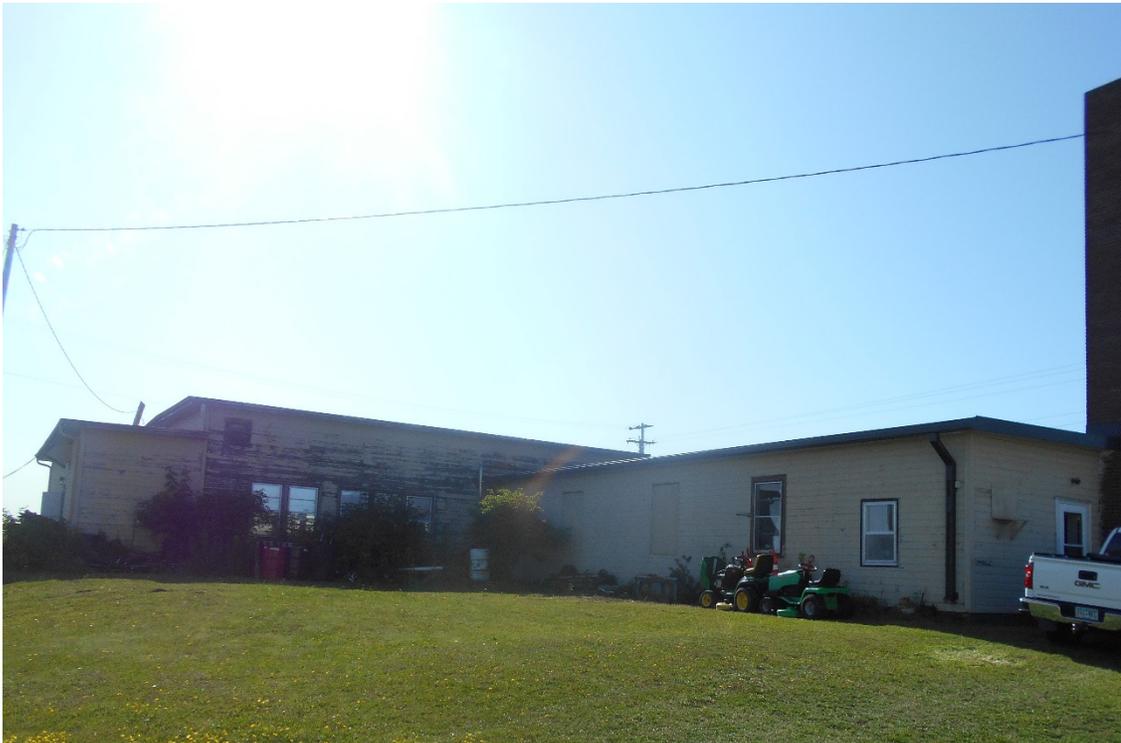
**Photo 3** Paint finish failing (West side)

- Clean and paint existing wood siding and wood framed windows and doors to prevent further deterioration. Replace any exterior sealant that shows signs of separation, cracking, or hardening of material. Replace missing ceiling insulation/ vapor barrier in shop (multiple locations). Roof was not accessible at time of site visit, so condition of existing roof system not observed.

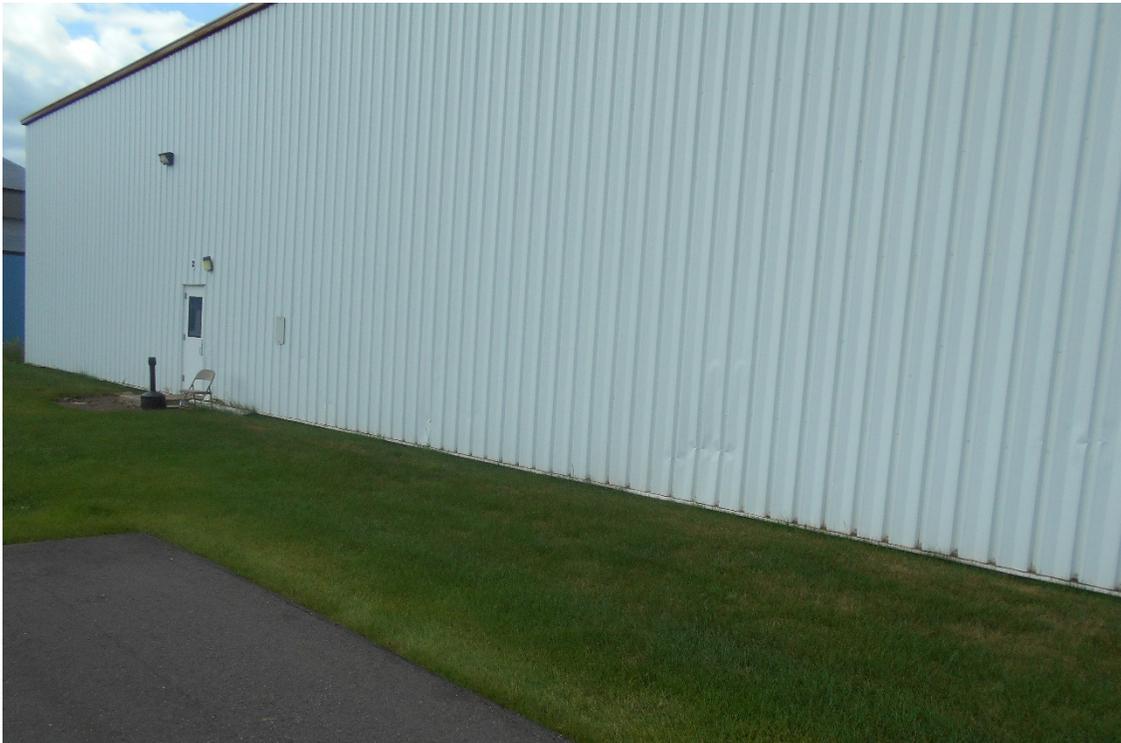
**Photo 3** Damage along bottom of prefinished metal wall panels
