# Building Assessments

Duluth Airport Authority

Duluth, Minnesota

DULAI 150733 | September 13, 2021

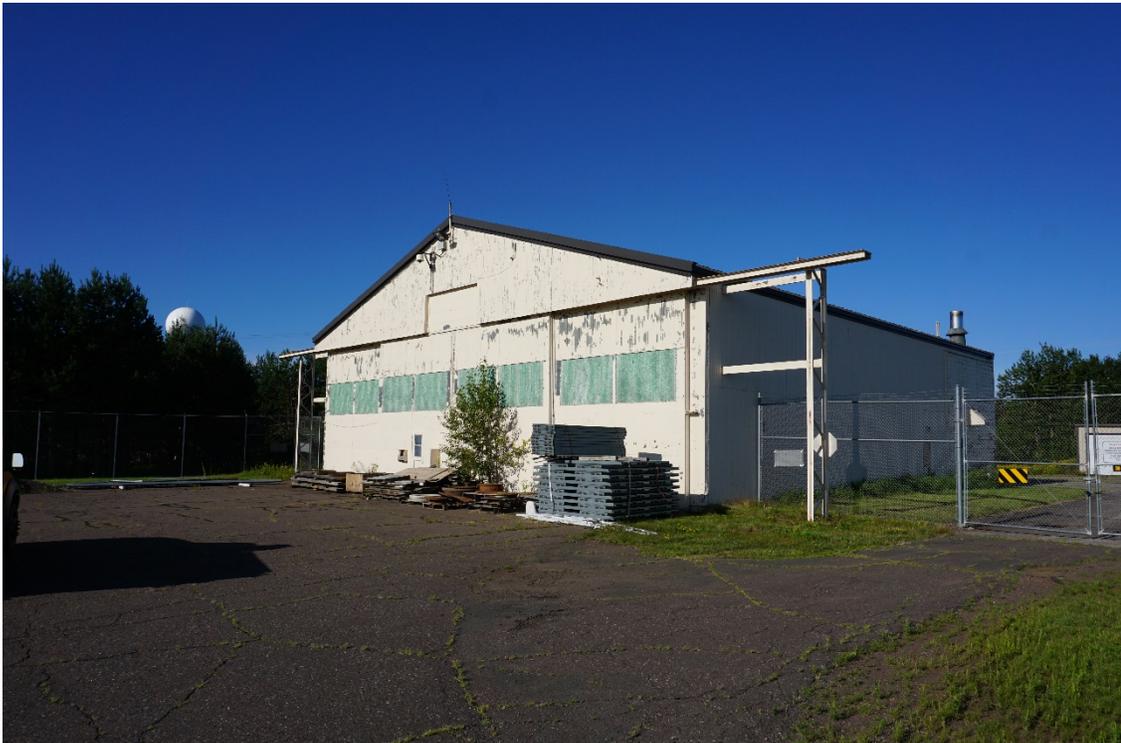
**Photo 1** DRMO Exterior Building / painted finish failing

- Clean off existing peeling/ flaking paint from corrugated metal siding and re-paint exterior. Clean and tuck-point damaged masonry and grout locations, and re-paint concrete masonry portion of building.
- Remove and reinstall failed sealant at joints between dissimilar material connections, door/ window frames, and at through wall penetrations.

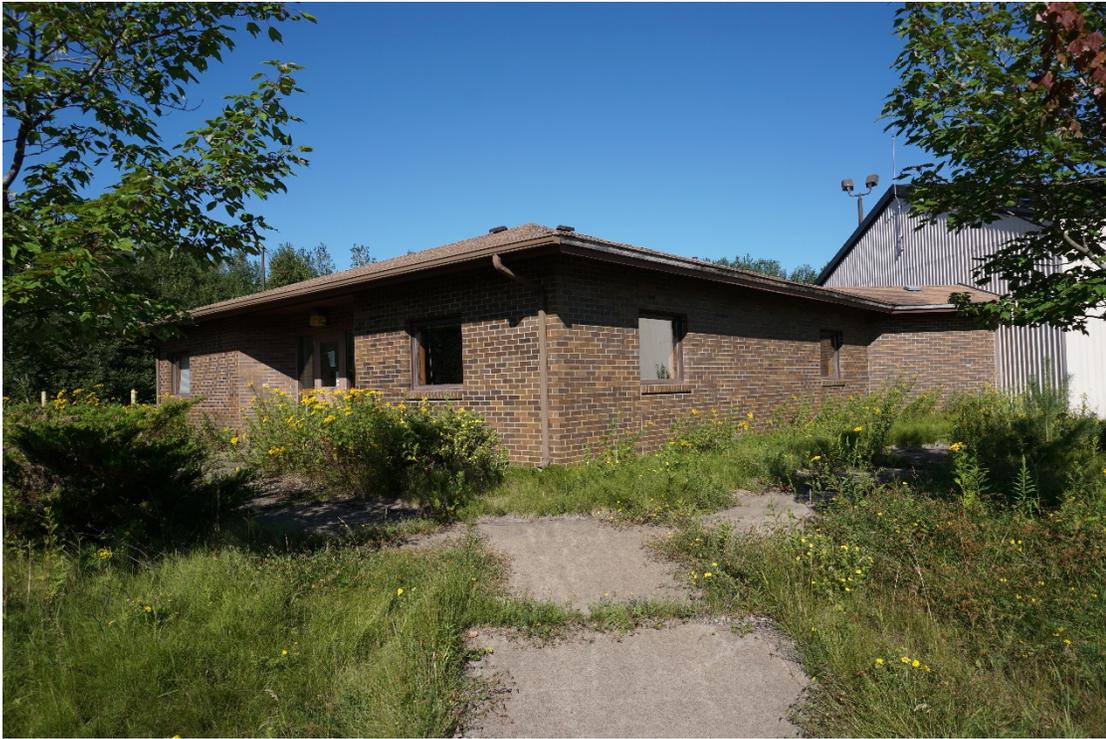
**Photo 3** Brick administrative building addition

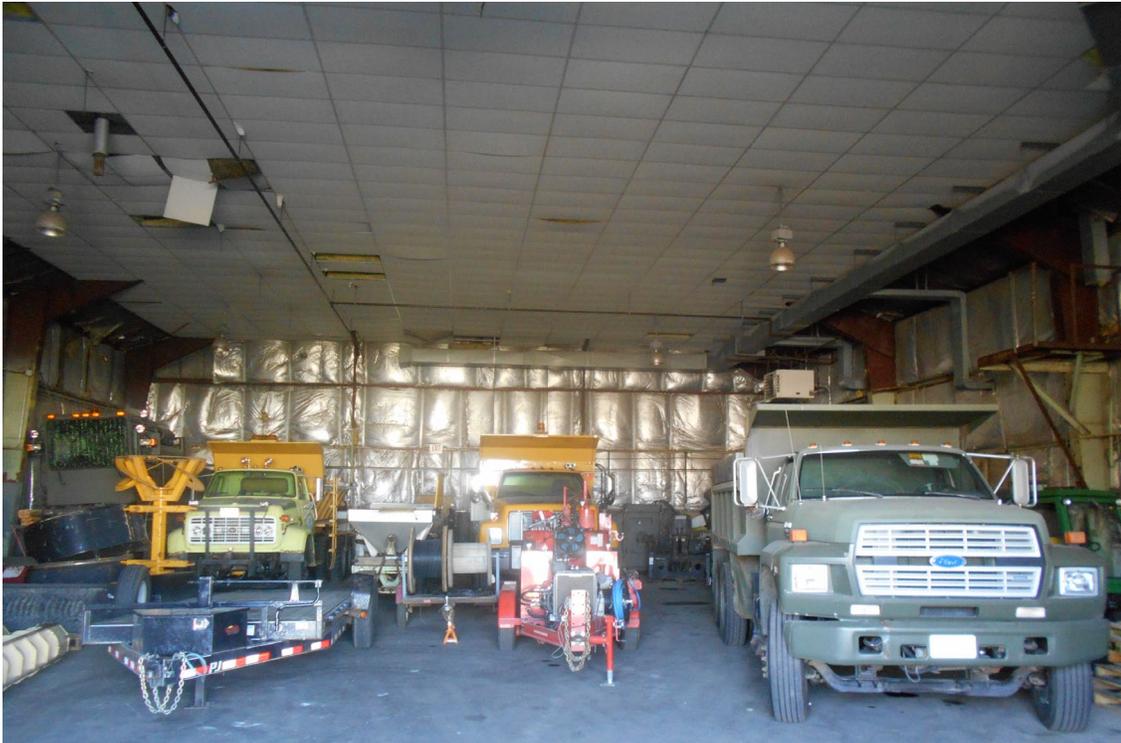
**Photo 3** Interior condition

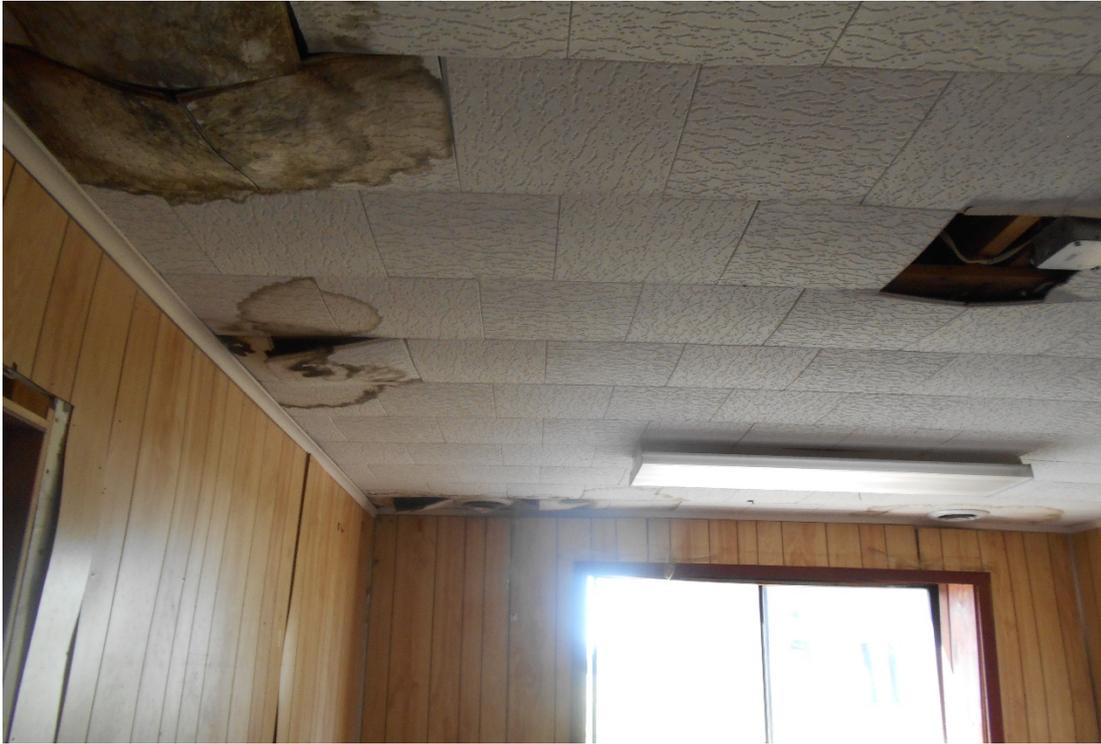
**Photo 5** Water intrusion

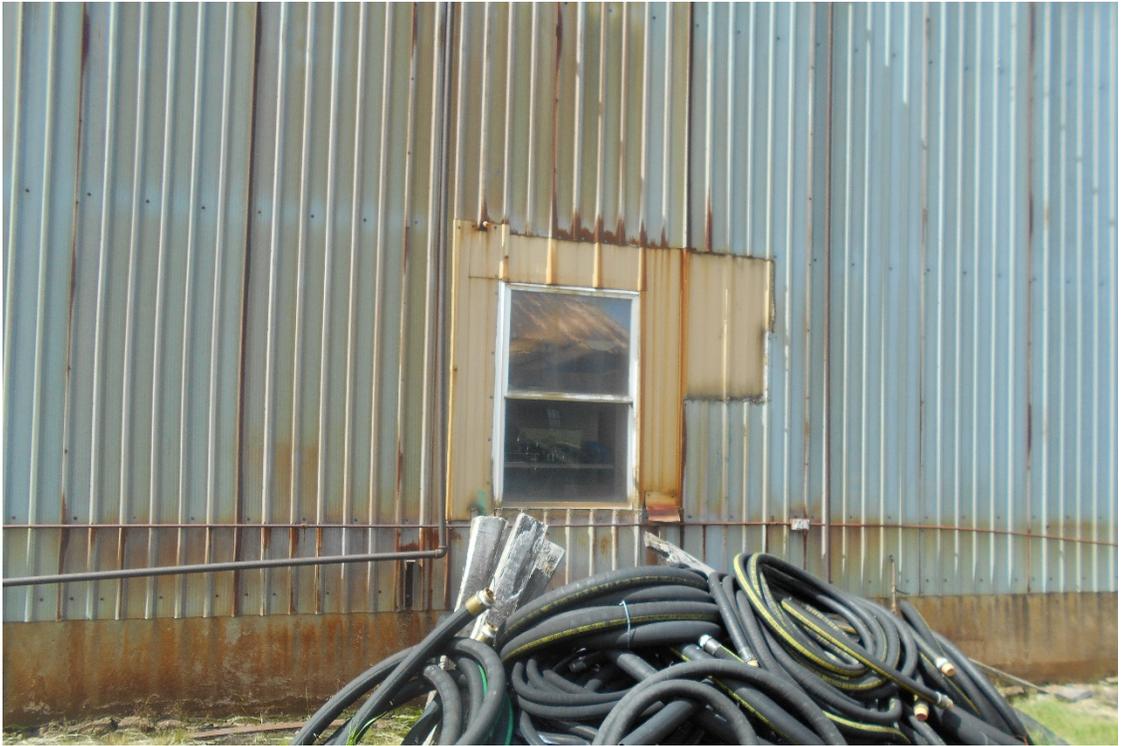
**Photo 3** Window patch/ repair

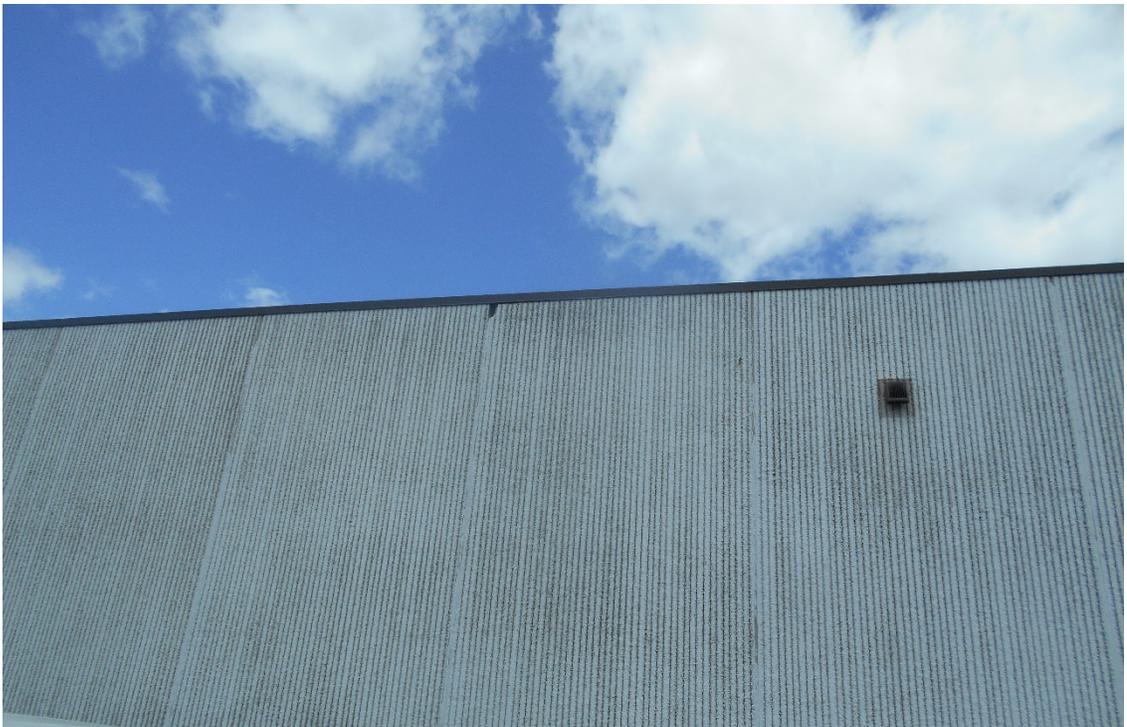
**Photo 2** Crack/ chip in original building precast concrete wall panel

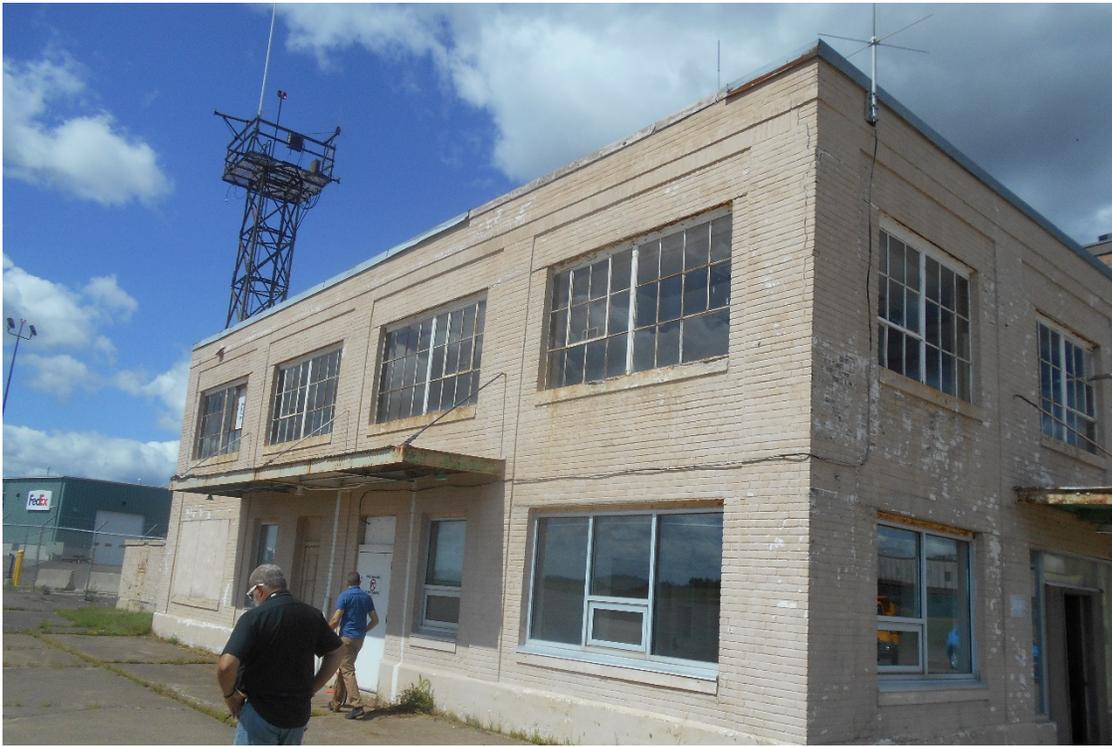
**Photo 3** Brick addition, in poor shape

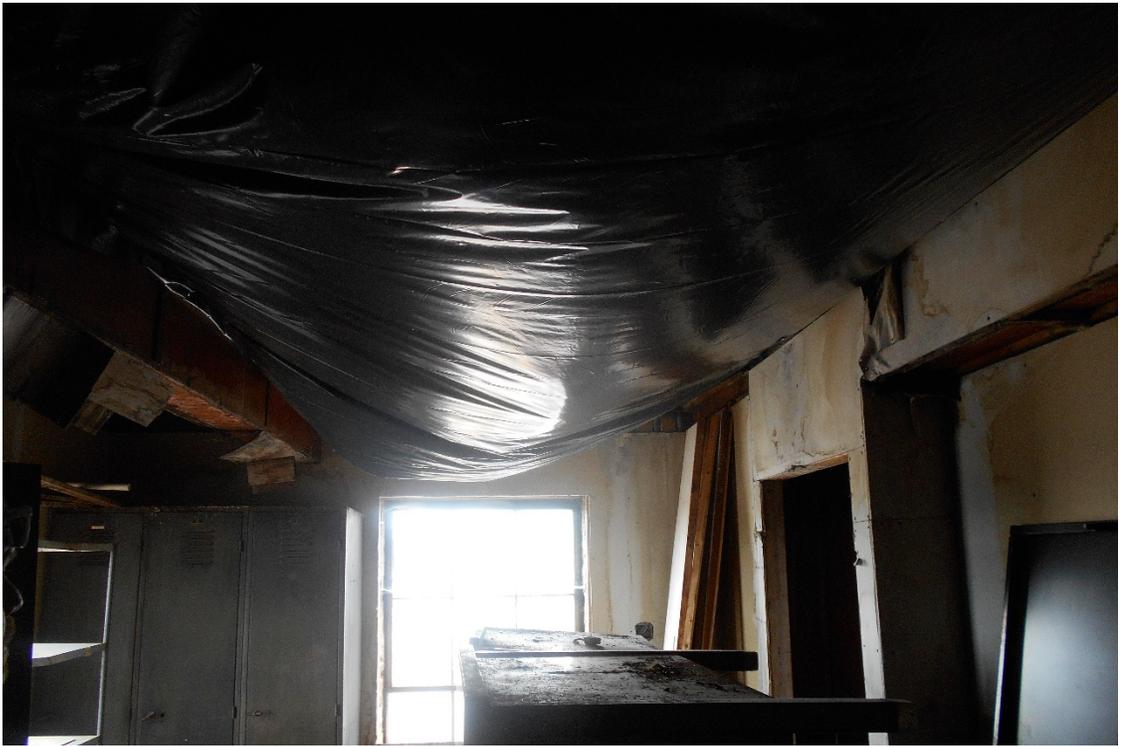
**Photo 5** Damage at interior of addition (multiple locations)

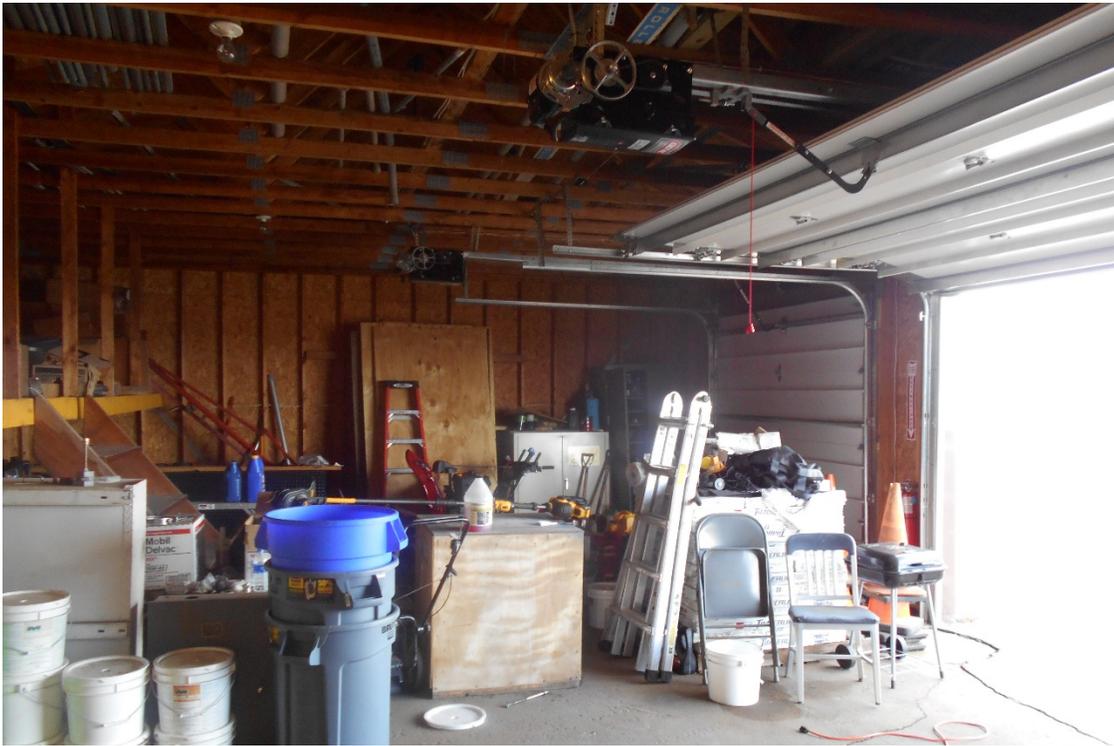
**Photo 3** Cracks in bituminous floor slab
