Landside Pavement Assessment

Duluth Airport Authority

Duluth, Minnesota

DULAI 150733 | September 13, 2020

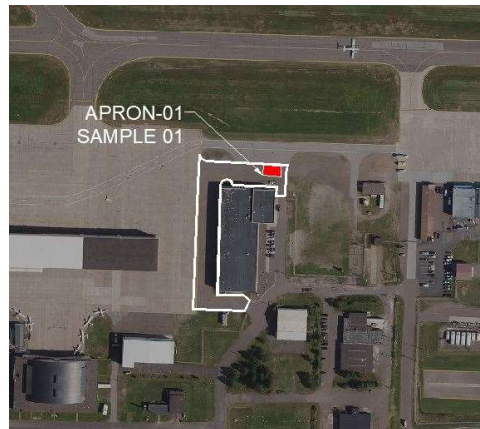
This apron section is located on the south side of the airport, adjacent to the SRE Building, and is for use by vehicles only. The Asphalt Concrete pavement in this section is in very good condition, and currently only requires preventative maintenance.

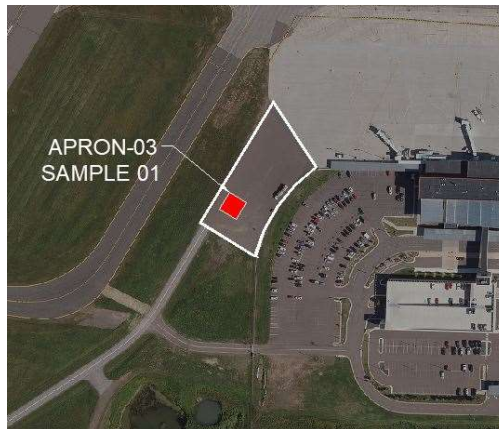
This apron section is located on the southeast side of the airport adjacent to the terminal ramp. The Asphalt Concrete pavement in this section is in very good condition, and currently only requires preventative maintenance.

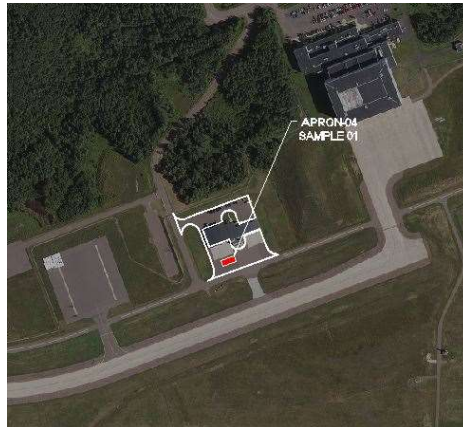
This apron section is located on the north side of the airport adjacent to the Aircraft Rescue and Fire Fighting (ARFF) building. The Asphalt Concrete pavement in this section is in excellent condition, and currently only requires preventative maintenance.

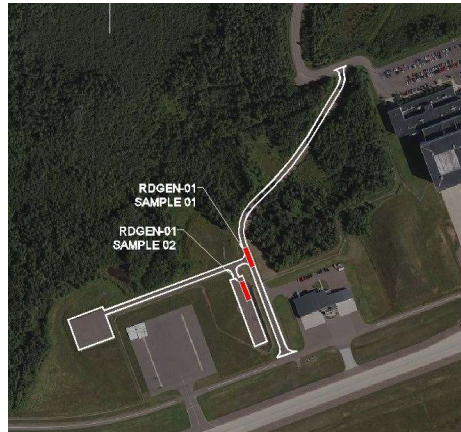
This general road section is located on the north side of the airport allowing access to the airport entrance. The Asphalt Concrete pavement in this section is in excellent overall condition, and currently only requires preventative maintenance.

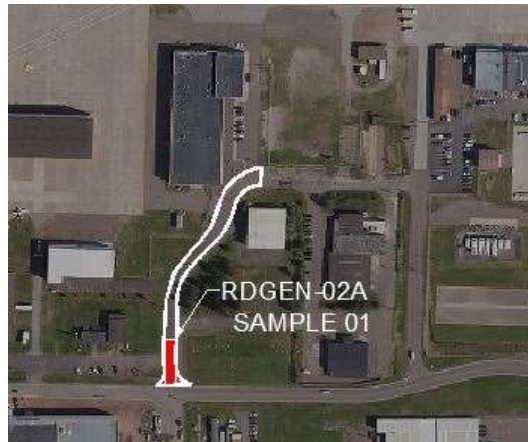
This general road section is located on the south side of the airport allowing vehicle access to several surrounding buildings. The Asphalt Concrete pavement in this section is in a failed condition and requires total reconstruction.

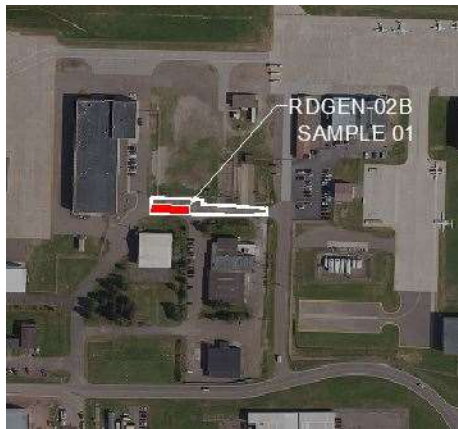
This general road section is located on the south side of the airport allowing vehicle access to several surrounding buildings. The Asphalt Concrete pavement in this section is in a failed condition and requires total reconstruction.

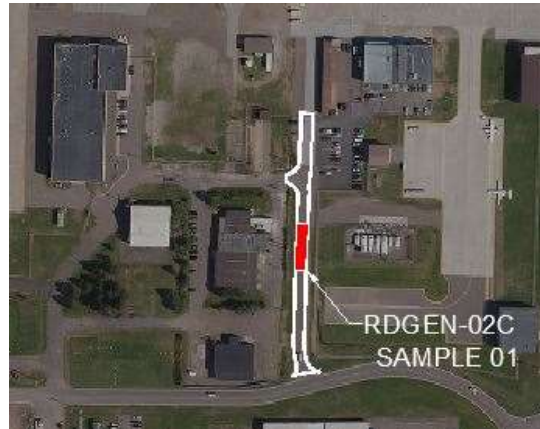
This general road section is located on the south side of the airport allowing vehicle access to several surrounding buildings. The Asphalt Concrete pavement in this section is in a very good condition, and currently only requires preventative maintenance.

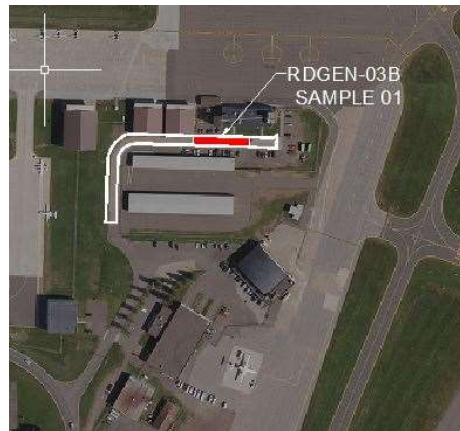
This general road section is located on the south side of the airport, providing vehicle access to the Air Traffic Control Tower and surrounding. The Portland Cement Concrete pavement in this section is in fair condition and requires major rehabilitation.

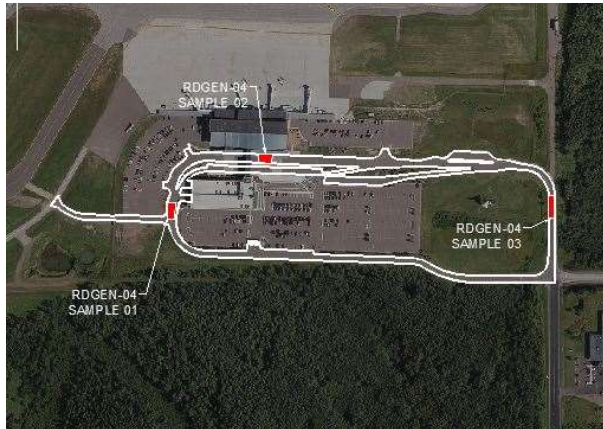
This general road section is located on the southeast side of the airport providing vehicle access to the airport terminal and parking lots. The Asphalt Concrete pavement in this section is in very good condition and will require preventative maintenance.

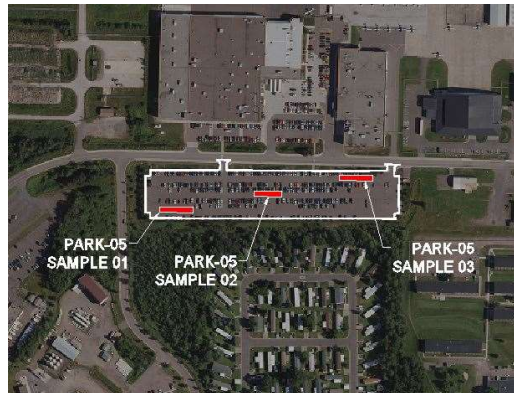
This parking lot section is located on the southwest side of the airport. The Asphalt Concrete pavement in this section is in excellent condition and currently only requires preventative maintenance.

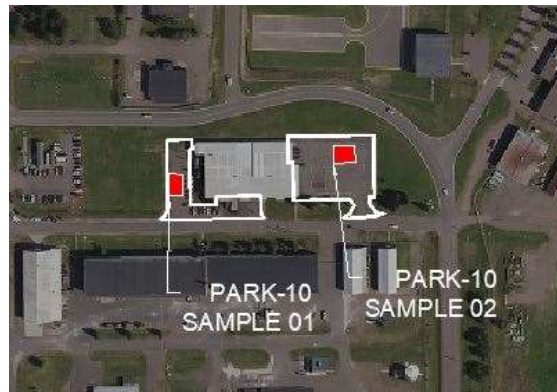
This parking lot section is located on the southwest side of the airport. The Asphalt Concrete pavement in this section is in poor condition and requires reconstruction.

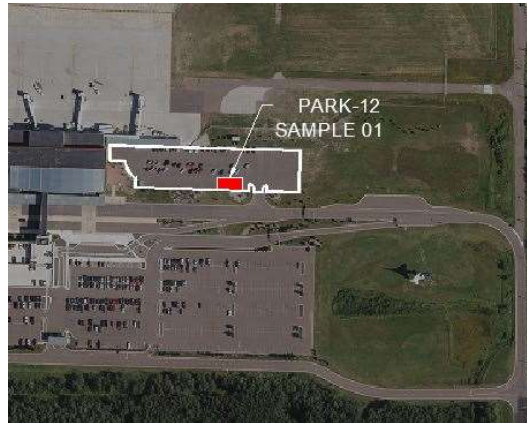
This parking lot section is located on the southeast side of the airport adjacent to the airport terminal. The Asphalt Concrete pavement in this section is in very good overall condition, and currently only requires preventative maintenance.

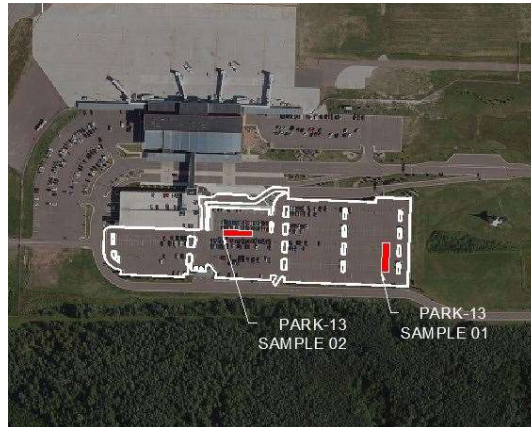
This parking lot section is located on the southeast side of the airport adjacent to the airport terminal. The Asphalt Concrete pavement in this section is in very good condition, and currently only requires preventative maintenance.

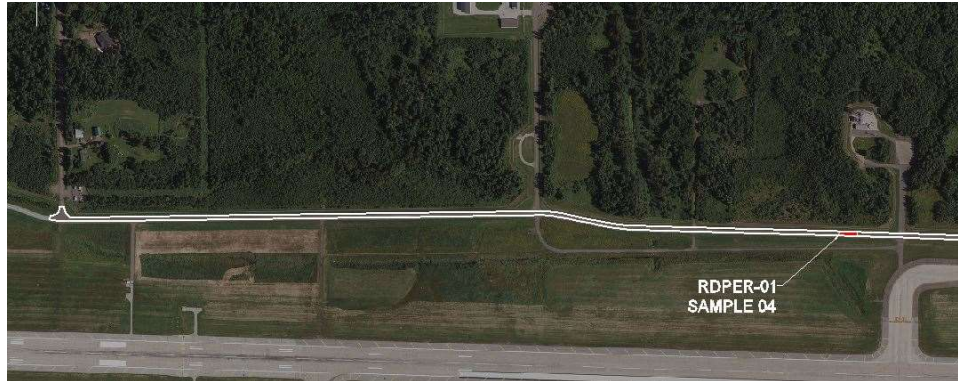
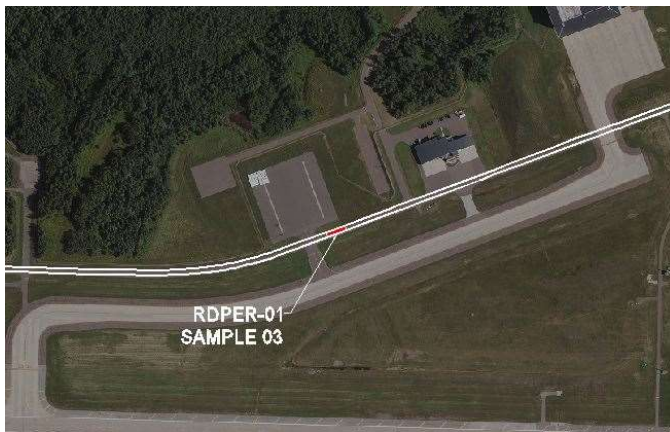
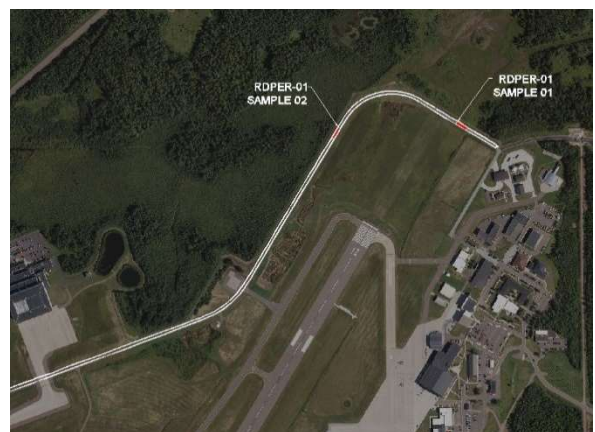
This perimeter road section is located on the north and northeast sides of the airport. The Asphalt Concrete pavement in this section is in very good condition, and currently only requires preventative maintenance.

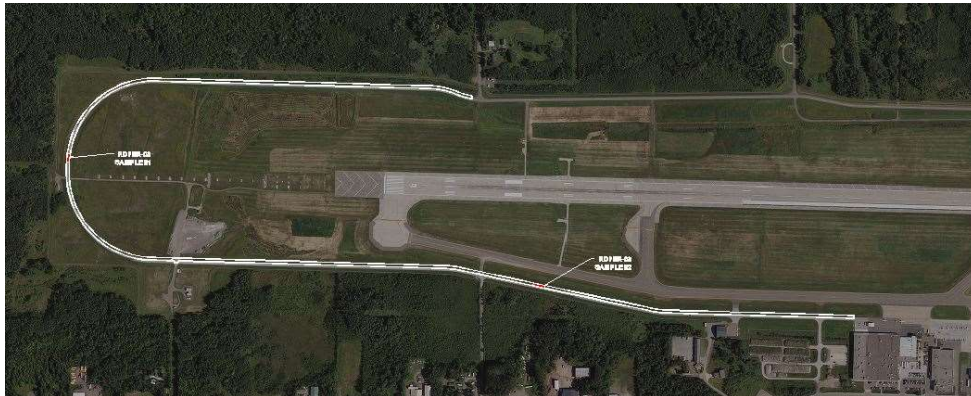
This perimeter road section is located on the north and west sides of the airport. The Asphalt Concrete pavement in this section is in very good condition, and currently only requires preventative maintenance.

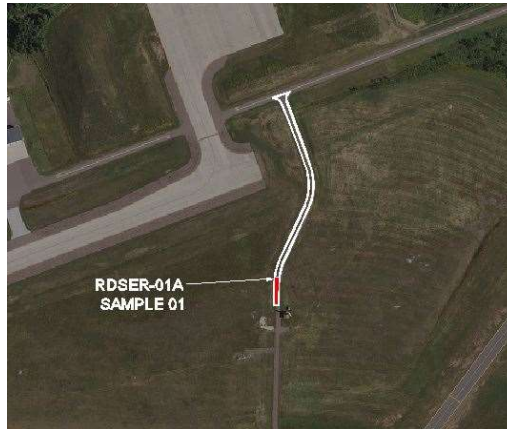
This service road section is located on the east side of the airport and provides vehicle access to the north of Runway 9-27. The Asphalt Concrete pavement in this section is in excellent overall condition, and currently only requires preventative maintenance.

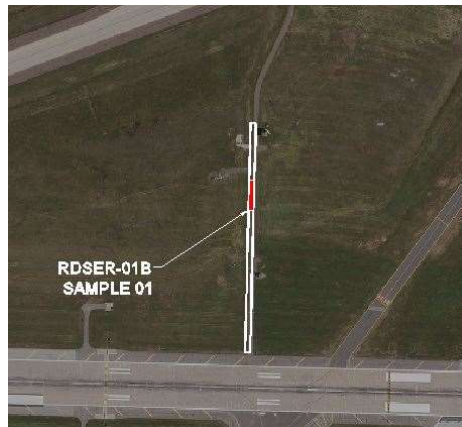
This service road section is located on the east side of the airport providing vehicle access to the north of Runway 9-27. The Asphalt Concrete pavement in this section is in fair condition and requires major rehabilitation.

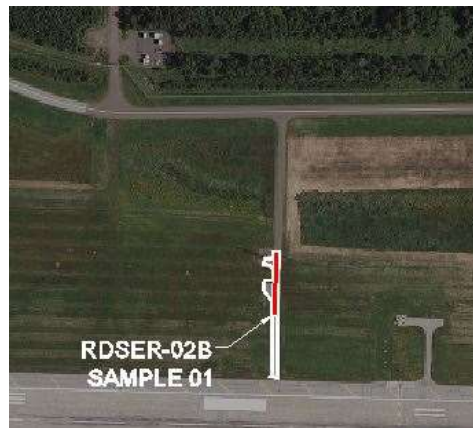
This service road section is located on the west side of the airport providing vehicle access to the north of Runway 9-27. The Asphalt Concrete pavement in this section is in fair condition, and requires major rehabilitation.
