INTENSIVE ARCHITECTURAL HISTORY SURVEY OF HANGAR 101 FOR THE DULUTH INTERNATIONAL AIRPORT MASTER PLAN PROJECT

Duluth, St. Louis County, Minnesota

September 2021

106 Group Project No. 2566

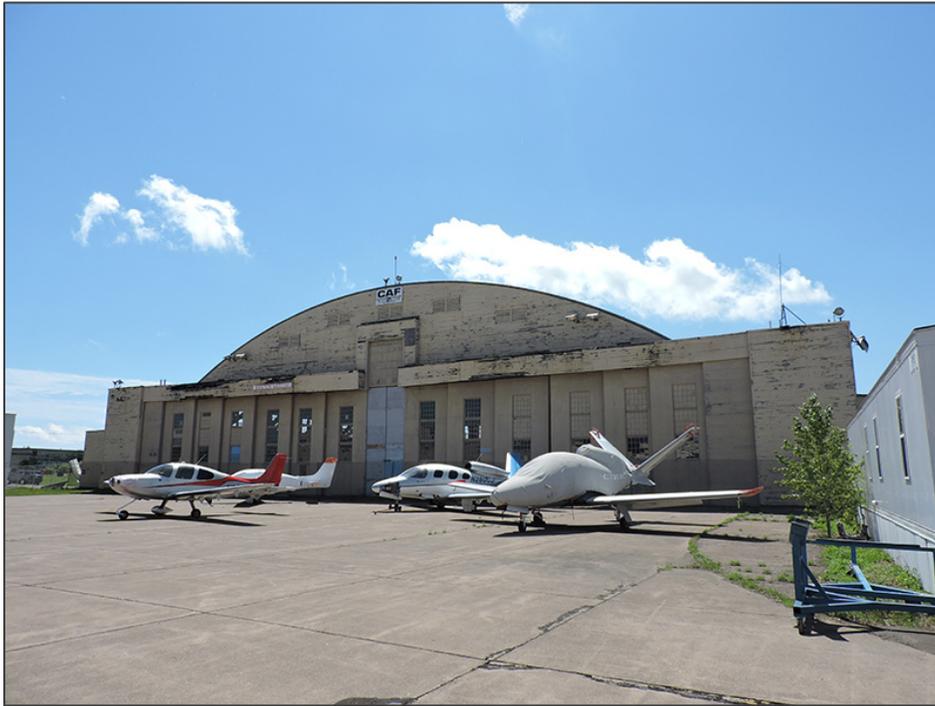
Hangar 101 is a single-bay, arched-roof hangar that is flanked by two-story, flat-roof maintenance and office wings on the east, south, and west elevations (Figures 2-3). The hangar is located in the southwest

Figure 2. Hangar 101, North Elevation, Facing Southeast (106 Group, May 2021)

Fenestration on the north elevation includes the 14-leaf sliding metal door; three sets of 20-light windows in each door panel; and a 36-light metal window.

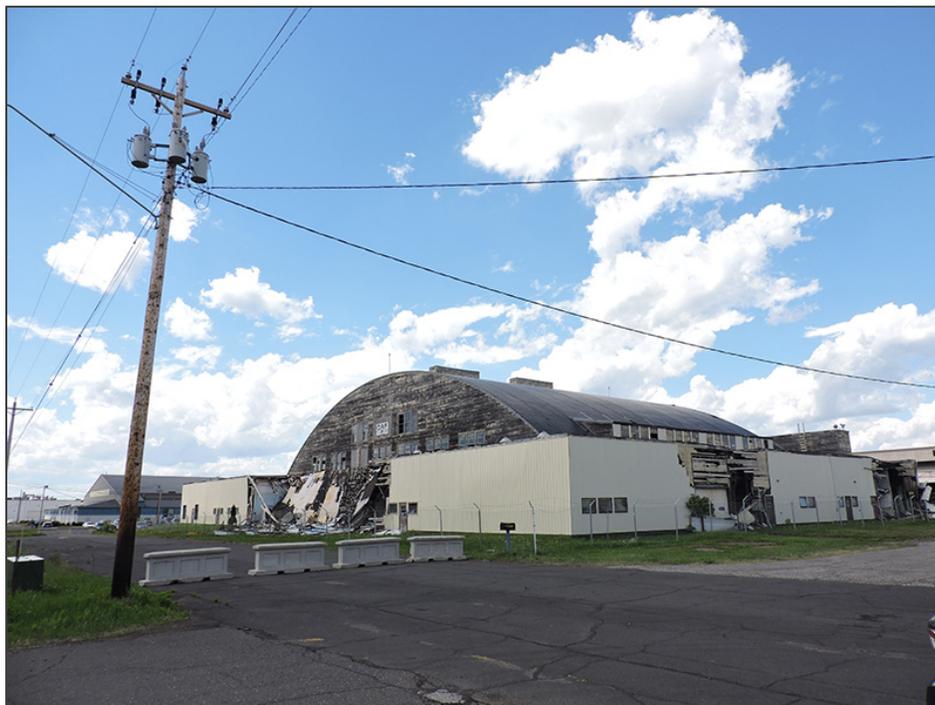
Figure 3. Hangar 101, Facing Northwest, Showing Collapsing Wings (106 Group, May 2021)

The wings obscure the view of the arched-roof hangar sections such that the arched-roof hangar section is only visible above the two-story wings. Clerestory sections are located on the east and west elevations, above the two-story wings. The building is clad in horizontal wood siding and replacement vertical metal panels. The north elevation features a tall, 14-leaf sliding metal door that splits in the middle. Signs at the top of the arched section on the north and south elevations read “CAF.” The north elevation also features a small sign that reads “Aviation Museum” above the 14-leaf sliding door. Two wood-sided mechanical boxes are located at the top of the arched-roof hangar section. The two-story wings on the east, south, and west elevations have collapsed in several locations and the interior of the building is visible through these sections.

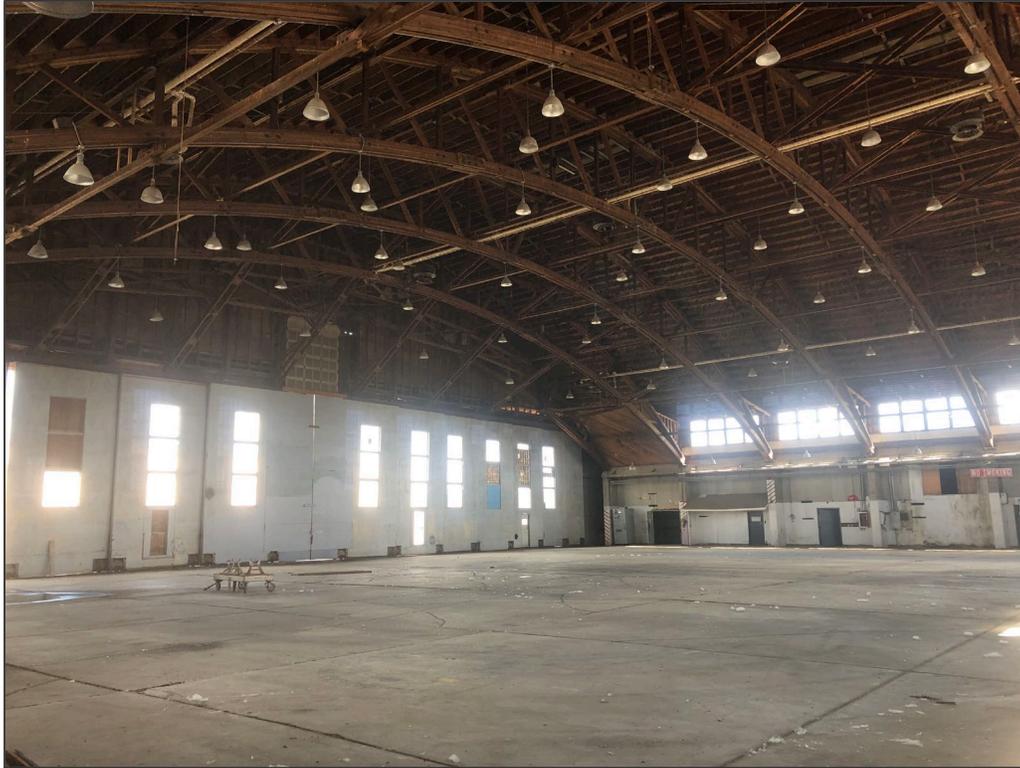
The interior of the central hangar section consists of a large unobstructed open area with a poured concrete floor and poured concrete walls (Figure 4). On the east and west walls, the concrete walls extend from the floor to the bottom of the wooden crescent arches. On the south wall, the concrete wall stops halfway from the floor to the top of the crescent arch; above the concrete wall, the remainder of the wall is constructed of wood framing and cladding. The north wall is comprised of a pair of seven-leaf sliding doors. Each leaf is set on wheels, which move the leaves along seven parallel tracks inlaid into the concrete floor. When the doors are open, each leaf recesses behind the preceding leaf into a wood-clad pocket structure that extends beyond the width of the hangar.

The roof system of the hangar consists of seven, two-hinged, wooden crescent arch trusses (Figure 4). The trusses are approximately 164 feet from east to west, and are spaced approximately 23 feet apart, north to south (Google Earth 2021). Each truss is a crescent truss with an arched top and bottom chord and has wooden vertical and diagonal members arranged in a saw tooth pattern. Wooden lateral bracing between the trusses is in a vertical “X” pattern. The roof rafters span between the trusses and the rafters are sheathed with wooden boards laid at a diagonal. Each truss is bolted to concrete piers/buttresses embedded into the concrete walls on the east and west sides of the hangar.

Figure 4. Hangar 101, Interior of the Central Hangar, Facing Northeast (SEH, March 2021)

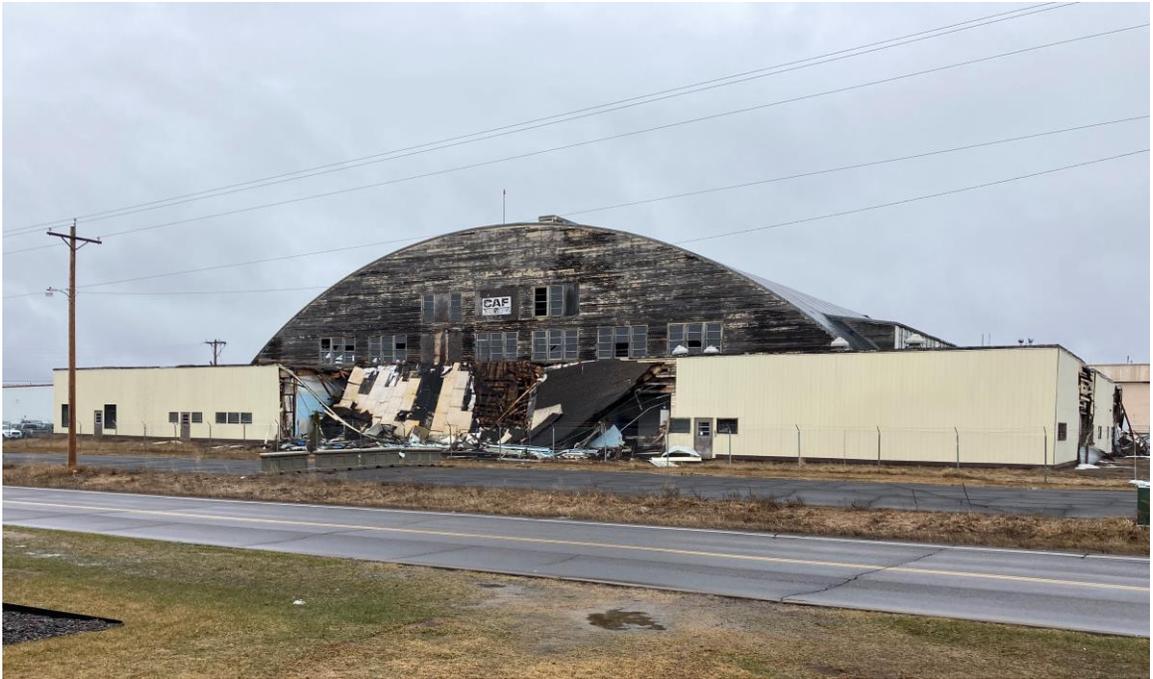
Fenestration on the south elevation includes modern two-light sliding metal windows with transoms; single-leaf metal doors with single-lights; and single-light fixed metal windows.

SL-DUL-3641 - 3/29/2021 - South Elevation, Facing North (SEH)

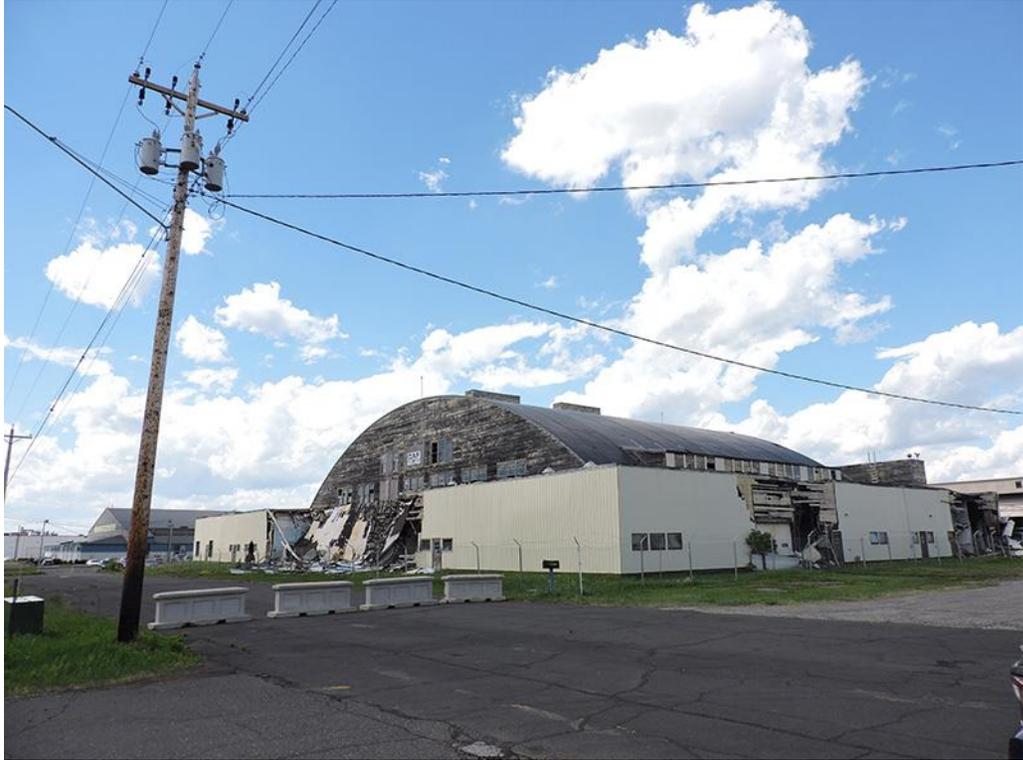
SL-DUL-3641 - 5/25/2021 - South & East Elevations, Facing Northwest

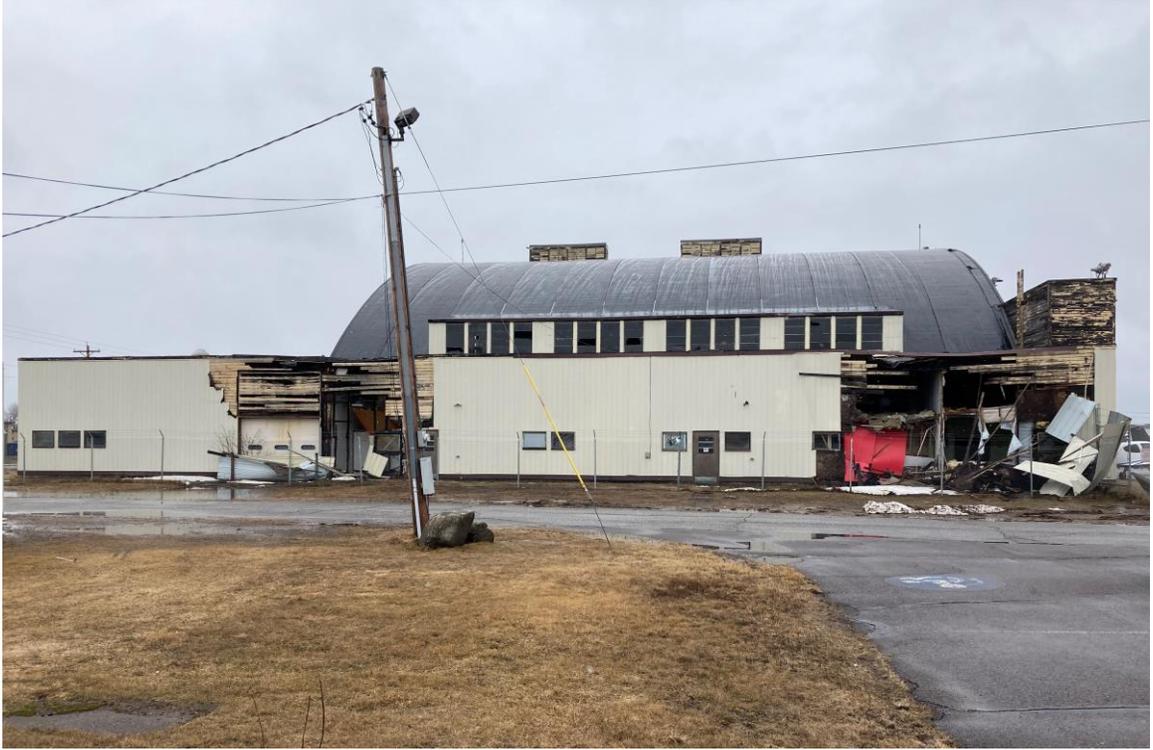
Fenestration on the east elevation includes three-light metal windows on the clerestory of the central hangar section. On the wing on the east elevation, fenestration includes a modern metal overhead garage door with three oval lights; single-light fixed metal windows; and single-leaf modern metal doors with single-lights.

SL-DUL-3641 - 3/29/2021 - East Elevation, Facing West (SEH)

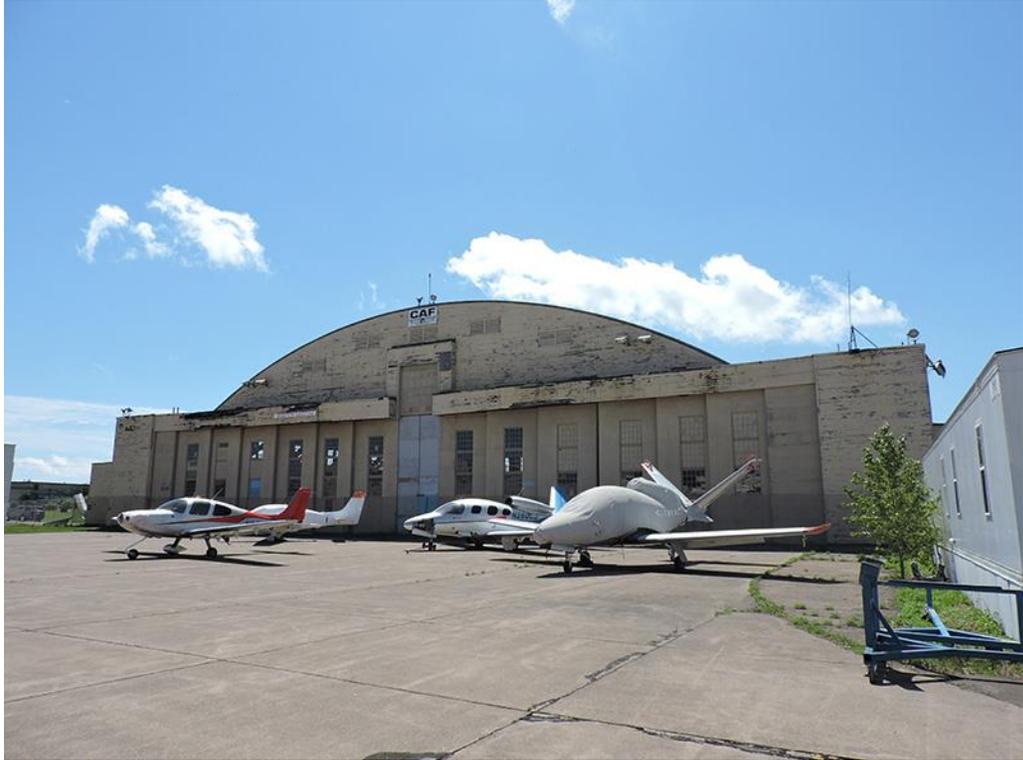
SL-DUL-3641 - 5/25/2021 - North Elevation, Facing Southeast

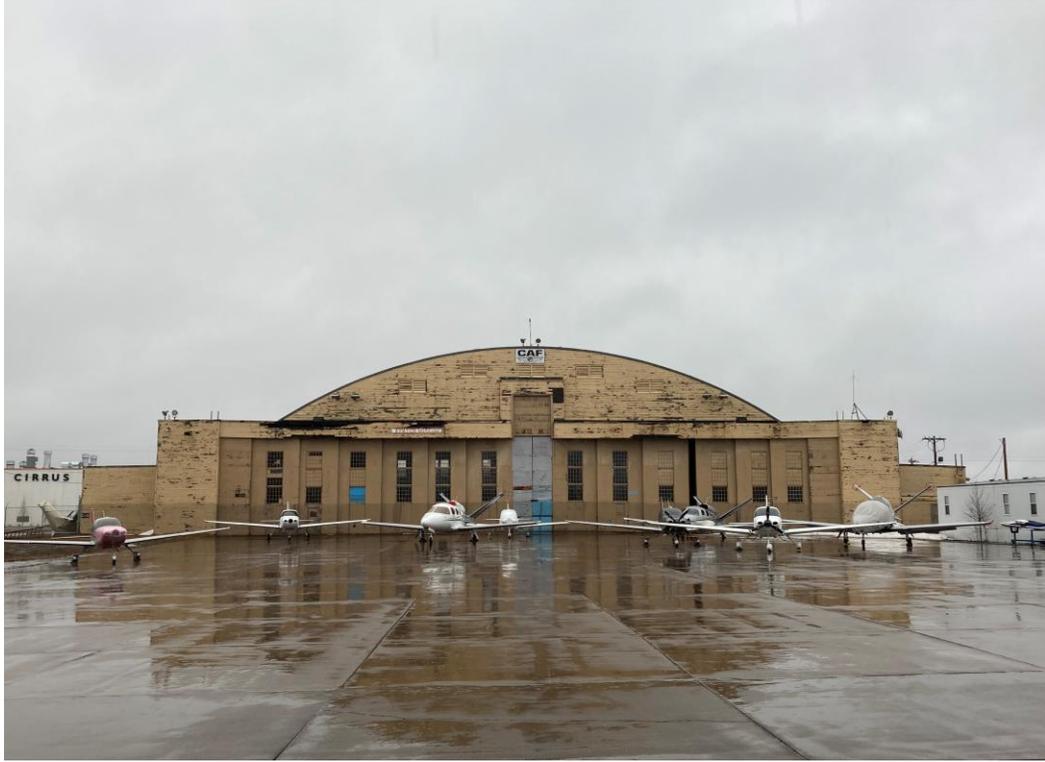
SL-DUL-3641 - 3/29/2021 - North Elevation, Facing South (SEH)

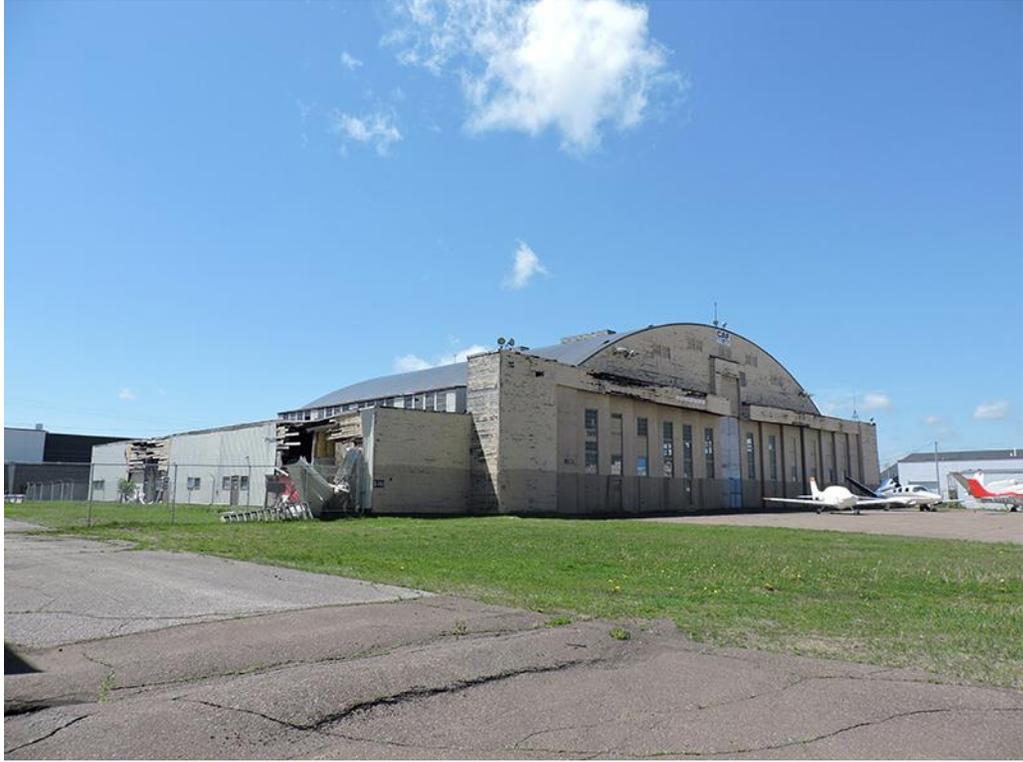
SL-DUL-3641 - 5/25/2021 - North & East Elevations, Facing Southwest

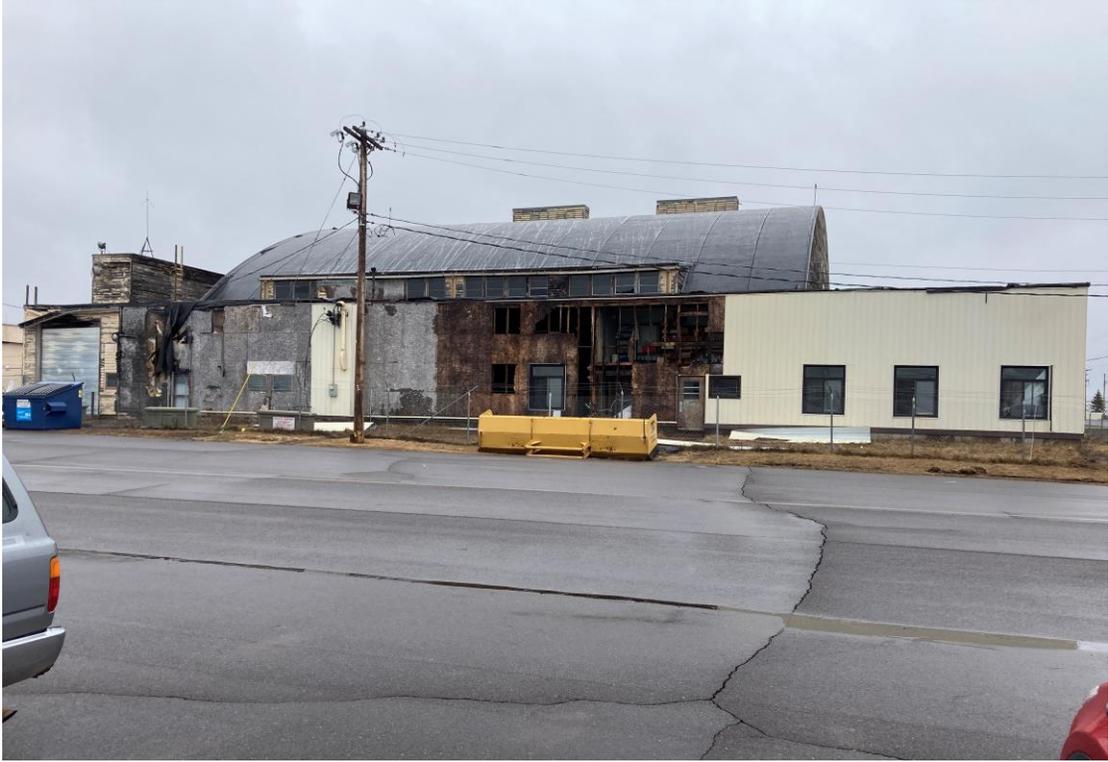
Fenestration on the wing on the west elevation includes modern two-light sliding metal windows with transoms; single-leaf metal doors with single-lights; single-light fixed metal windows; and a modern overhead metal garage door. Fenestration on the clerestory of the central hangar section of the west elevation includes fixed metal windows.

SL-DUL-3641 - 3/29/2021 - West Elevation, Facing East (SEH)

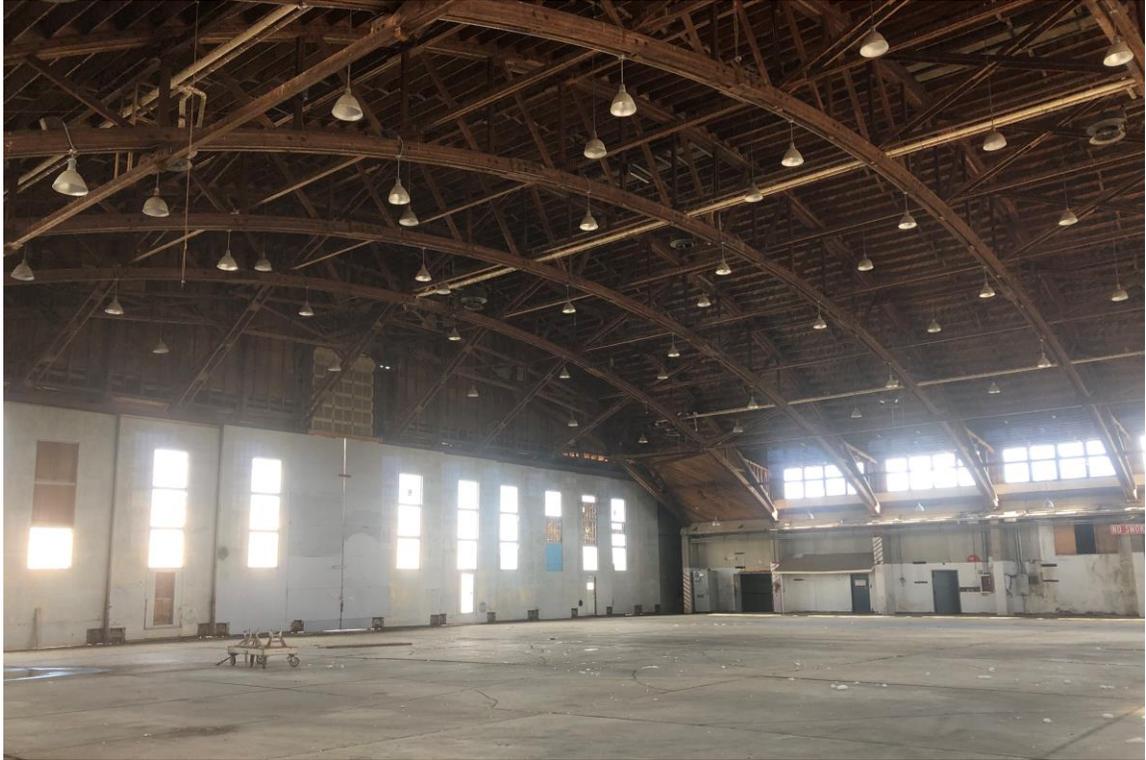
SL-DUL-3641 - 3/29/2021 - Interior of Central Hangar, Facing Northeast (SEH)

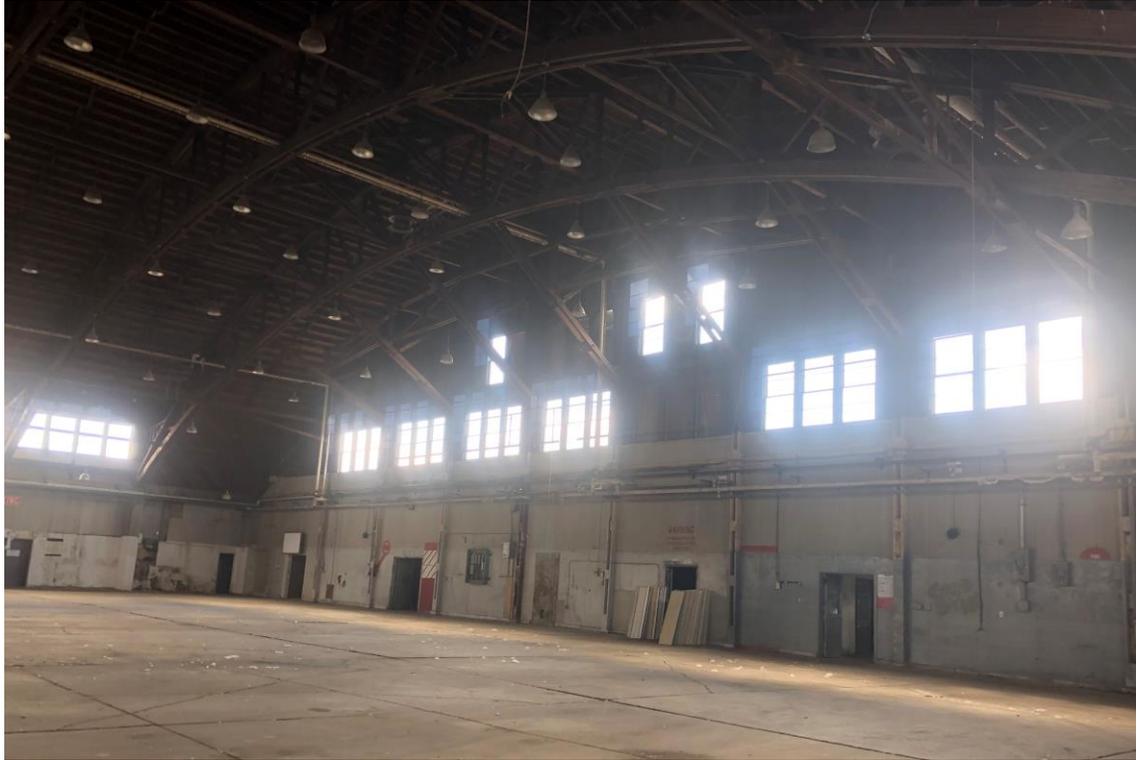
SL-DUL-3641 - 3/29/2021 - Interior of Central Hangar, Facing Southeast (SEH)
