Environmental Assessment for Hangar 101 Demolition

Airport Name: Duluth International Airport Identifier: DLH

Project Title: Hangar 101 Demolition – Emergency Action

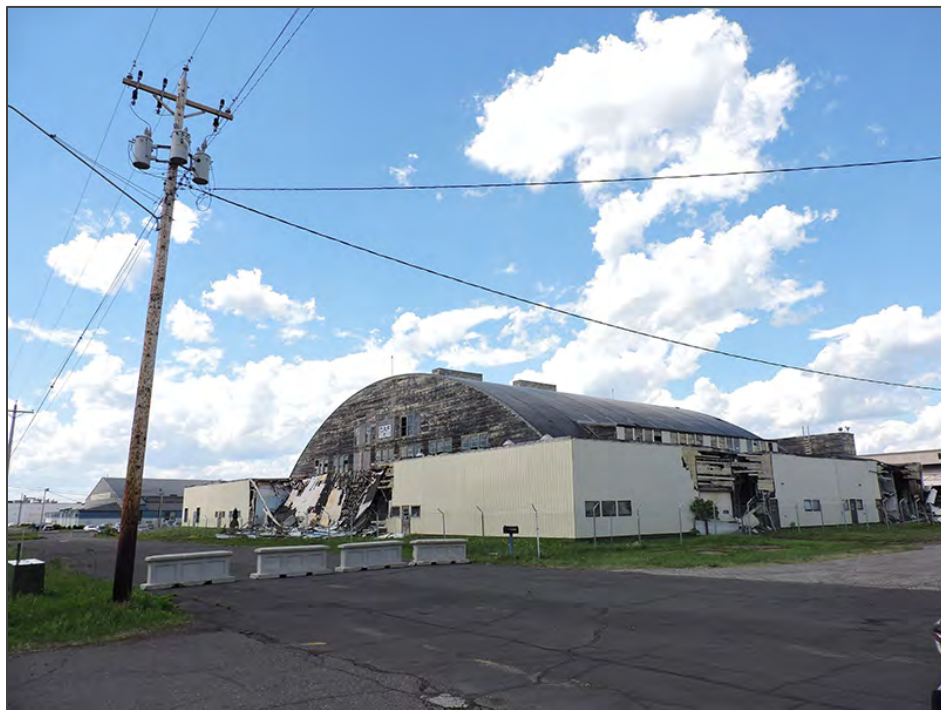
Figure 3. Hangar 101, Facing Northwest, Showing Collapsing Wings (106 Group, May 2021)

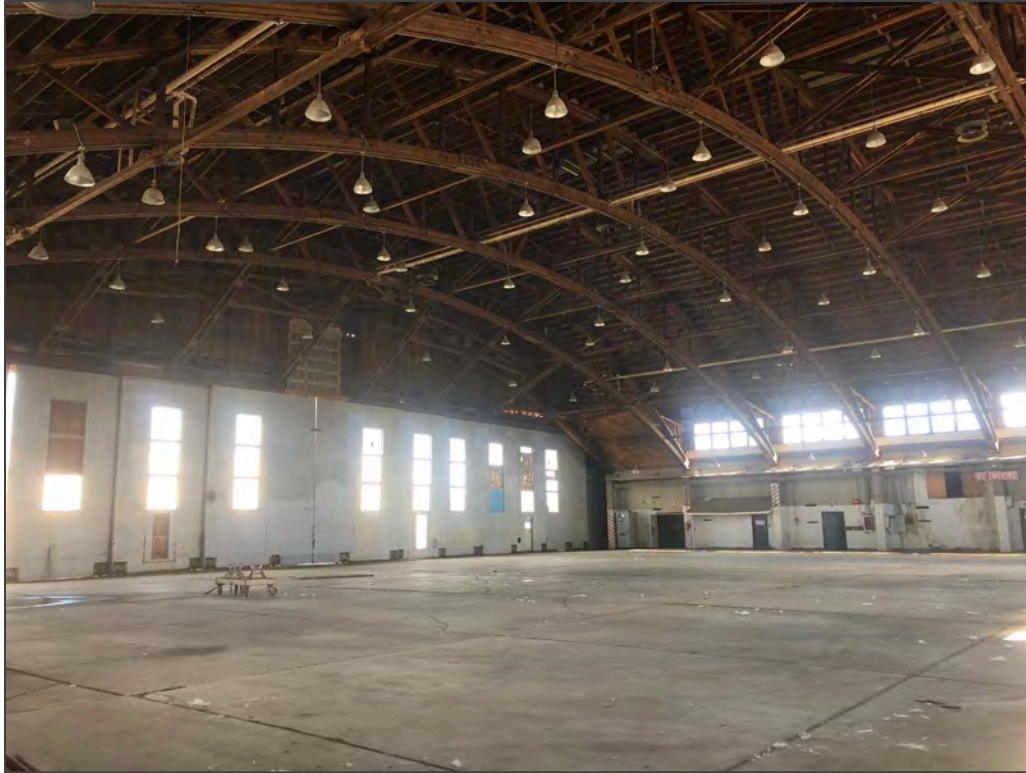
The roof system of the hangar consists of seven, two-hinged, wooden crescent arch trusses (Figure 4). The trusses are approximately 164 feet from east to west, and are spaced approximately 23 feet apart, north to south (Google Earth 2021). Each truss is a crescent truss with an arched top and bottom chord and has wooden vertical and diagonal members arranged in a saw tooth pattern. Wooden lateral bracing between the trusses is in a vertical “X” pattern. The roof rafters span between the trusses and the rafters are sheathed with wooden boards laid at a diagonal. Each truss is bolted to concrete piers/buttresses embedded into the concrete walls on the east and west sides of the hangar.

Figure 4. Hangar 101, Interior of the Central Hangar, Facing Northeast (SEH, March 2021)

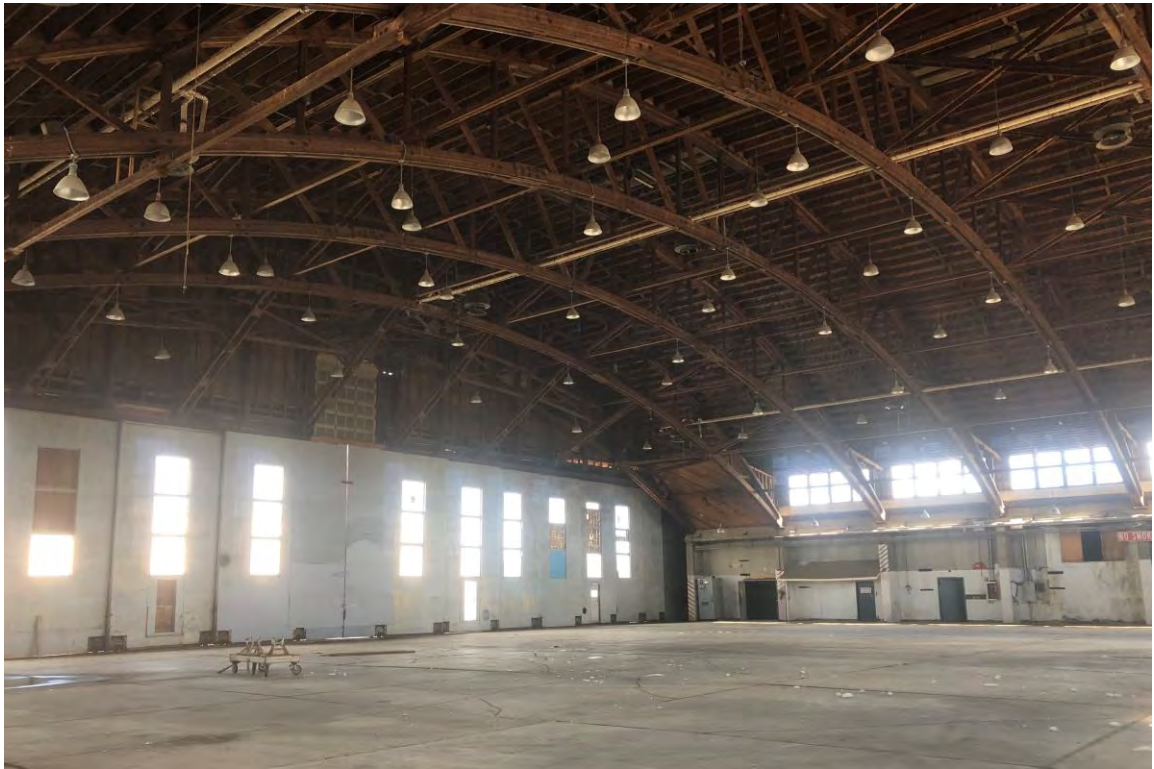
SL-DUL-3641 - 3/29/2021 - Interior of Central Hangar, Facing Northeast (SEH)

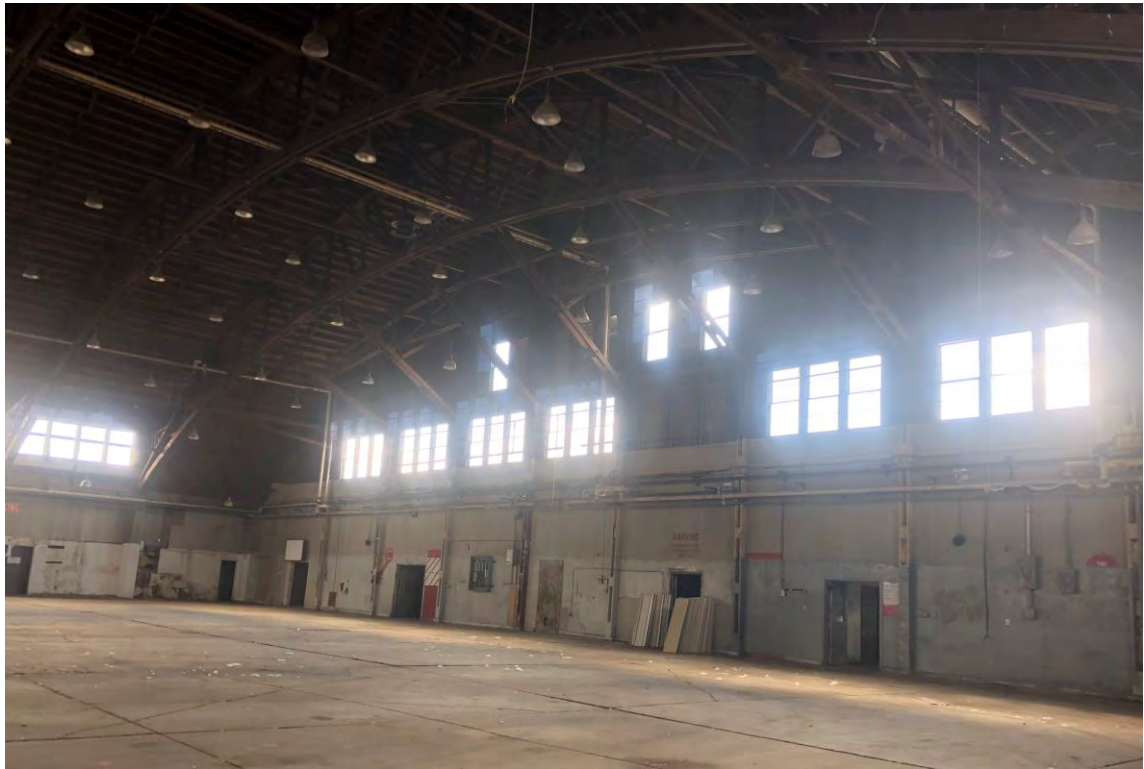
SL-DUL-3641 - 3/29/2021 - Interior of Central Hangar, Facing Southeast (SEH)
