Landside Pavement Assessment

Duluth Airport Authority

Duluth, Minnesota

DULAI 150733 | September 13, 2020

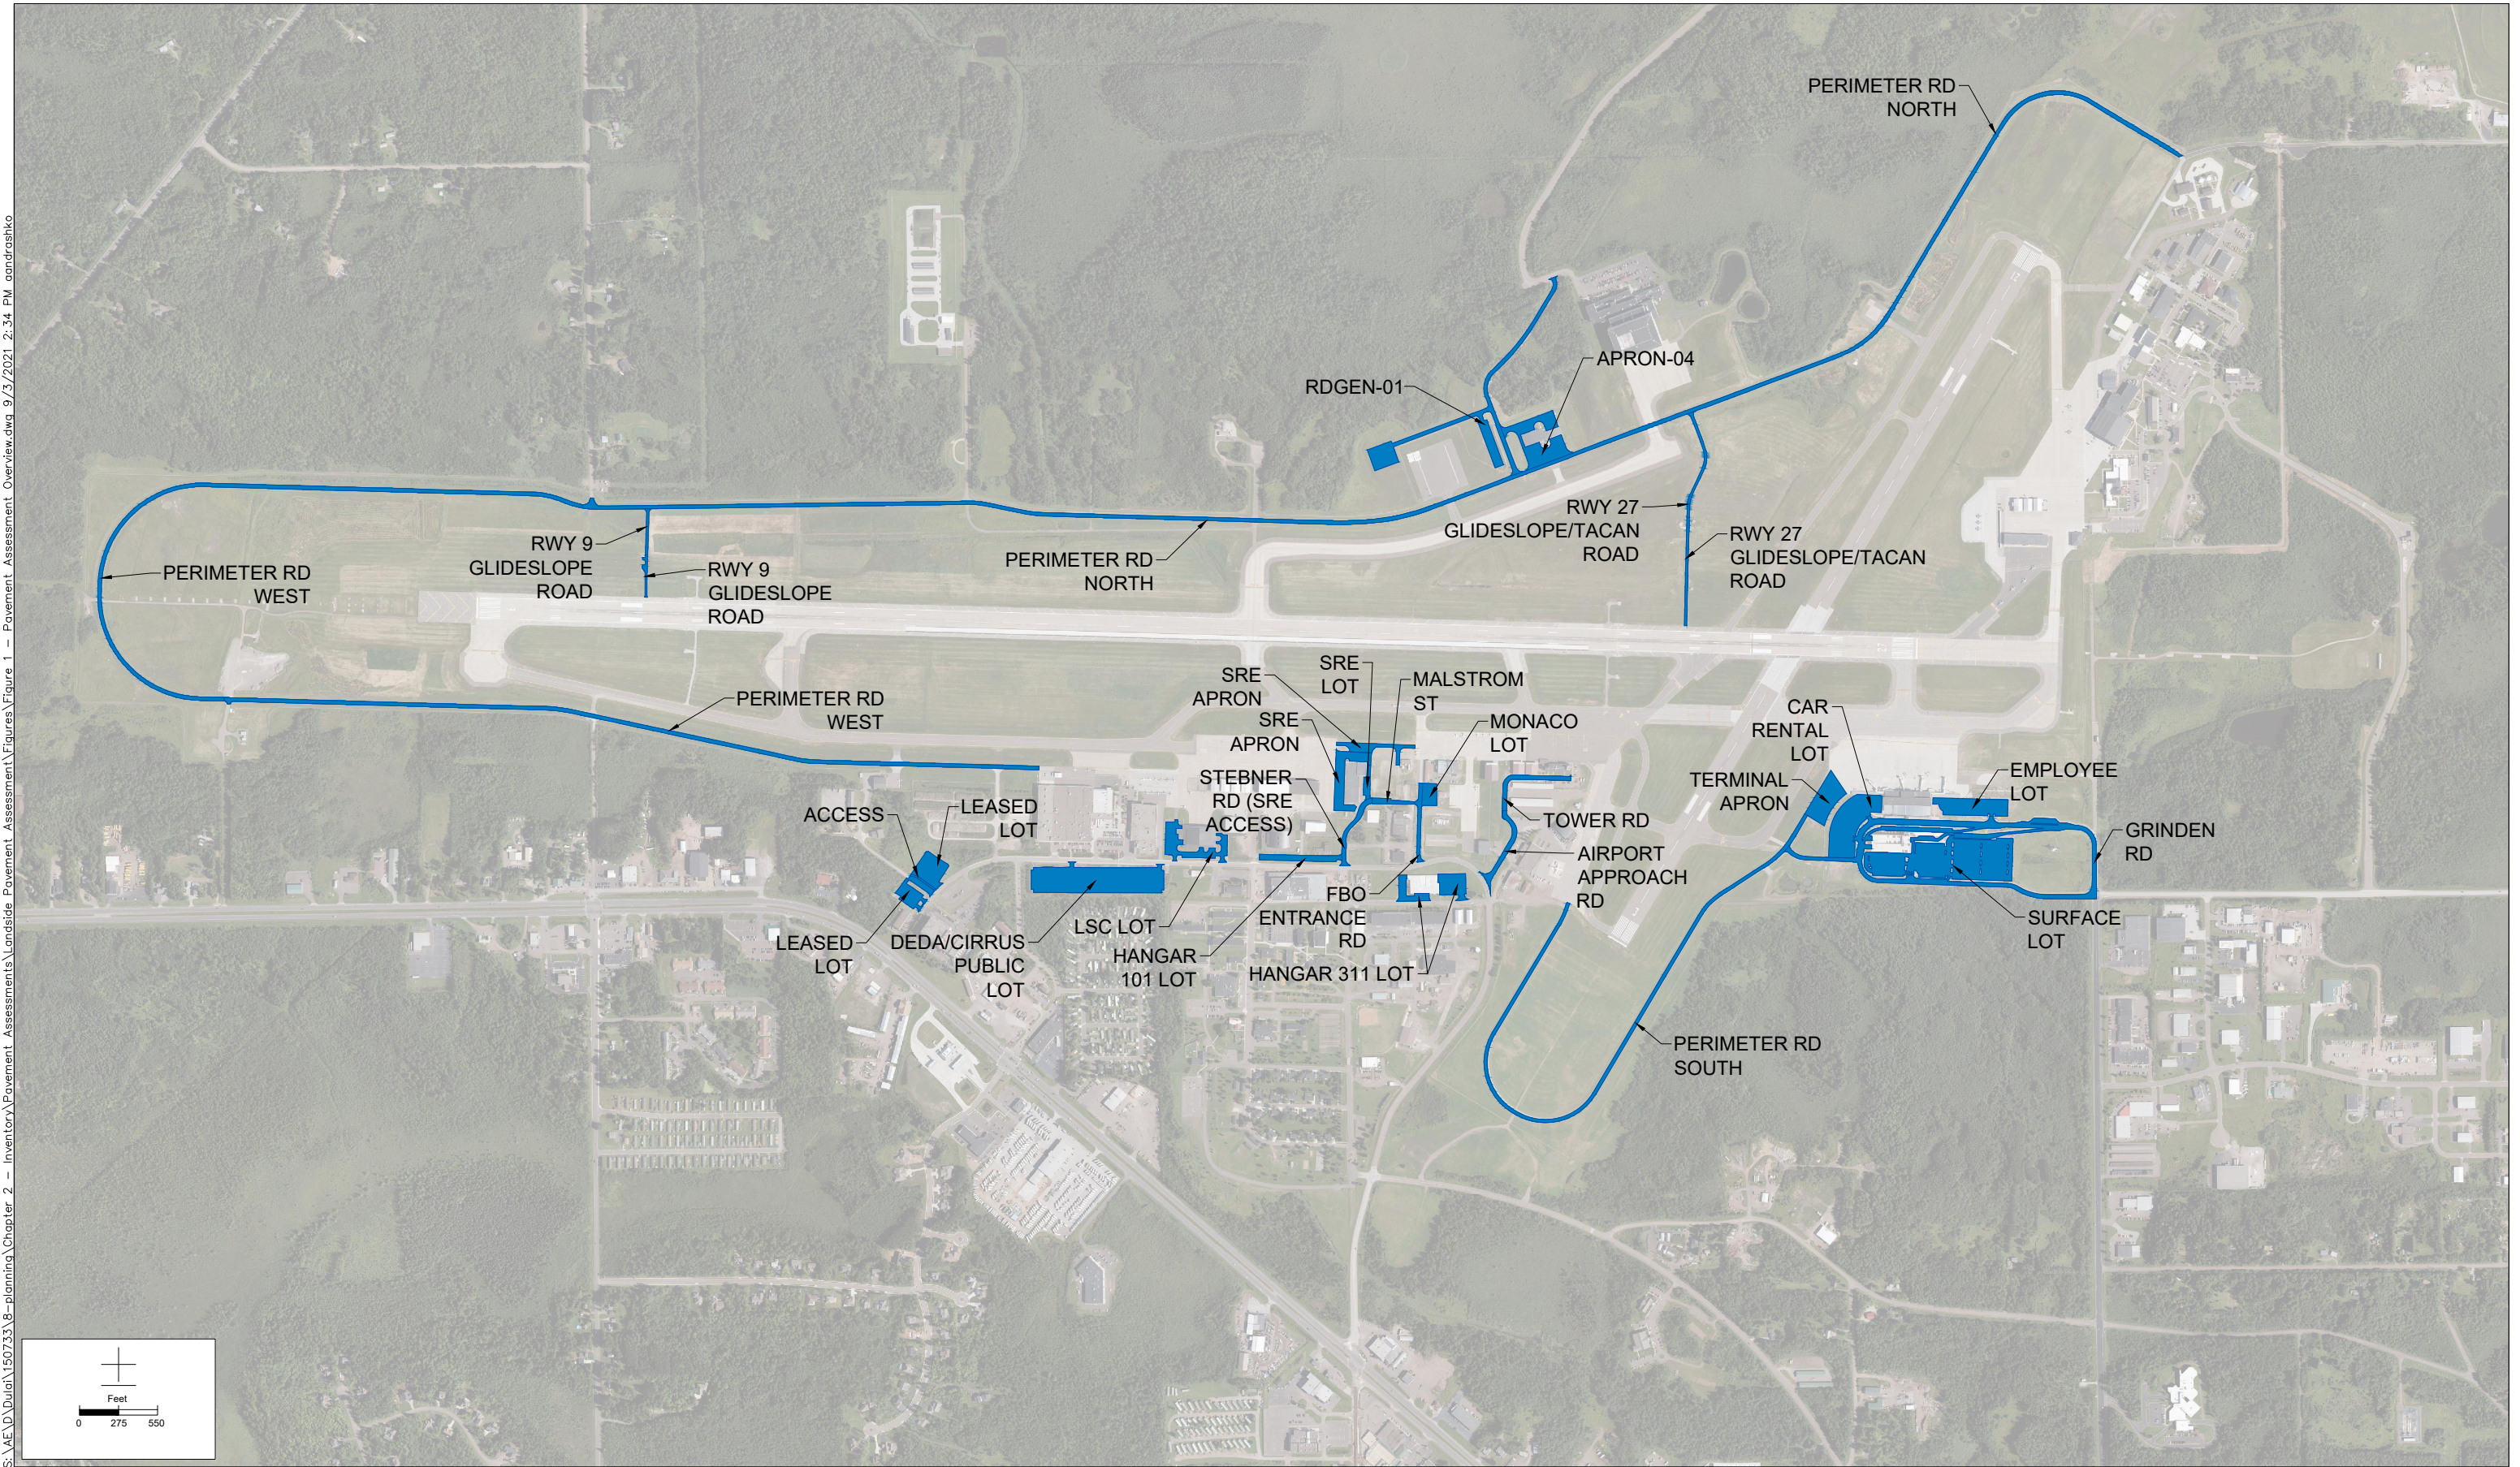
Figure 2 – PCI Results presents a visual representation of the PCI results. As discussed above, using the PCI value, each pavement section was assigned a PCI rating ranging from failed to excellent. Colors were assigned to each PCI rating range to provide a visual.

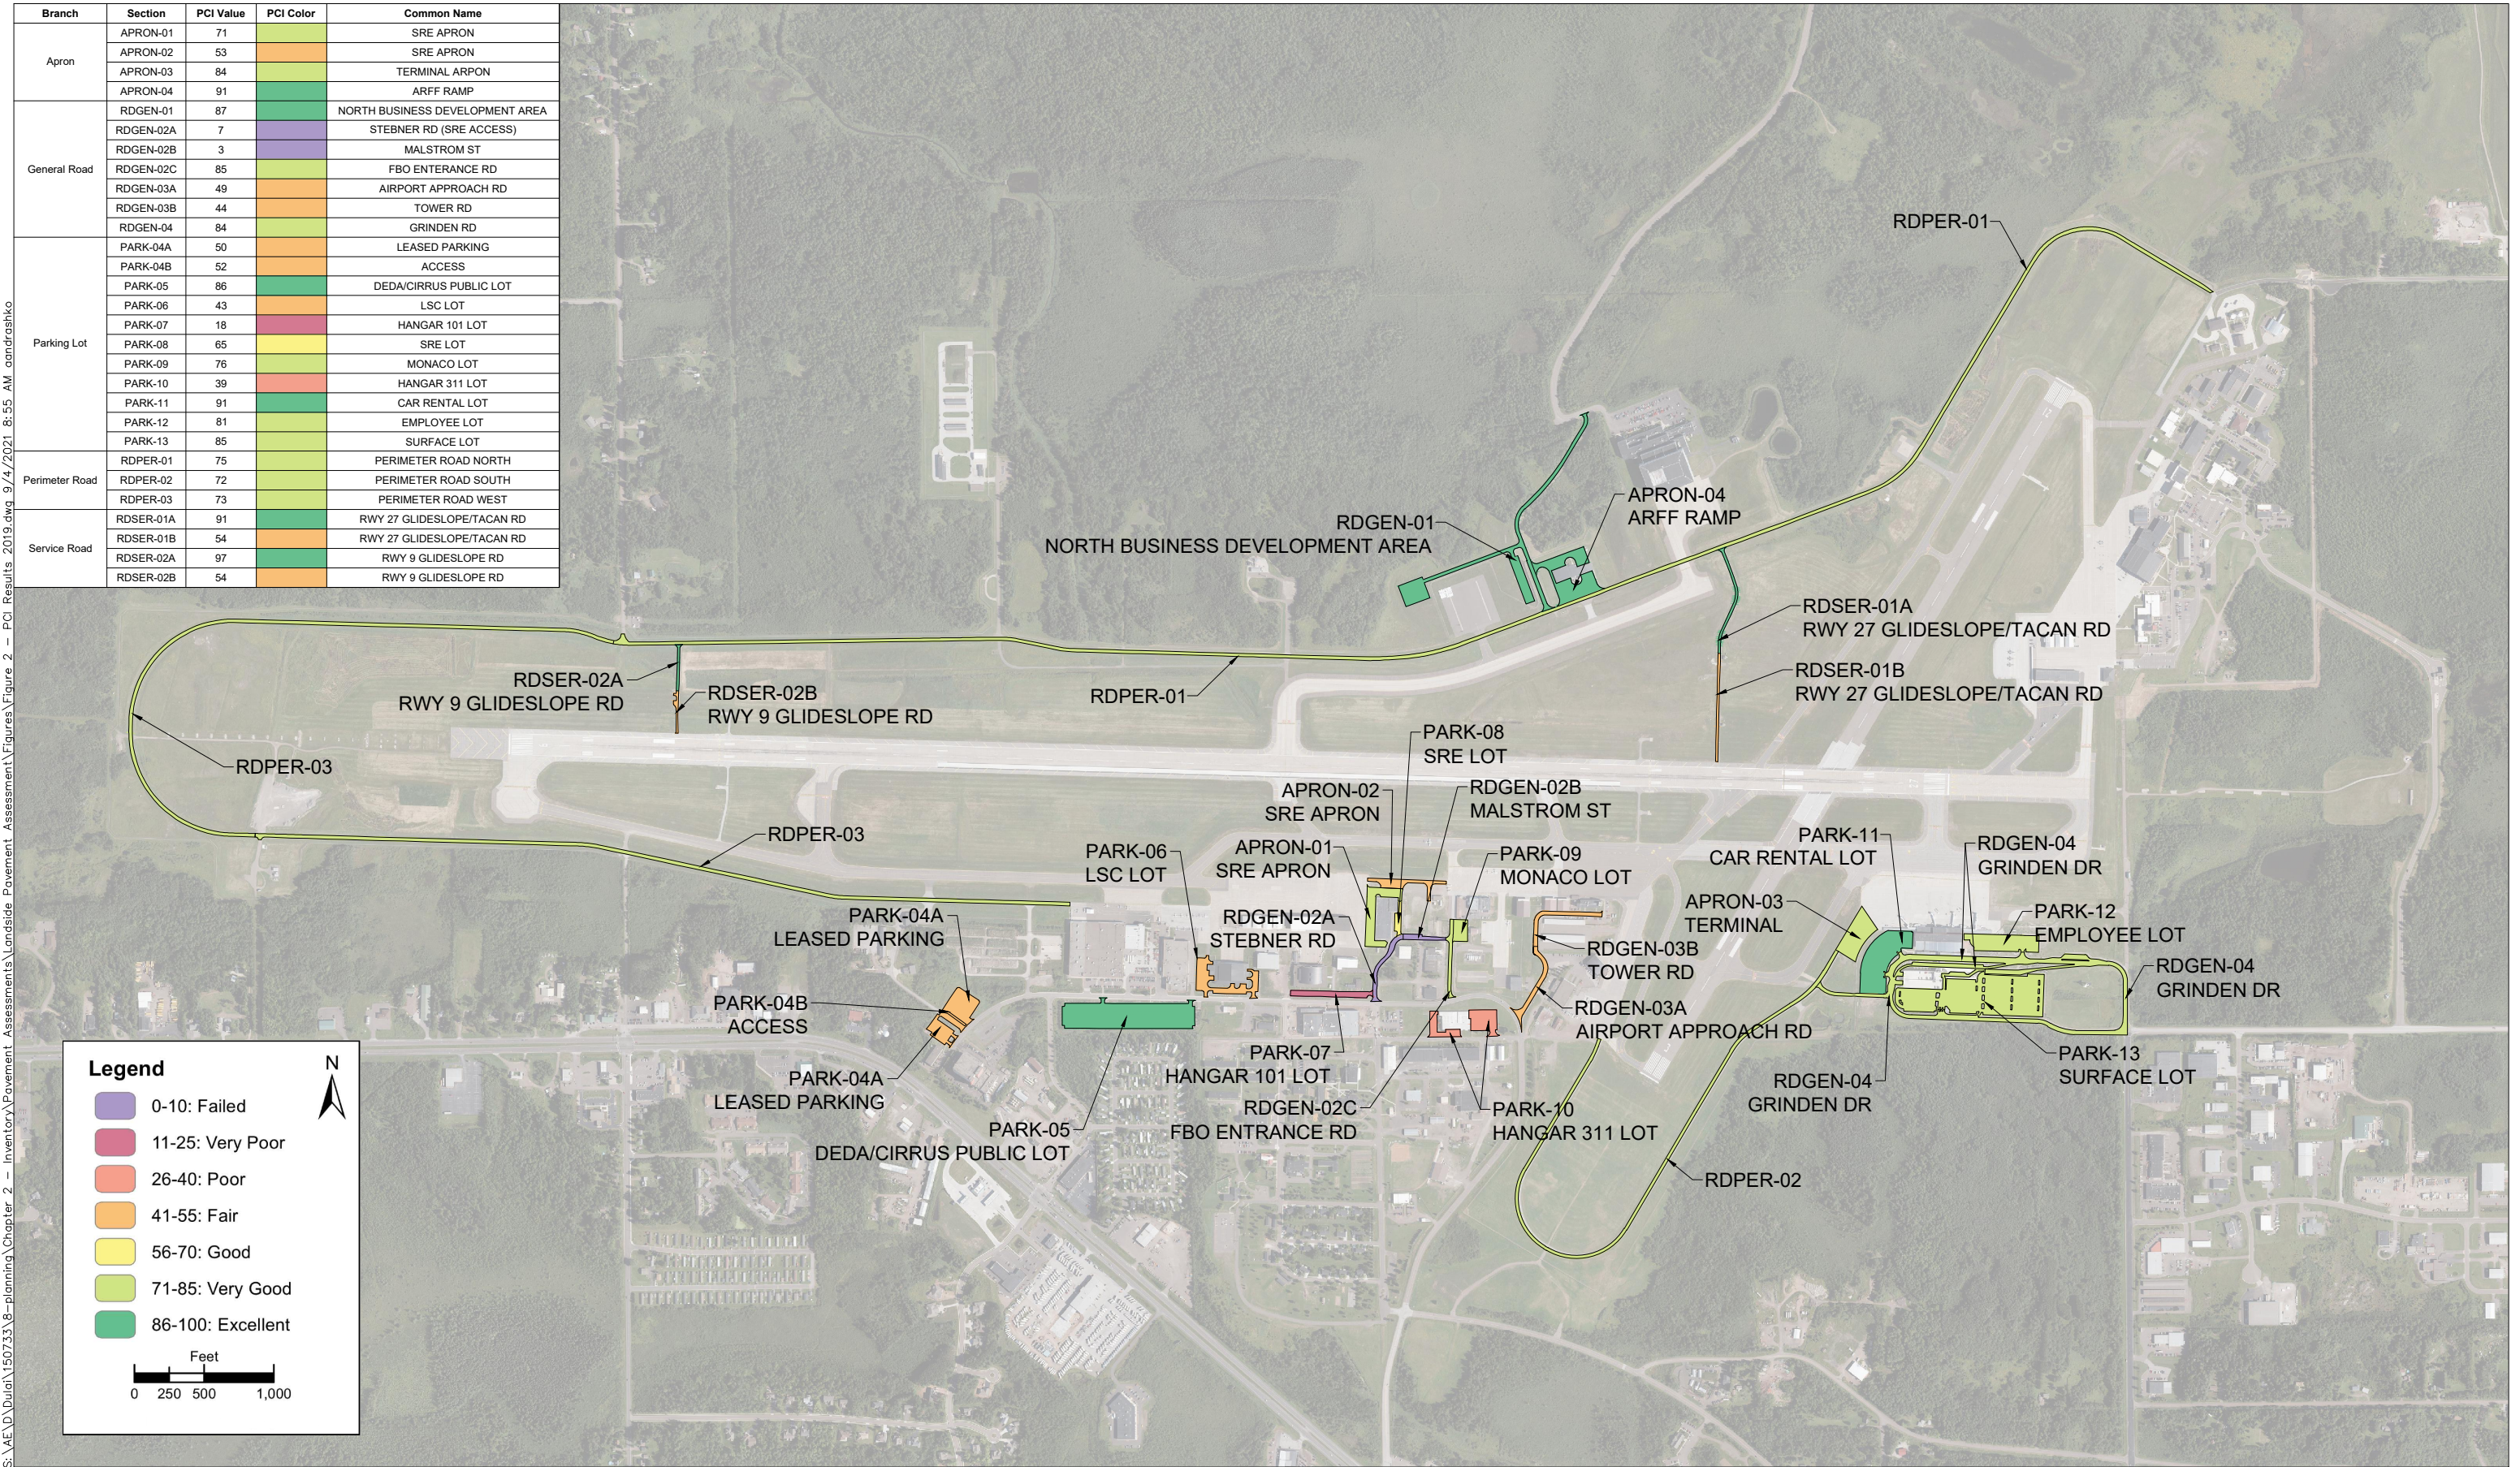
Figure 3 – 3A and 3B Sample Locations illustrates all the sample locations for each pavement section.

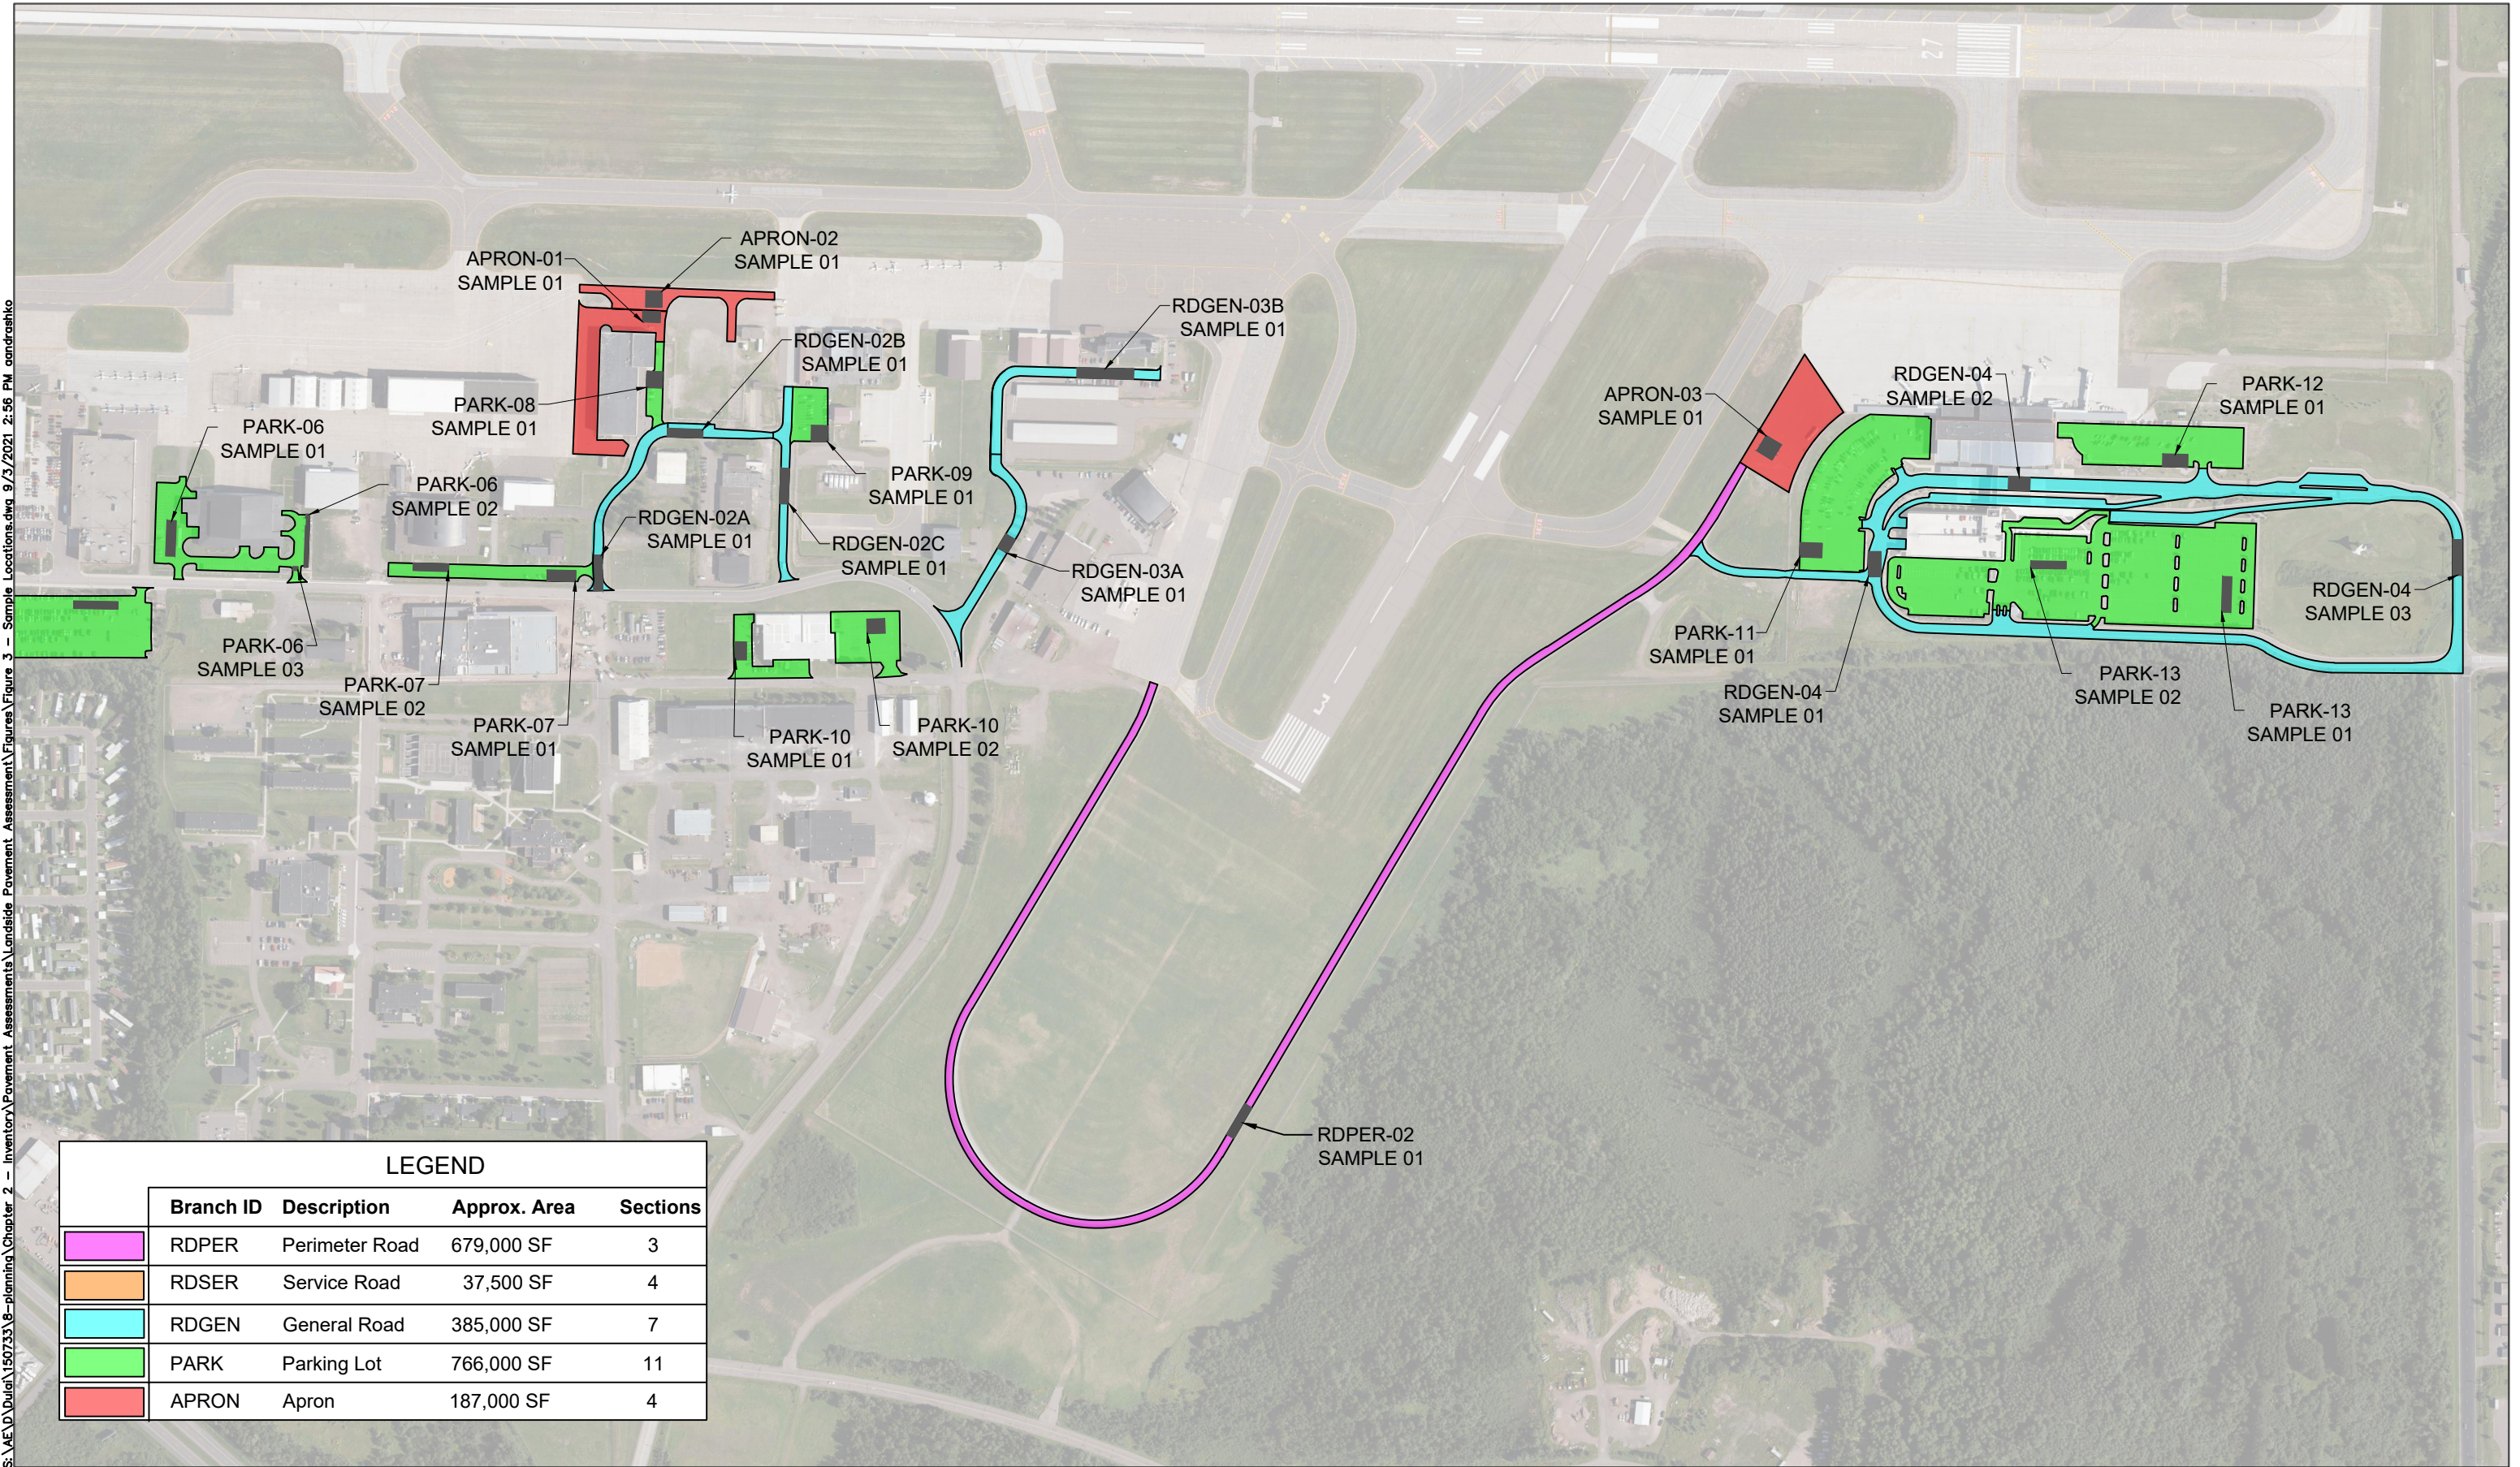
Figure 4 – Work Repair Levels presents the recommended work repair level for each pavement section which was also determined based on its respective PCI values.

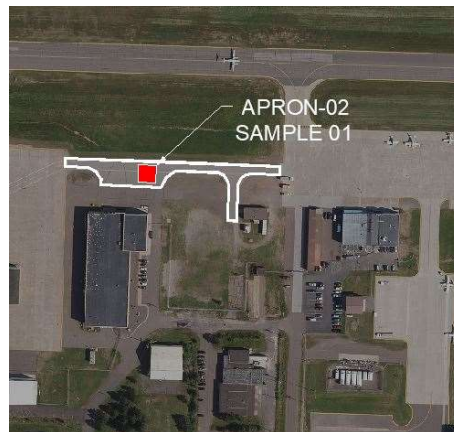
This apron section is located on the south side of the airport, in front of the SRE Building, and is for use by vehicles only. The Asphalt Concrete pavement in this section is in fair condition, and requires major rehabilitation.

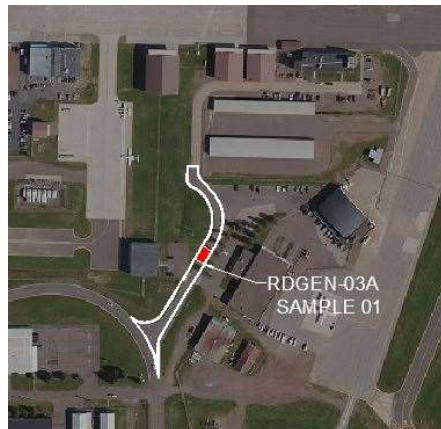
This general road section is located on the south side of the airport allowing vehicle access to several surrounding buildings. The Asphalt Concrete pavement in this section is in a fair condition and requires major rehabilitation.

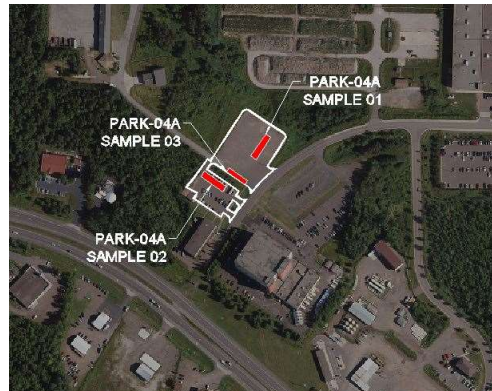
This parking lot section is located on the southwest side of the airport. The Asphalt Concrete pavement in this section is in fair condition, and requires major rehabilitation.

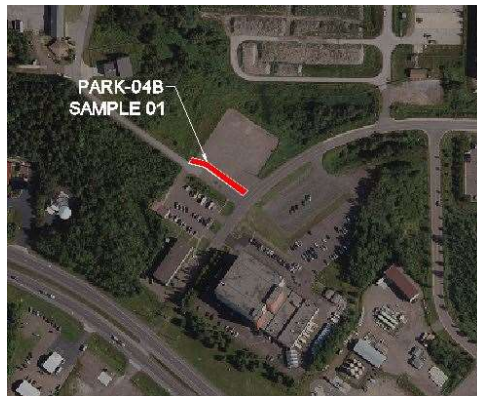
This parking lot section is located on the southwest side of the airport. The Asphalt Concrete pavement in this section is in fair condition and requires major rehabilitation.

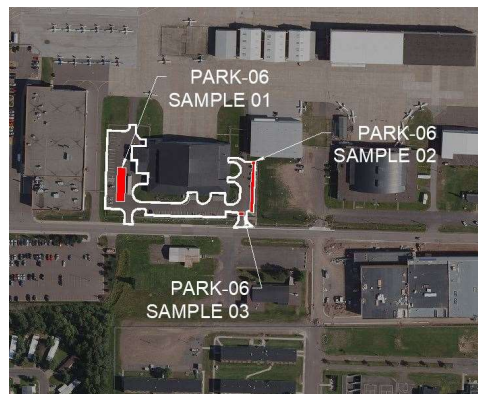
This parking lot section is located on the southwest side of the airport. The Asphalt Concrete pavement in this section is in fair condition and requires major rehabilitation.

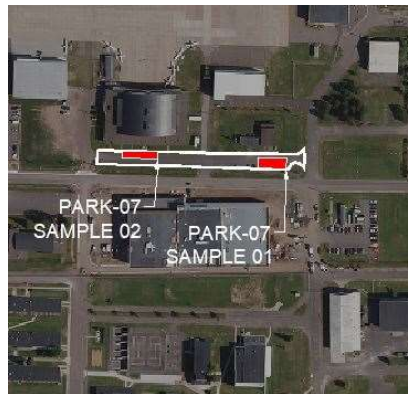
This parking lot section is located on the southwest side of the airport. The Asphalt Concrete pavement in this section is in very poor condition and requires reconstruction.

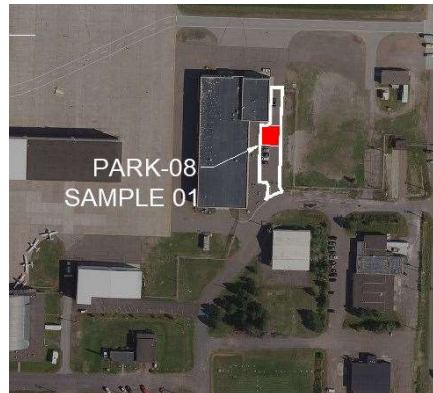
This parking lot section is located on the southwest side of the airport. The Asphalt Concrete pavement in this section is in good condition and requires preventative maintenance.

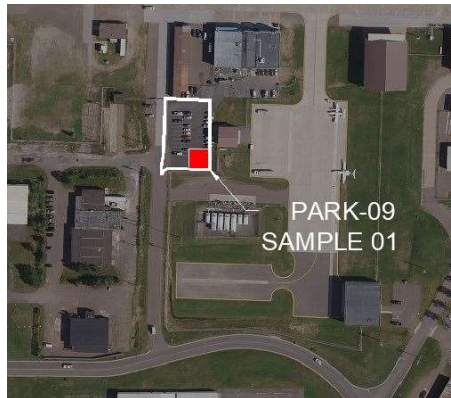
This parking lot section is located on the southwest side of the airport. The Asphalt Concrete pavement in this section is in very good condition and currently only requires preventative maintenance.

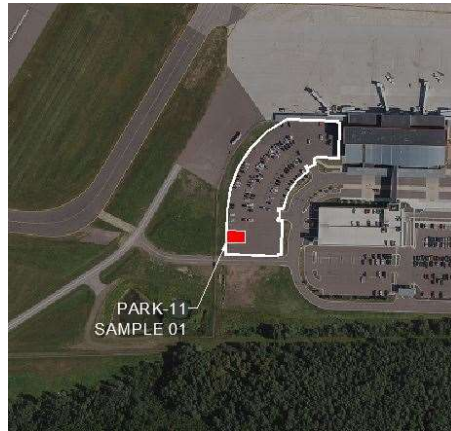
This parking lot section is located on the southeast side of the airport adjacent to the airport terminal. The Asphalt Concrete pavement in this section is in excellent overall condition and will require preventative maintenance.

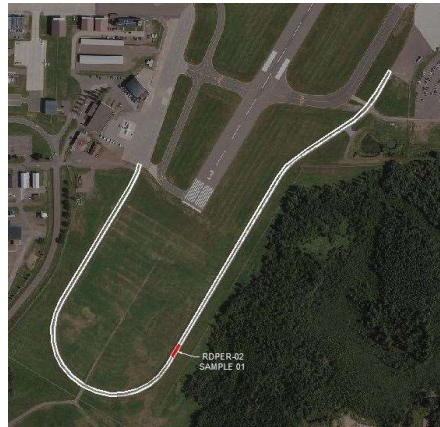
This perimeter road section is located on the southeast side of the airport. The Asphalt Concrete pavement in this section is in very good overall condition, and currently only requires preventative maintenance.

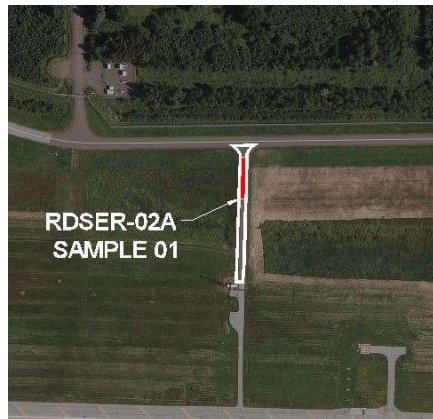
This service road section is located on the west side of the airport providing vehicle access to the north of Runway 9-27. The Asphalt Concrete pavement in this section is in excellent condition, and currently only requires preventative maintenance.

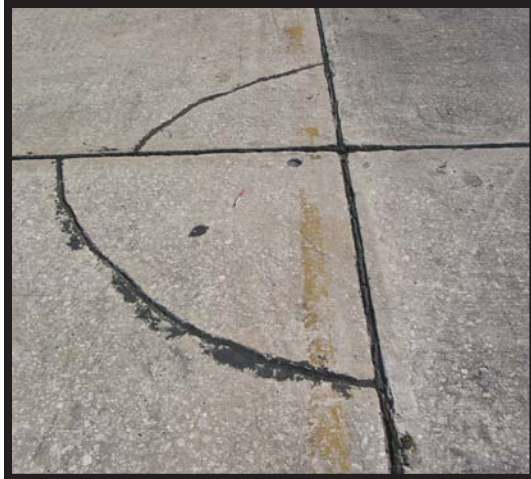
LOW

Crack has either no spalling or minor spalling (no FOD potential). If non-filled, it has a mean width less than approximately 1/8 inch (3 mm); a filled crack can be of any width, but the filler material must be in satisfactory condition. The area between the corner break and the joints is not cracked.

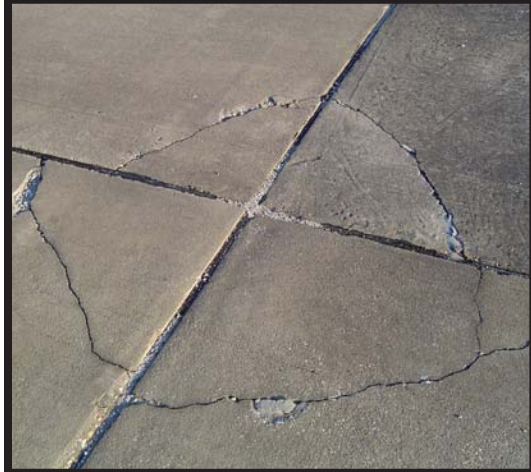
MEDIUM

One of the following conditions exists: (1) filled or non-filled crack is moderately spalled (some FOD potential); (2) a non-filled crack has a mean width between 1/8 inch (3 mm) and 1 inch (25 mm); (3) a filled crack is not spalled or only lightly spalled, but the filler is in unsatisfactory condition; (4) the area between the corner break and the joints is lightly cracked. Lightly cracked means one low severity crack dividing the corner into two pieces.

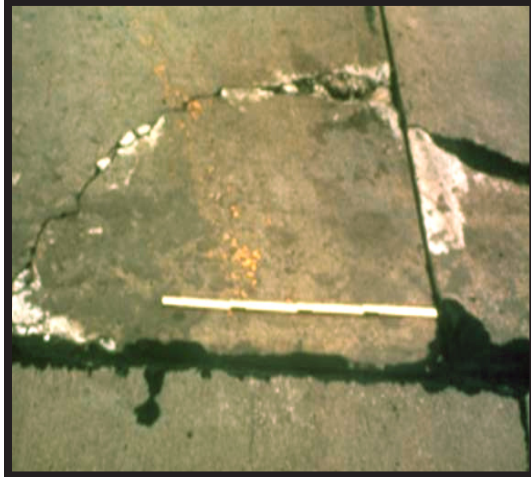
HIGH

One of the following conditions exists: (1) filled or non-filled crack is severely spalled, causing definite FOD potential; (2) a non-filled crack has a mean width greater than approximately 1 inch (25 mm), creating a tire damage potential; or (3) the area between the corner break and the joints is severely cracked.

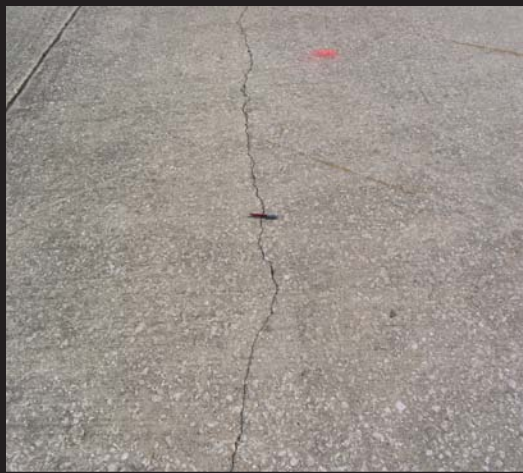
LOW

L Crack has no spalling or minor spalling (no FOD potential). If non-filled, it is less than 1/8 inch (3 mm) wide. A filled crack can be of any width, but its filler material must be in satisfactory condition; or the slab is divided into three pieces by low severity cracks.

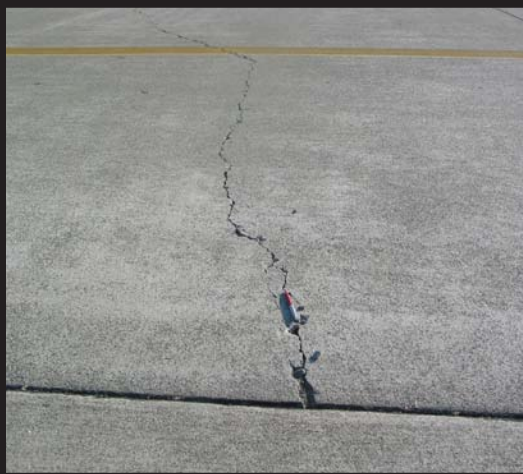
MEDIUM

M One of the following conditions exists: (1) a filled or non-filled crack is moderately spalled (some FOD potential); (2) a non-filled crack has a mean width between 1/8 inch (3 mm) and 1 inch (25 mm); (3) a filled crack has no spalling or minor spalling, but the filler is in unsatisfactory condition; or (4) the slab is divided into three pieces by two or more cracks, one of which is at least medium severity.

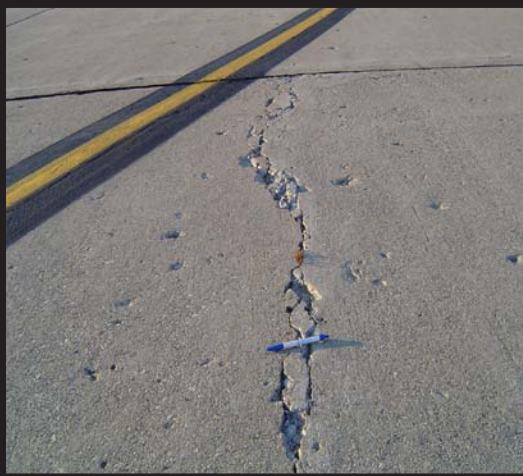
HIGH

H One of the following conditions exists: (1) a filled or non-filled crack is severely spalled (definite FOD potential); (2) a non-filled crack has a mean width approximately greater than 1 inch (25 mm), creating tire damage potential, or (3) the slab is divided into three pieces by two or more cracks, one of which is at least high severity.

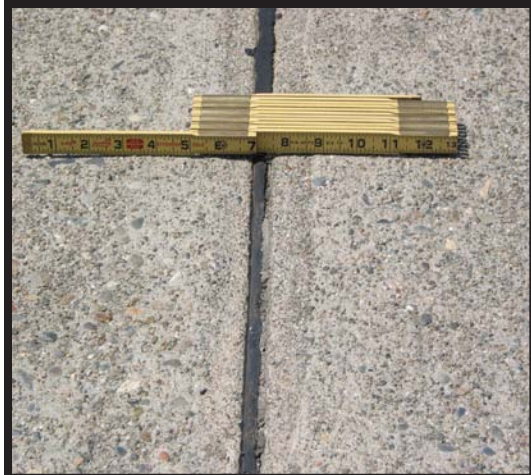
LOW

Joint sealer is in generally good condition throughout the sample. Sealant is performing well, with only a minor amount of any of the above types of damage present. Joint seal damage is at low severity if a few of the joints have sealer which has debonded from, but is still in contact with, the joint edge. This condition exists if a knife blade can be inserted between the sealer and joint face without resistance.

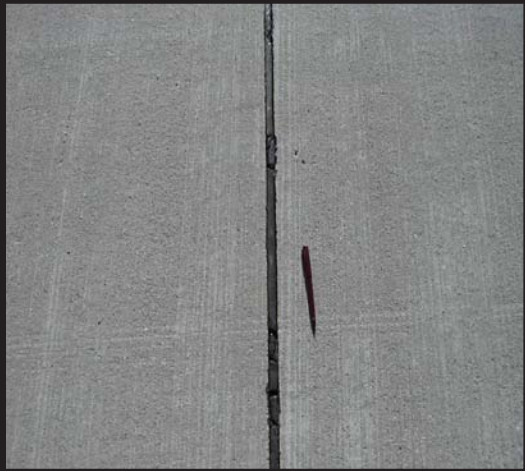
MEDIUM

Joint sealer is in generally fair condition over the entire surveyed section, with one or more of the above types of damage occurring to a moderate degree. Sealant needs replacement within 2 years. Joint seal damage is at medium severity if a few of the joints have any of the following conditions: (1) joint sealer is in place, but water access is possible through visible openings no more than 1/8 inch (3 mm) wide. If a knife blade cannot be inserted easily between sealer and joint face, this condition does not exist; (2) pumping debris are evident at the joint; (3) joint sealer is oxidized and 'lifeless' but pliable (like a rope), and generally fills the joint opening; or (4) vegetation in the joint is obvious, but does not obscure the joint opening.

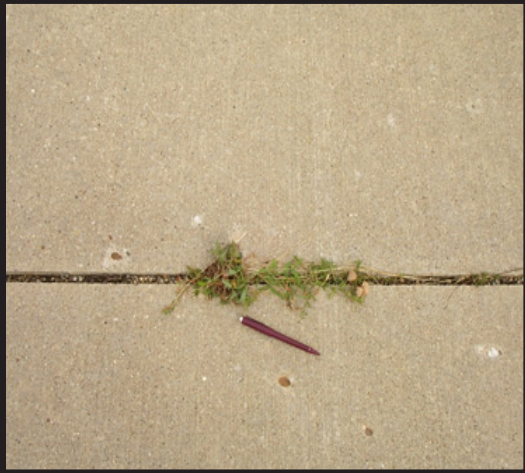
HIGH

Joint sealer is in generally poor condition over the entire surveyed section, with one or more of the above types of damage occurring to a severe degree. Sealant needs immediate replacement. Joint seal damage is at high severity if 10% or more of the joint sealer exceeds limiting criteria listed above, or if 10% or more of sealer is missing.

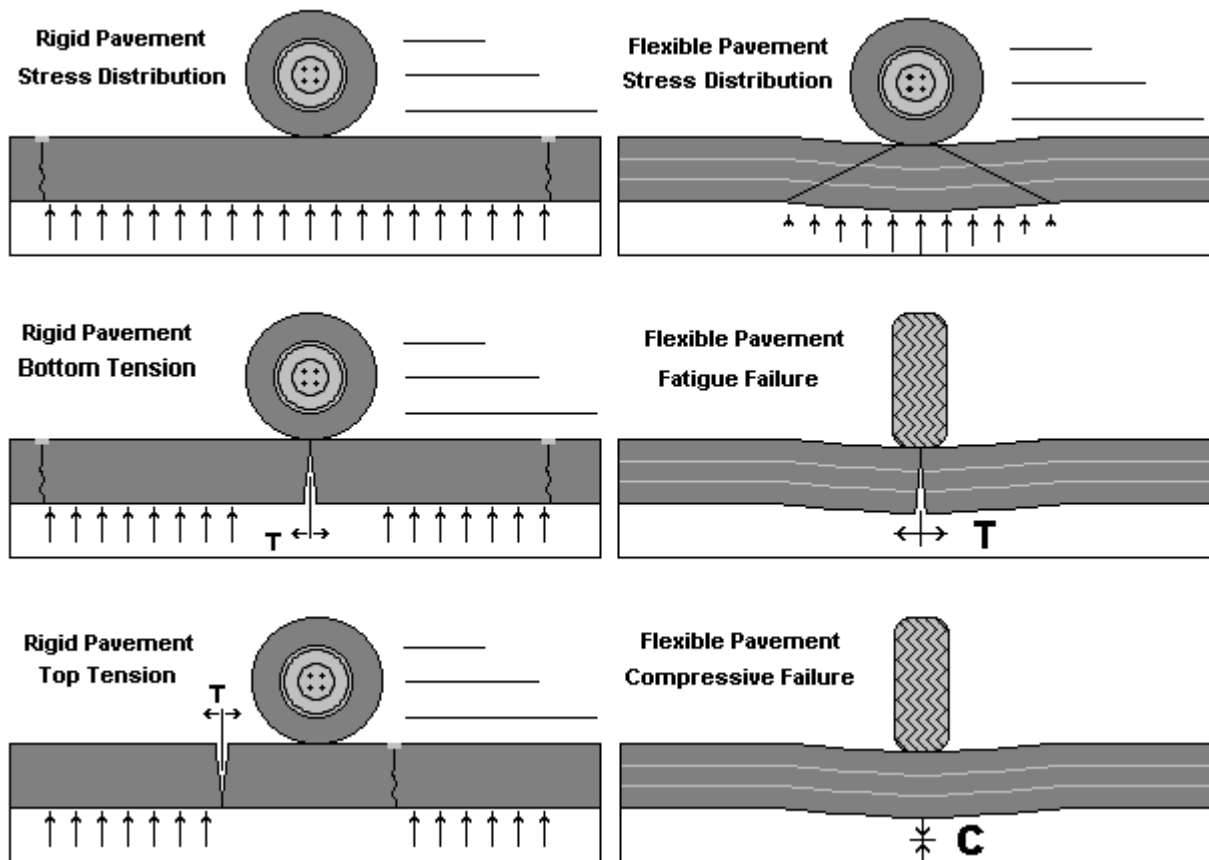
Figure 1. Pavement failure.

Load-related cracks can start at the top or bottom of a pavement section. In asphalt sections, load-related (fatigue) cracks start at the bottom. If a load-related crack reaches the surface, it usually indicates significant structural deficiency. In PCC pavement, corner breaks are caused by top tension, and the crack propagates downward. Mid-slab LTD cracks are examples of bottom tension.

Spalls can be caused by either wheel loads or environmental factors, anytime there is movement between adjacent slabs. If a small rock is allowed into a joint, a differential movement between adjacent slabs can cause a spall. Spalling can be minimized by keeping joint and crack sealant intact.

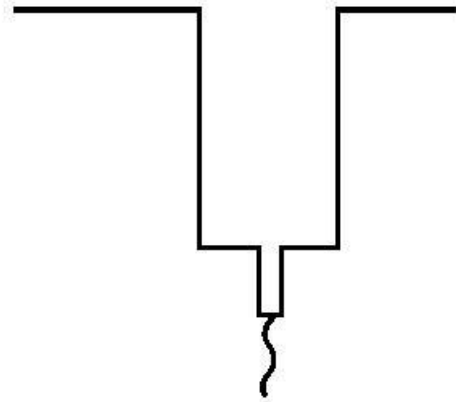
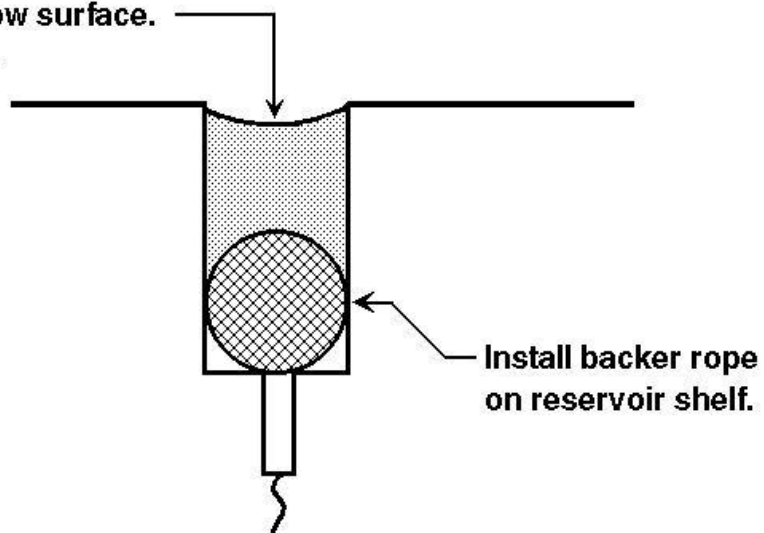
Figure 6. PCC joint/crack repair.

Typical joint with deficient sealant and a collection of debris & incompressibles.

- Rout a reservoir for the sealant. Sealant reservoir should be $\frac{1}{2}$ inch wide and 1 inch deep.
- For cracks wider than $\frac{1}{2}$ inch, the reservoir should be $\frac{1}{4}$ inch wider than the crack. Depth should be such that sealant above the backer rope is at most equal to reservoir width, or as recommended by manufacturer.

Rout out old sealant, debris and incompressibles. Clean joint sides to expose fresh, clean concrete and stone. Retain existing reservoir shape.

Fill to 1/8" below surface.
Do not overfill.
