# Building Assessments

Duluth Airport Authority

Duluth, Minnesota

DULAI 150733 | September 13, 2021

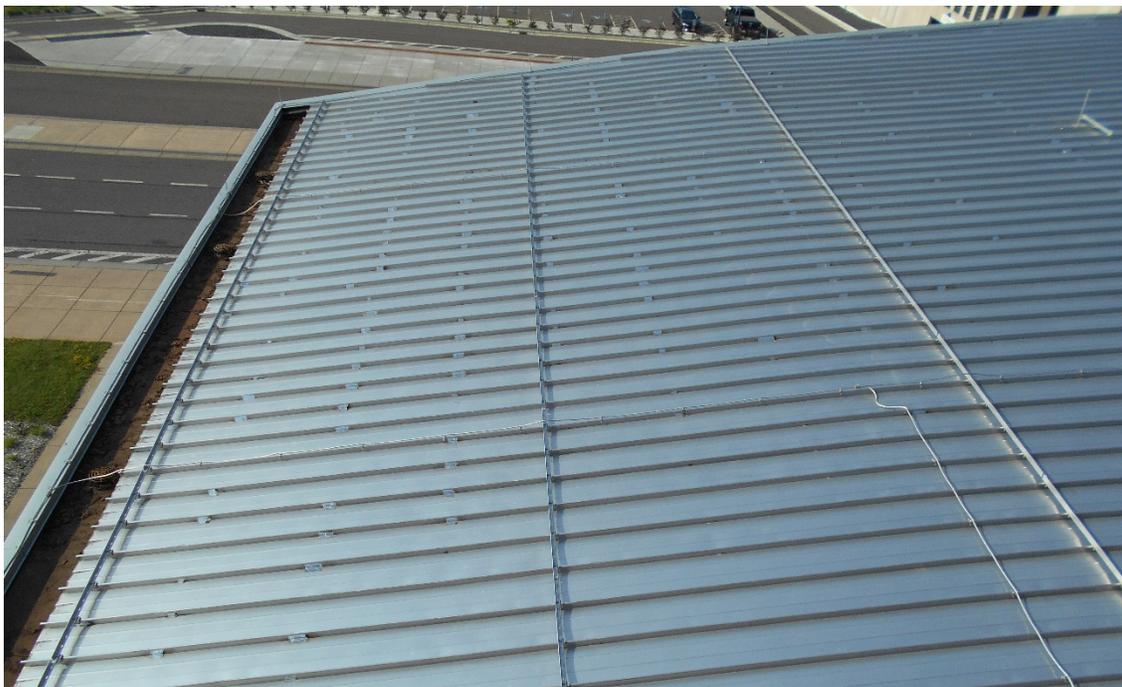
**Photo 4** Spot repairs completed at standing seam metal roof system

- Replace the existing standing seam metal roof system due to level of existing repairs/ patches completed along with the constant maintenance required, estimated \$1.3M for replacement with standing seam metal roof system /or \$1M for replacement with fully adhered EPDM roof membrane.

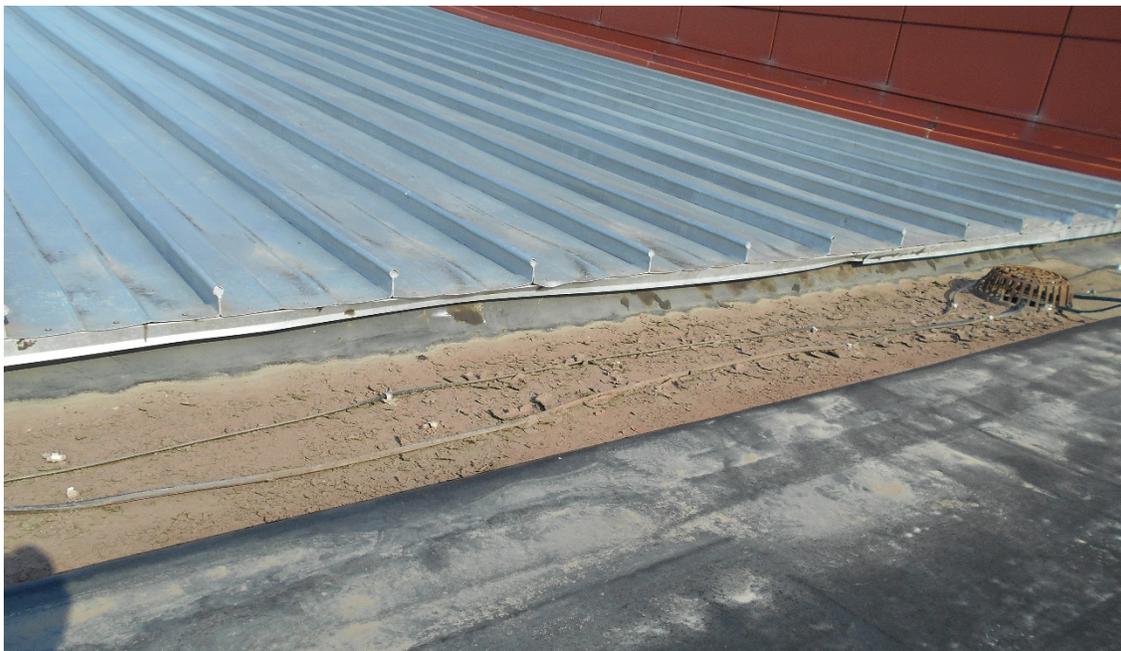
**Photo 6** Damage at standing seam metal roof at roof drainage channel

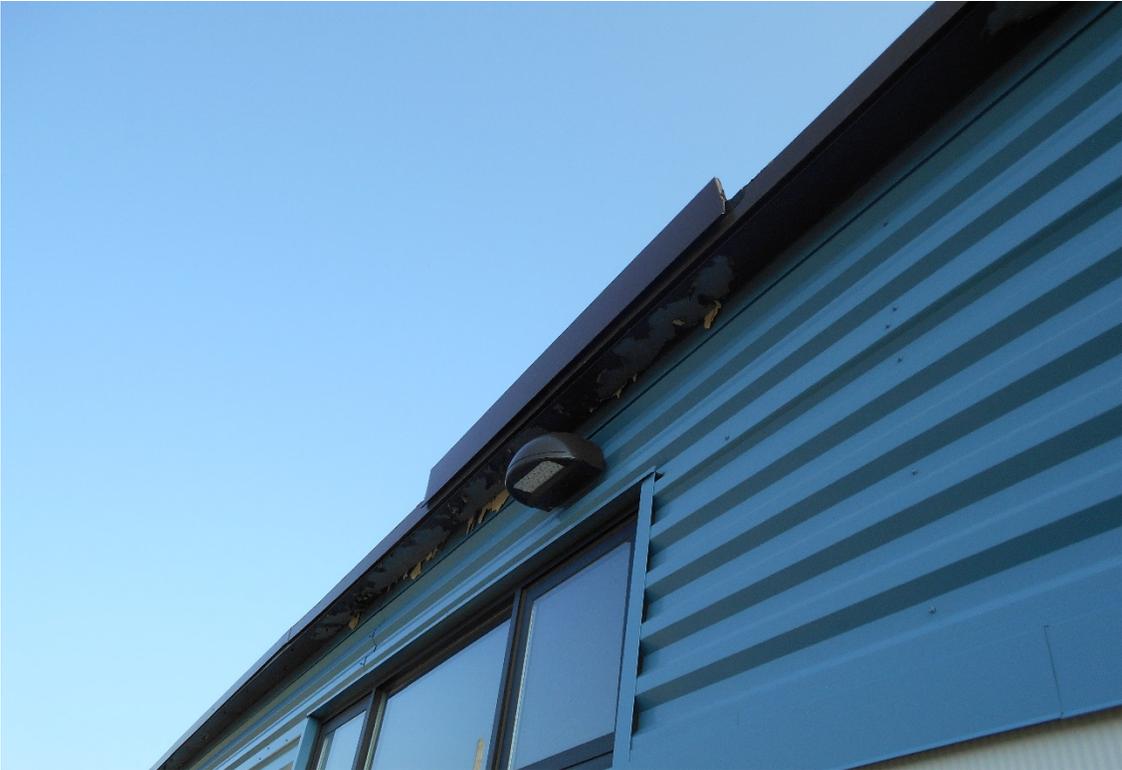
Photo 2 Peeling Paint at Soffit

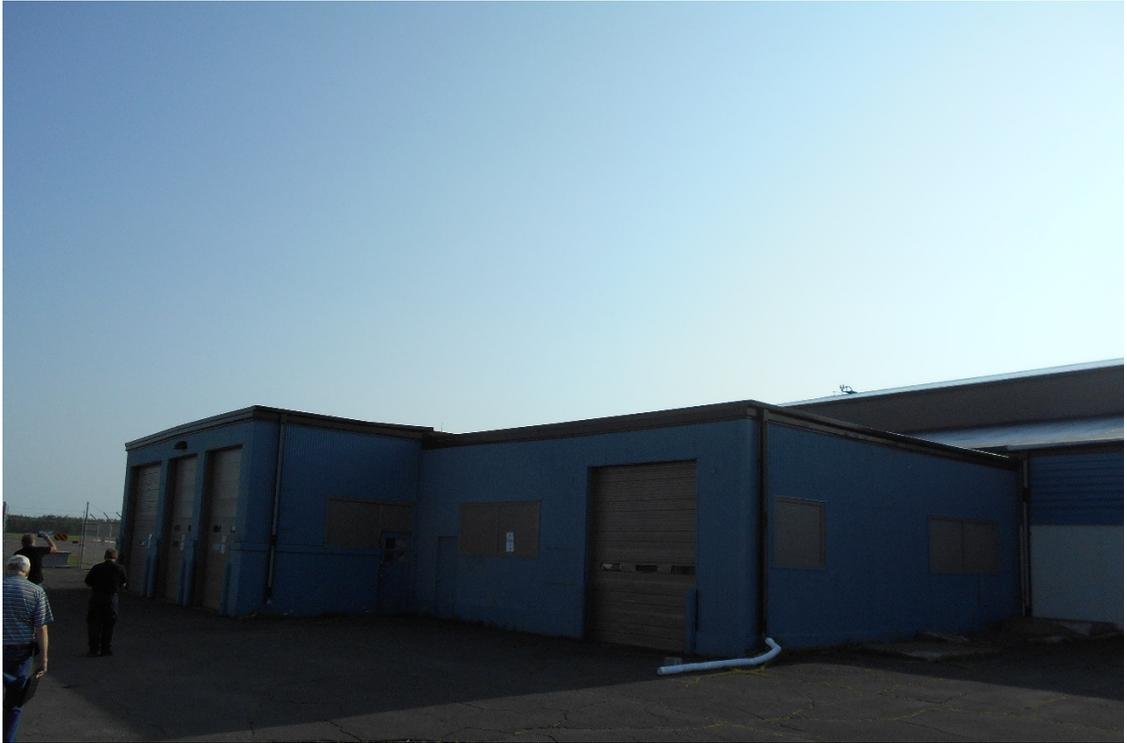
**Photo 3** Wood framing / paneling infilled openings

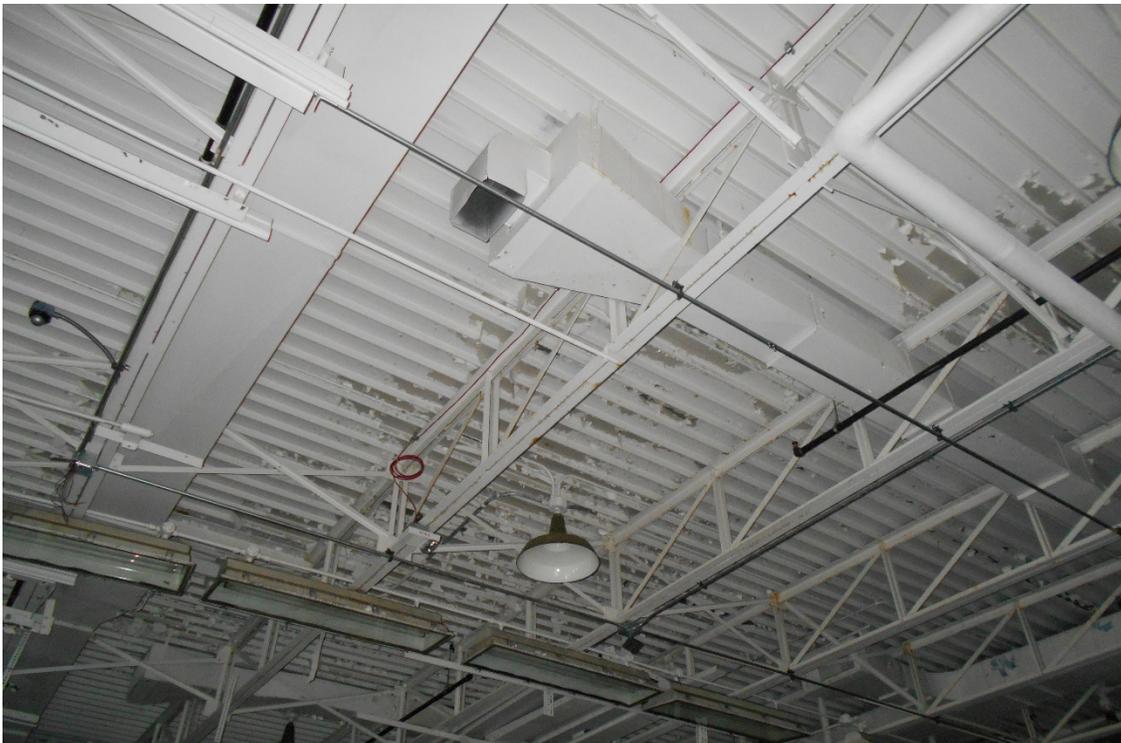
**Photo 6** Peeling Paint at underside of roof deck in Service Garage

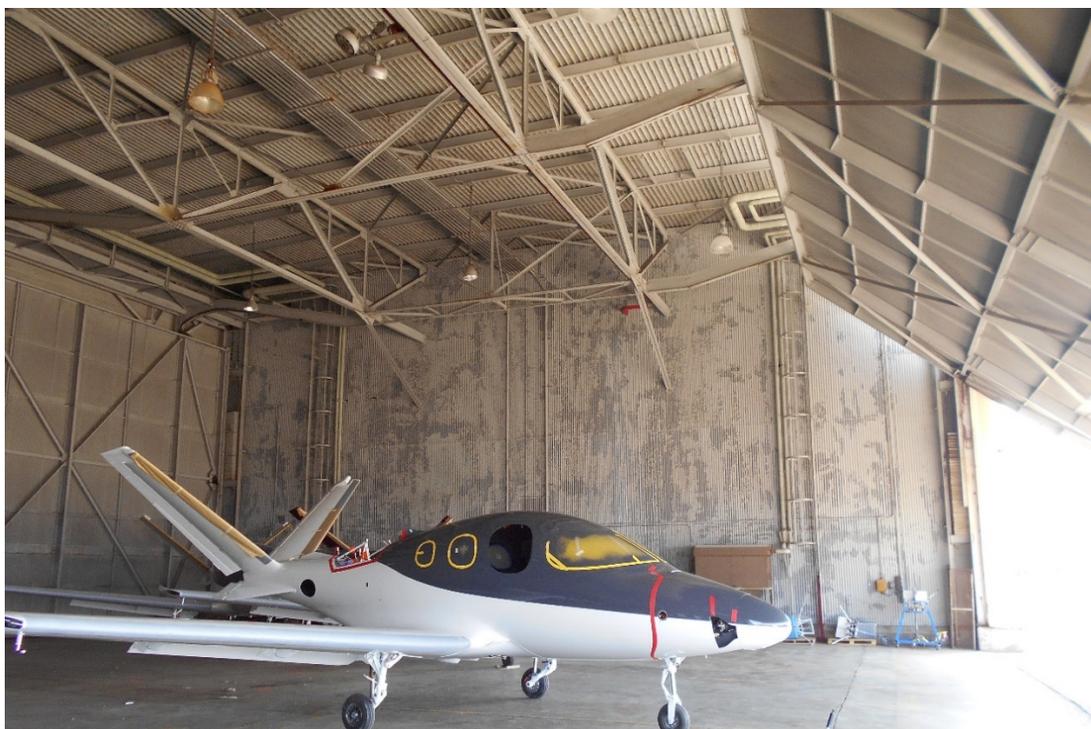
**Photo 2** Peeling Paint at Interior Metal Liner Panel

- Clean and re-paint exterior metal wall/ door panel cladding, CMU base, and exposed metals on building, estimated \$92,500.
- Clean and re-paint interior metal wall liner panel, estimated \$134,500.
- Clean surface rust present on interior steel roof framing structure and touch-up paint, estimated \$10,250.
- Service existing hangar doors and hydraulic operator.
- Replacement of power distribution system, electrical service equipment, and interior and exterior lighting

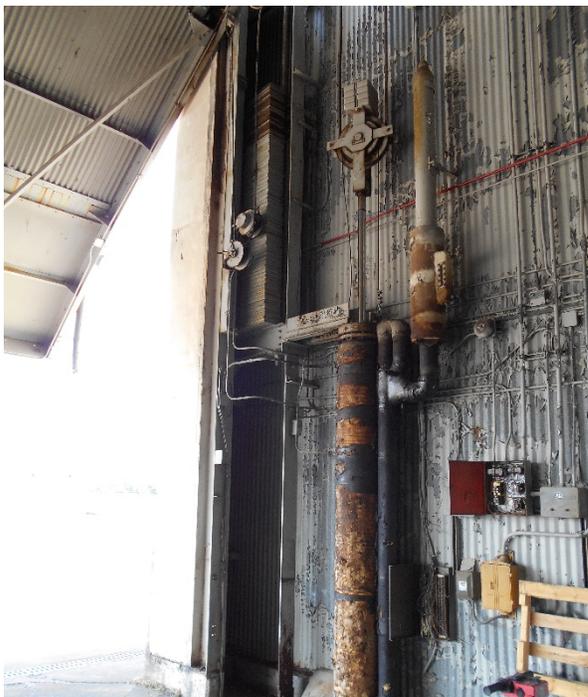
**Photo 4** Hydraulic System That Operates Hangar Doors

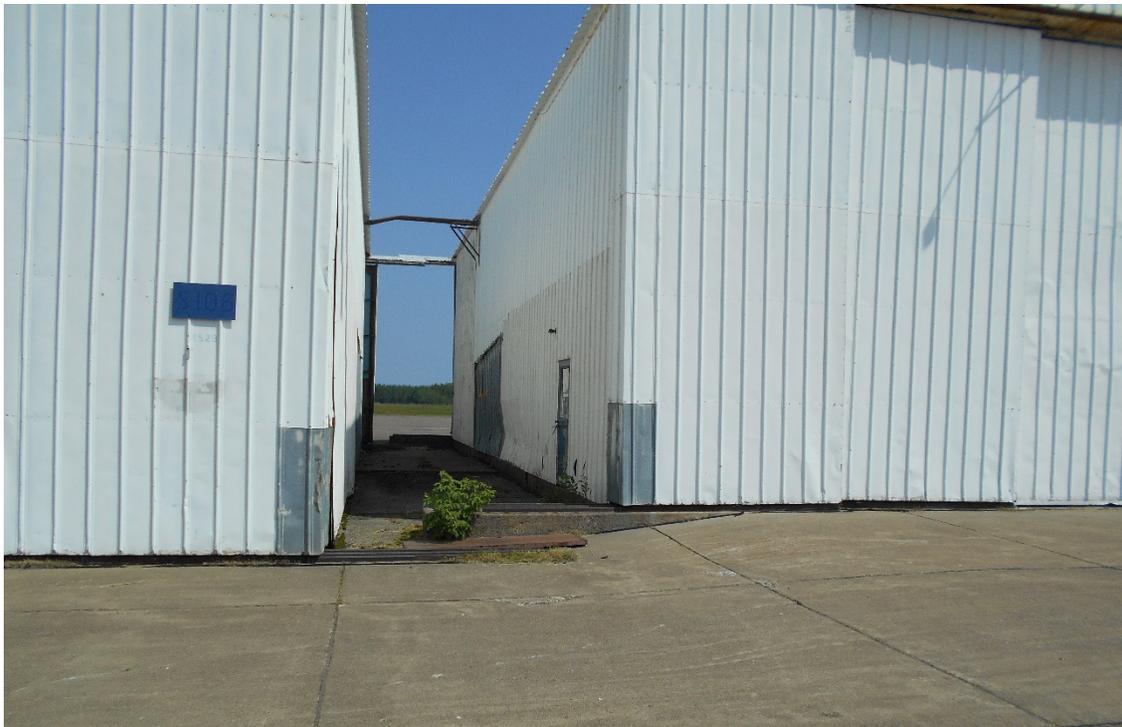
**Photo 2** Damaged Exterior Metal Wall Panels

- Patch and repair any punctured or damaged exterior wall and hangar door metal panels, estimated \$15,000 (each bldg.).
- Clean and re-paint exposed metal wall panels on exterior of building, estimated \$16,500 (each bldg.).
- Replace exterior wood doors and frames, estimated \$3,000 (2 thus, each bldg.).
- Service existing sliding hangar doors and guide rail system.
- Clean surface rust present on interior steel roof framing structure and touch-up paint, estimated \$13,750.
- Replace existing metal roof panels, estimated \$190,000.
- Replace existing electrical distribution system, including panels and distribution transformers
- Replace interior lighting with LED high bay fixtures
- Replace exterior lighting with LED fixtures

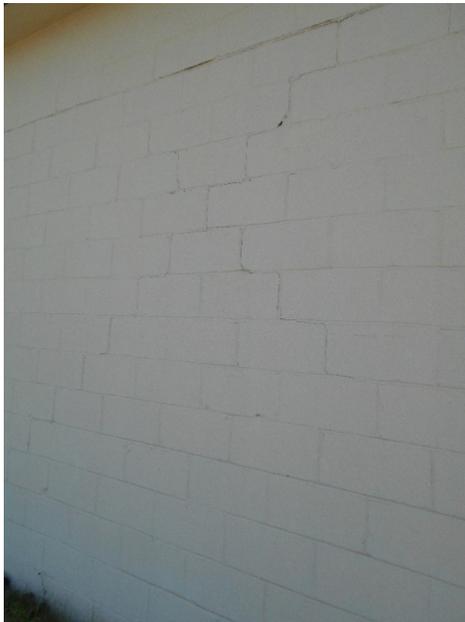
**Photo 2** Cracks / Grout Joints in Need of Repair

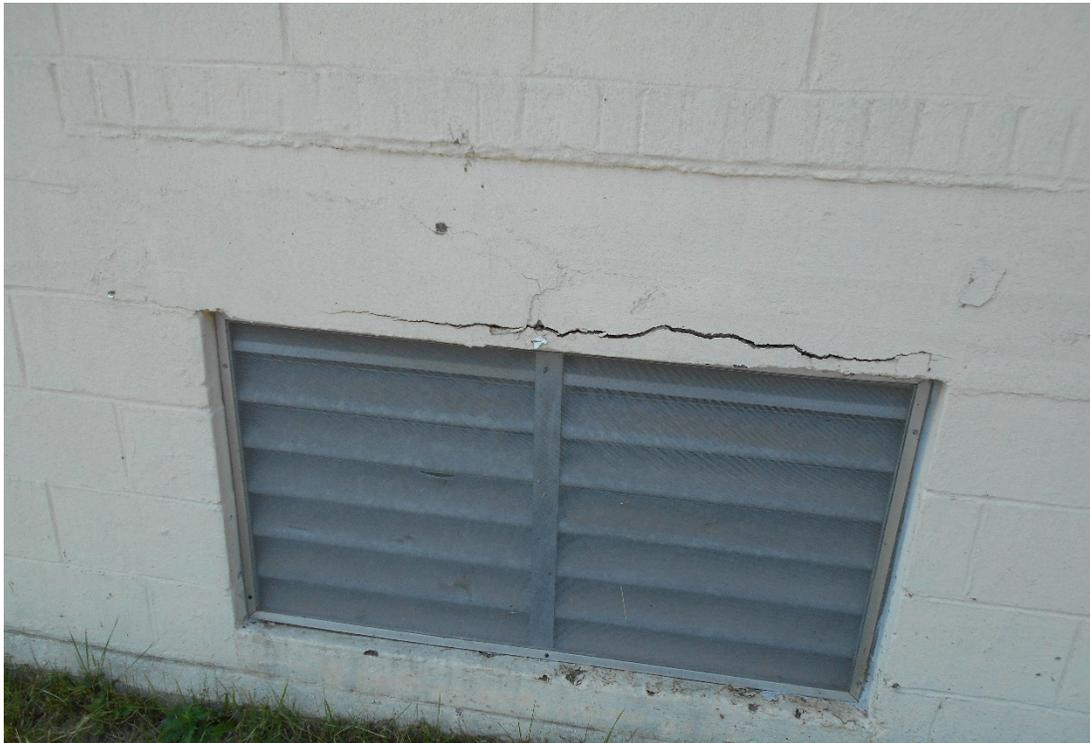
**Photo 3** Crack in Structural Concrete Lintel above Louver opening

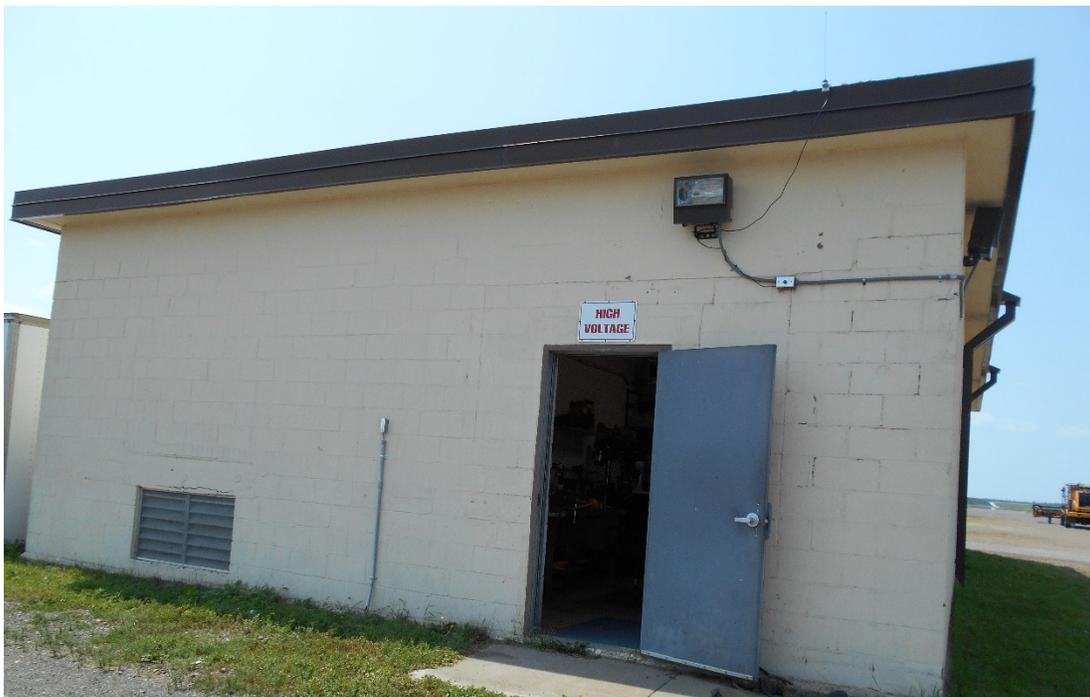
**Photo 4** Cracks / Grout Joints in Need of Repair & Exterior Service Door

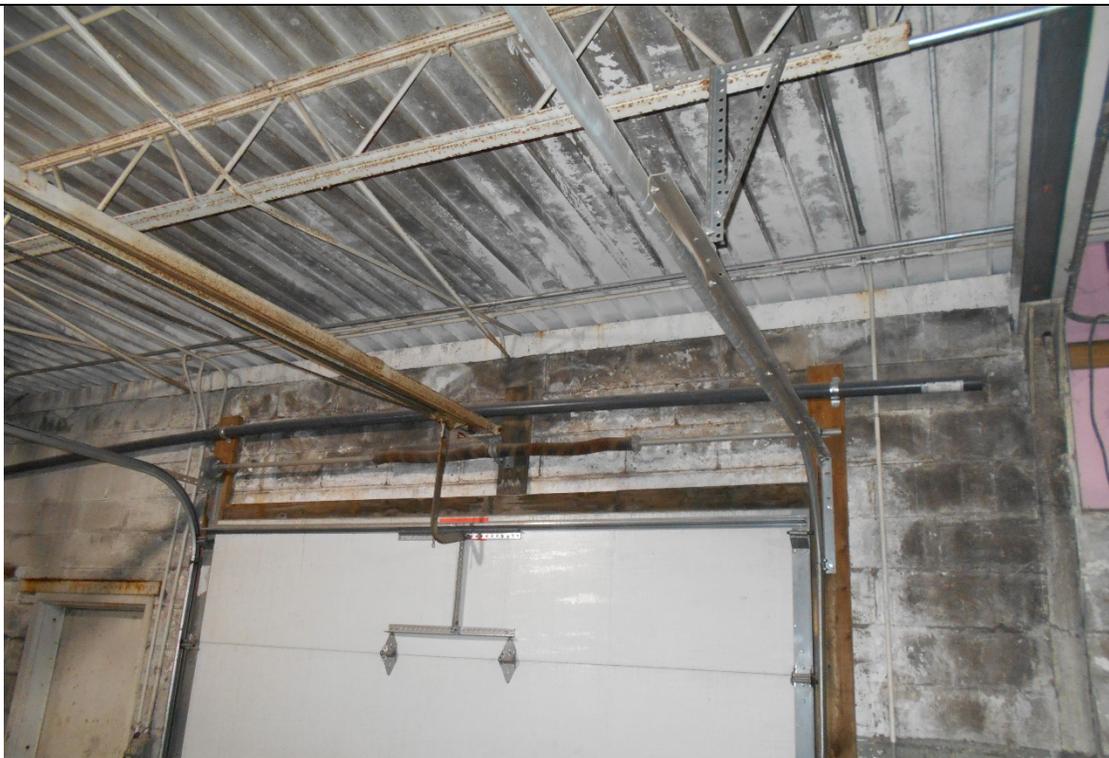
**Photo 2** Efflorescence on Interior of Exterior Masonry Wall (loading dock area)

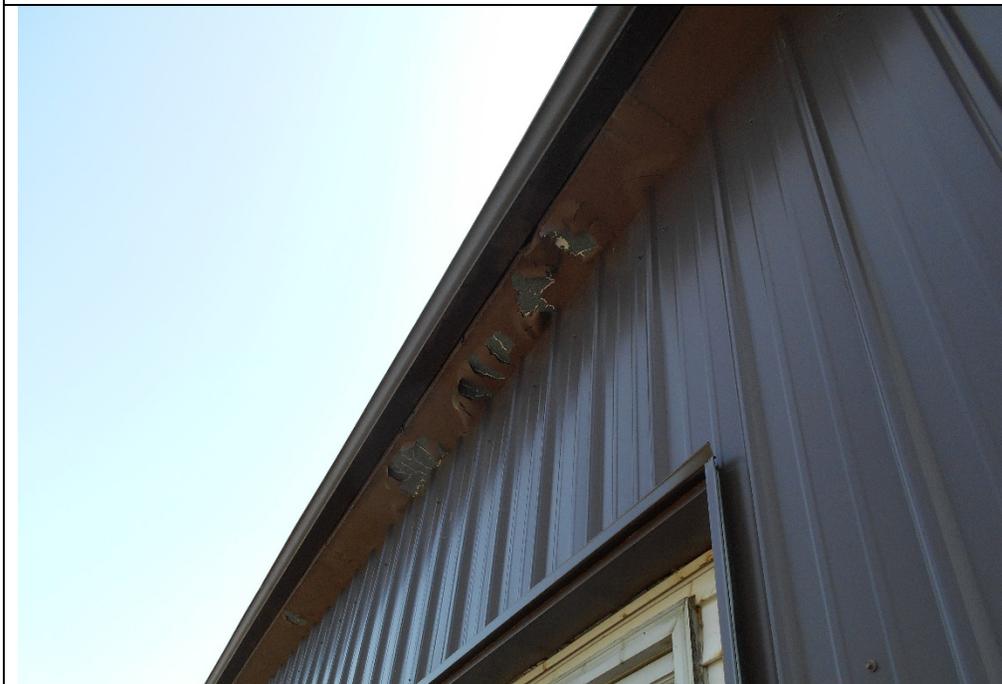
**Photo 4** Paint Finish Failure/ Peeling Paint at Soffit

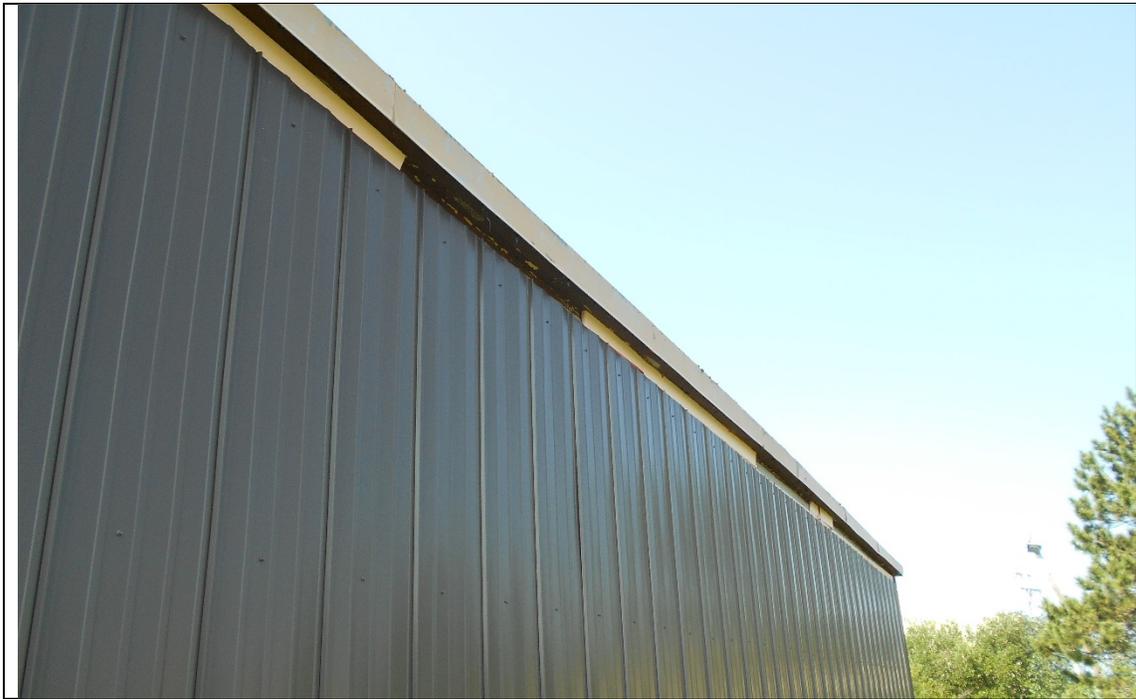
**Photo 5** Exterior Metal Wall Panels Not Flashing at Soffit Exposing Insulation Board. Potential Water Infiltration

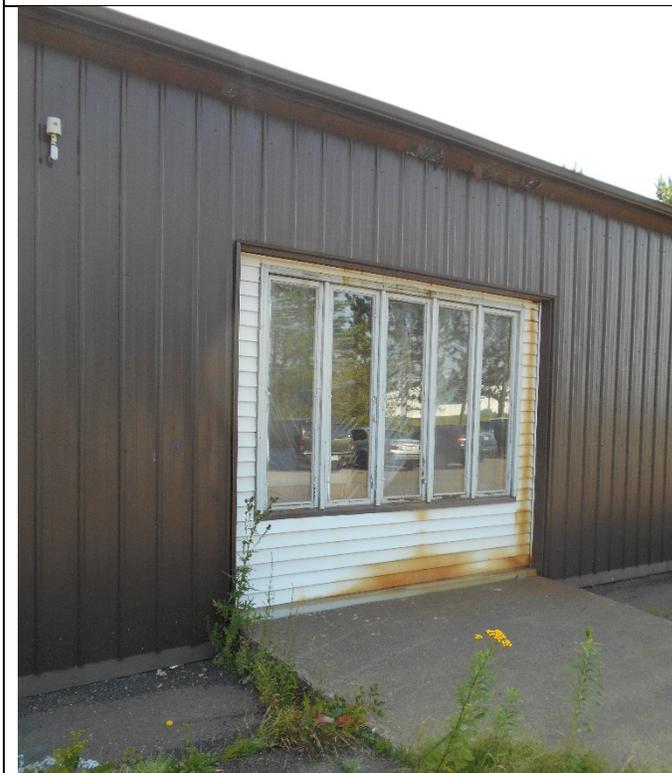
**Photo 6** Infilled Openings along Exterior Building Wall & Wood Framed Windows

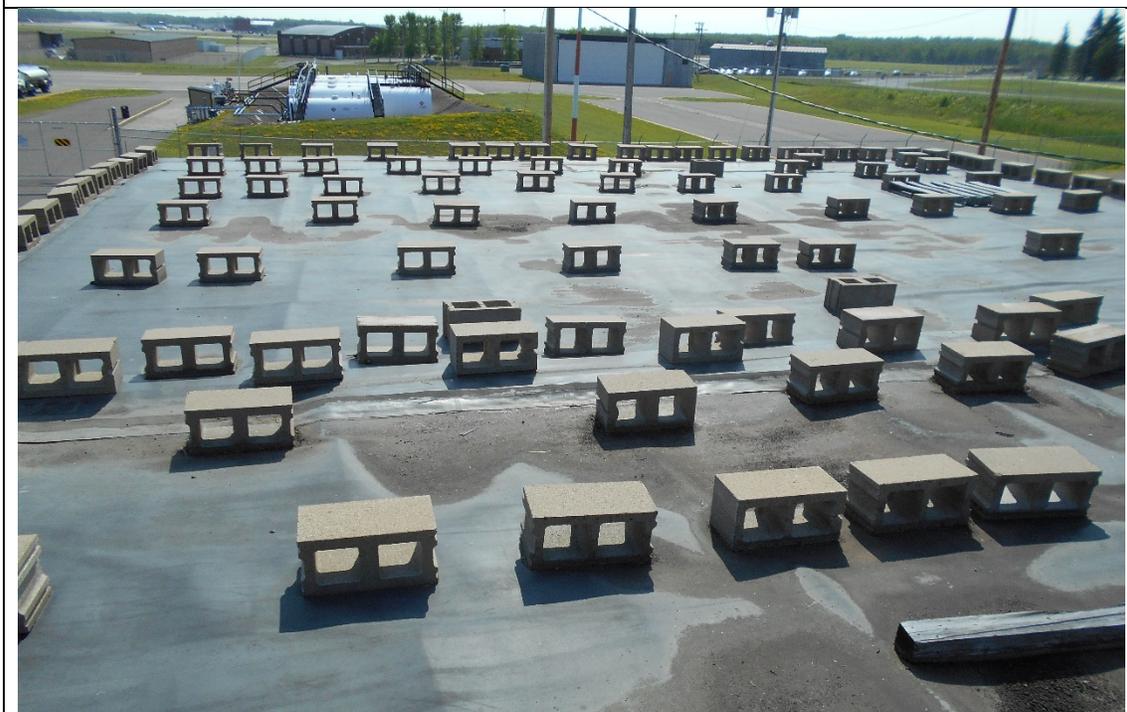
**Photo 8** Re-Roof Section with Membrane and Masonry (CMU) Used as Ballast

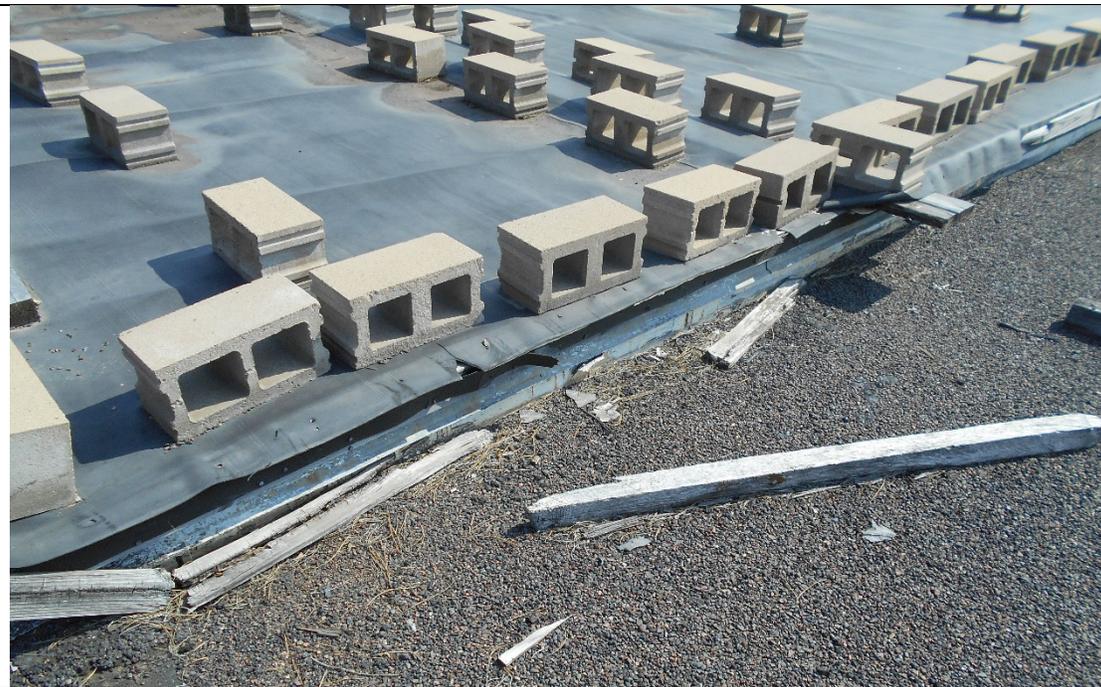
**Photo 10** Roof Edge Condition Not Properly Flashing/ Secured & Failing

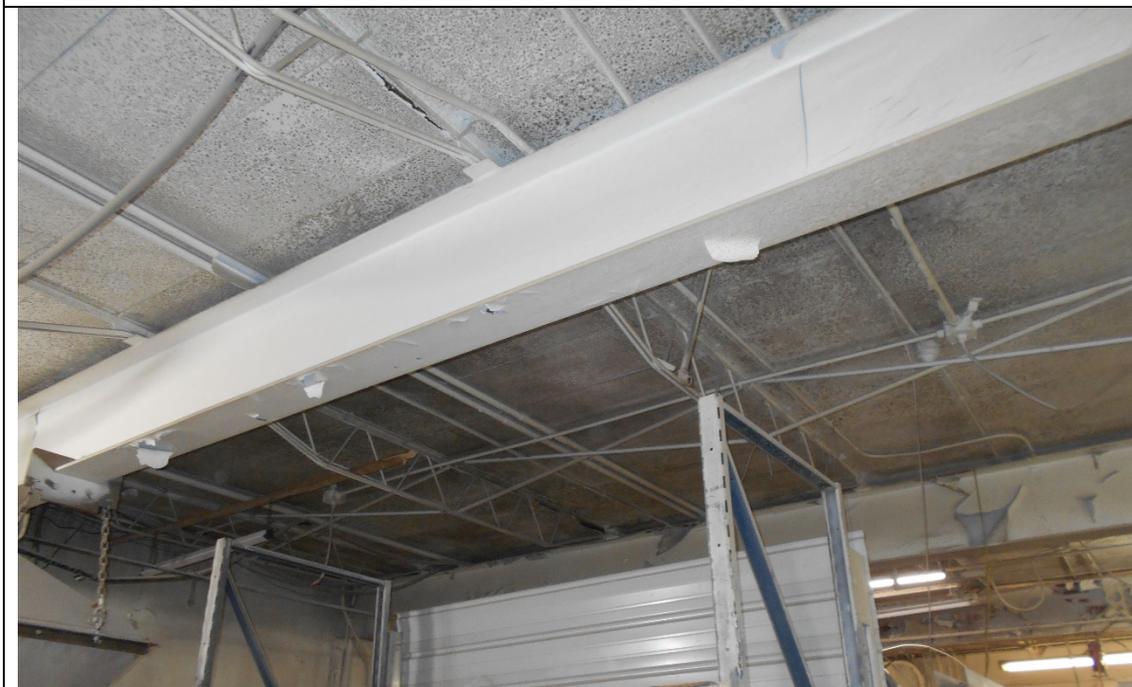
**Photo 12** Possible Mold/ Mildew and Paint Peeling from Structure at Underside of Concrete Roof Deck

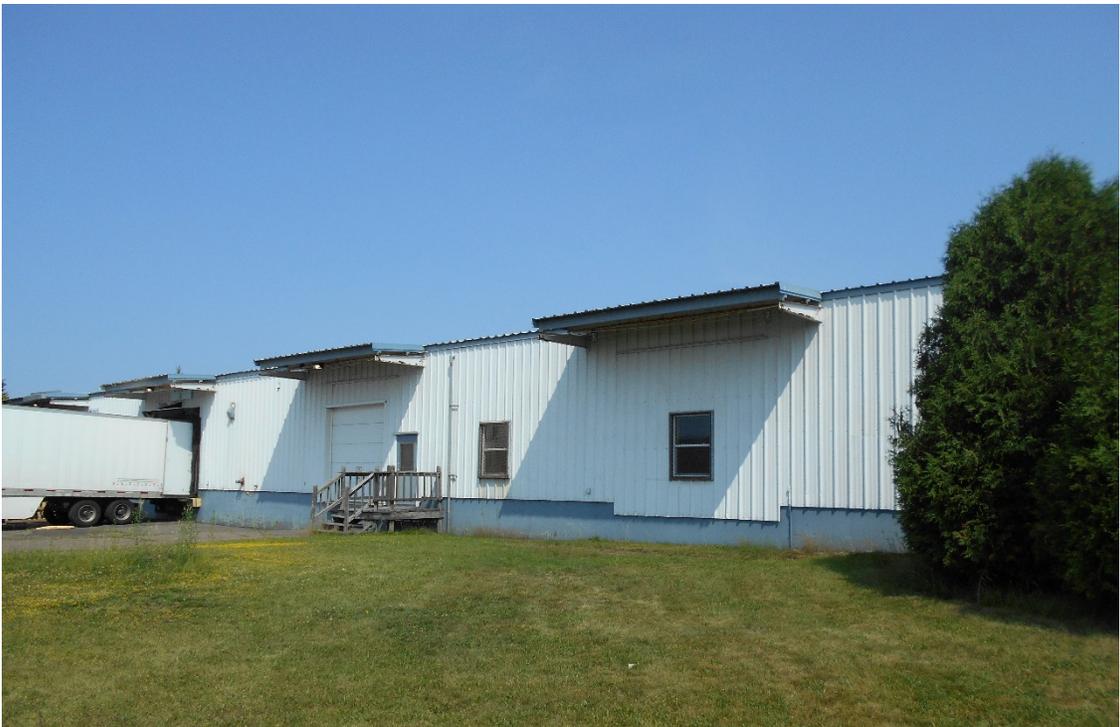
**Photo 2** Surface Rust Beginning to Form on Exterior Steel at Underside of Canopy Overhangs

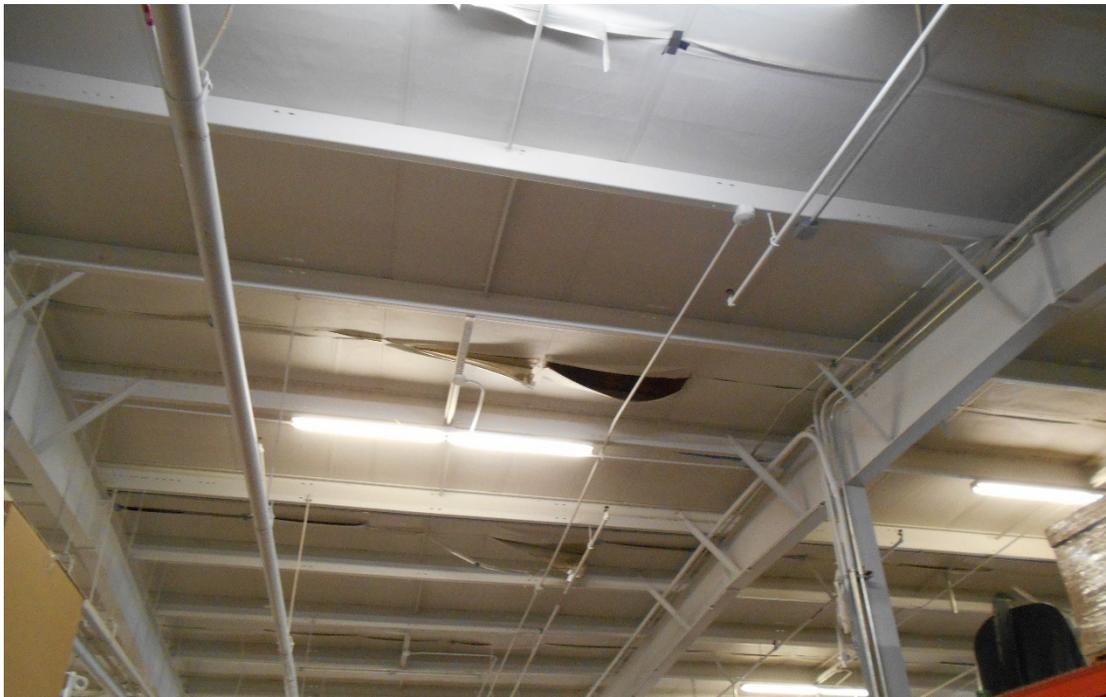
**Photo 4** Roof Insulation and Vapor Barrier Failing

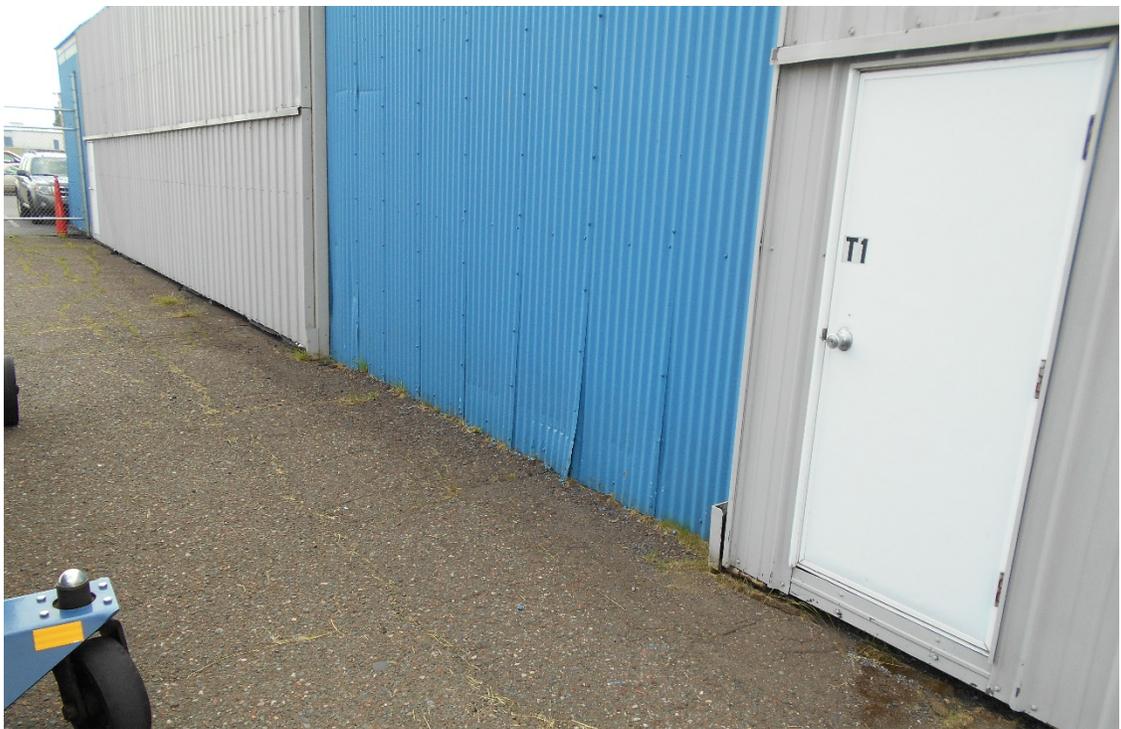
**Photo 2** Damaged exterior metal wall panels near ground level

- Patch and repair any punctured or damaged exterior metal wall and hangar door panels, estimated \$13,500.
- Clean and re-paint exterior metal wall panel and hangar door cladding, estimated \$9,700.
- Clean and re-paint exterior wood frames and hollow metal doors, estimated \$3,000.
- Service the existing hangar doors and operator, along with replacing bottom seals, estimated \$3,000.
- Replace existing metal roof panel system, estimated \$190,000.
- Replace exterior wall pack lighting.

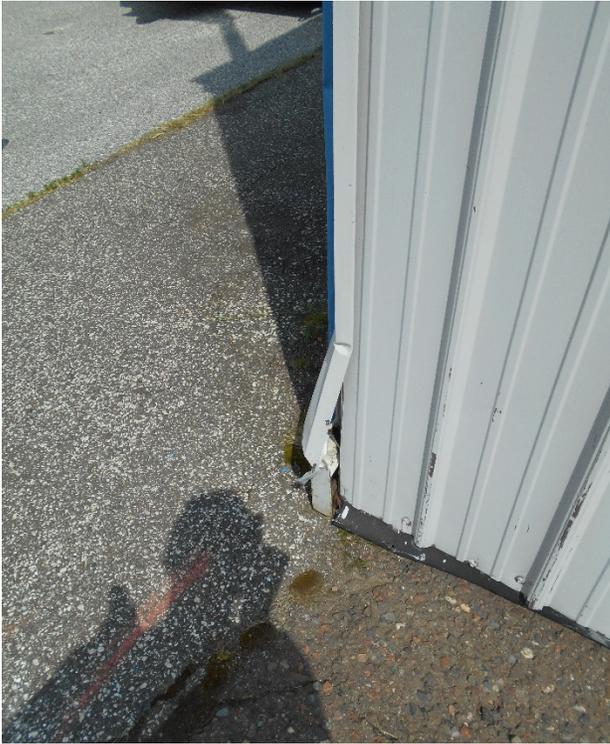
**Photo 3** Damage near bottom of hangar door

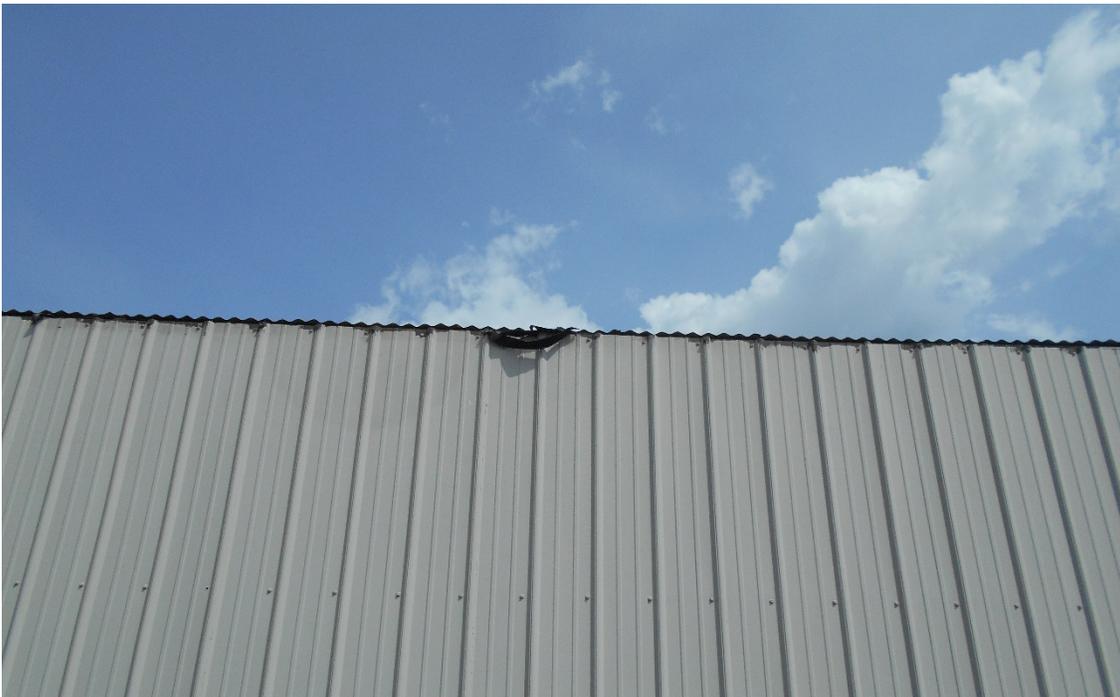
**Photo 4** Damaged exterior metal wall panels near top of hangar door

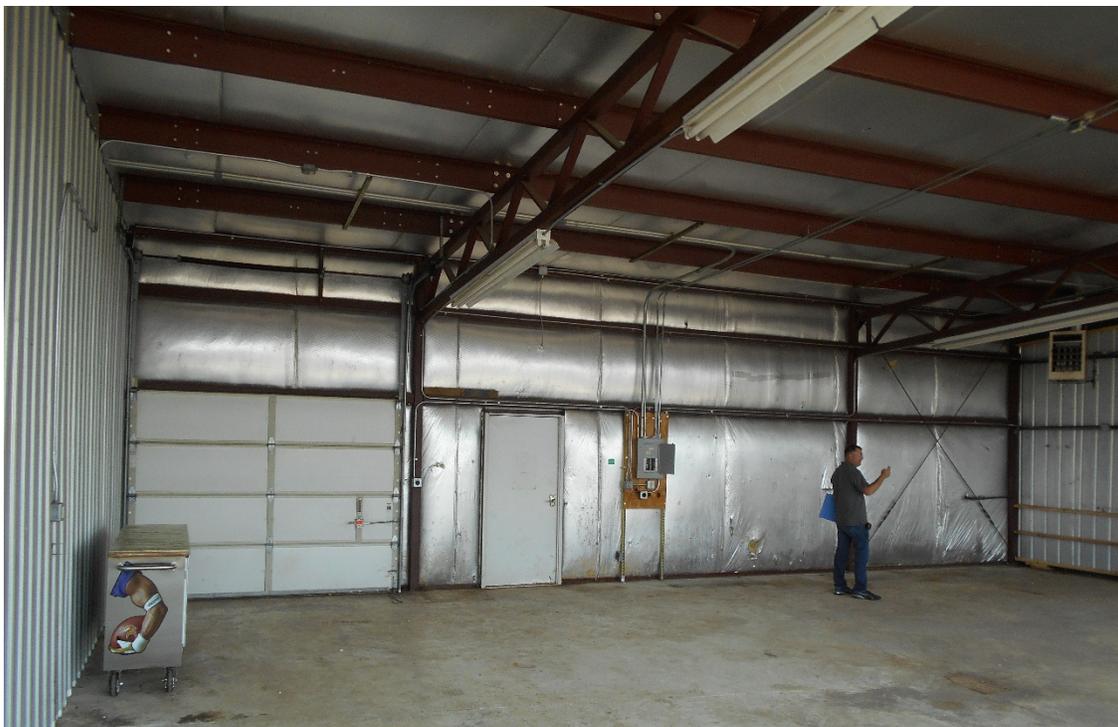
**Photo 2** Interior building steel framing and exposed insulation. Coating applied over concrete floor slab wearing

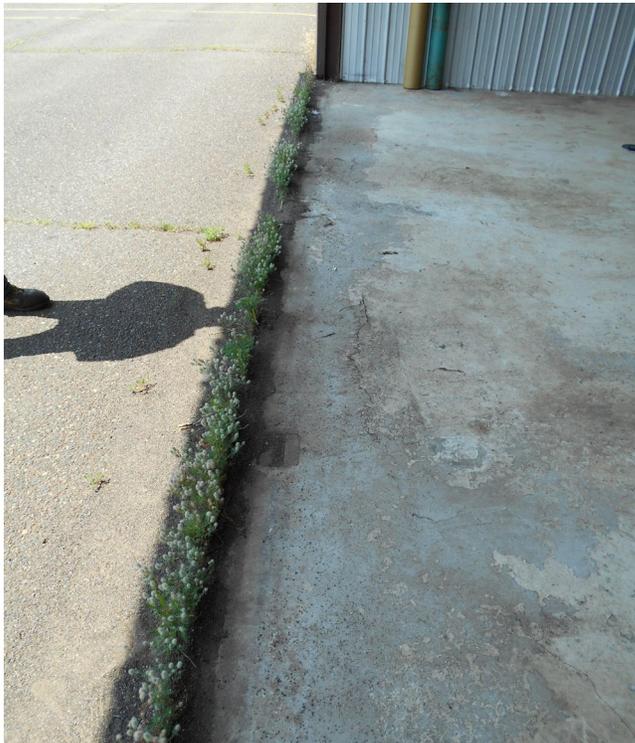
**Photo 3** Joint between concrete floor slab and bituminous pavement

- Patch and repair any punctured or damaged exterior metal wall and hangar door panels, estimated \$6,000.
- Remove overgrowth and fill joint between the interior concrete floor slab and exterior bituminous pavement with an expansion material and sealant, estimated \$5,000.
- Clean and re-paint exterior wood frames and hollow metal doors, estimated \$7,000. Repair damaged doors.
- Service the existing hangar doors and operator, along with replacing bottom seals, estimated \$3,500.
- Clean and re-paint exterior overhead service doors, estimated \$4,000. Adjust door/ track as necessary.

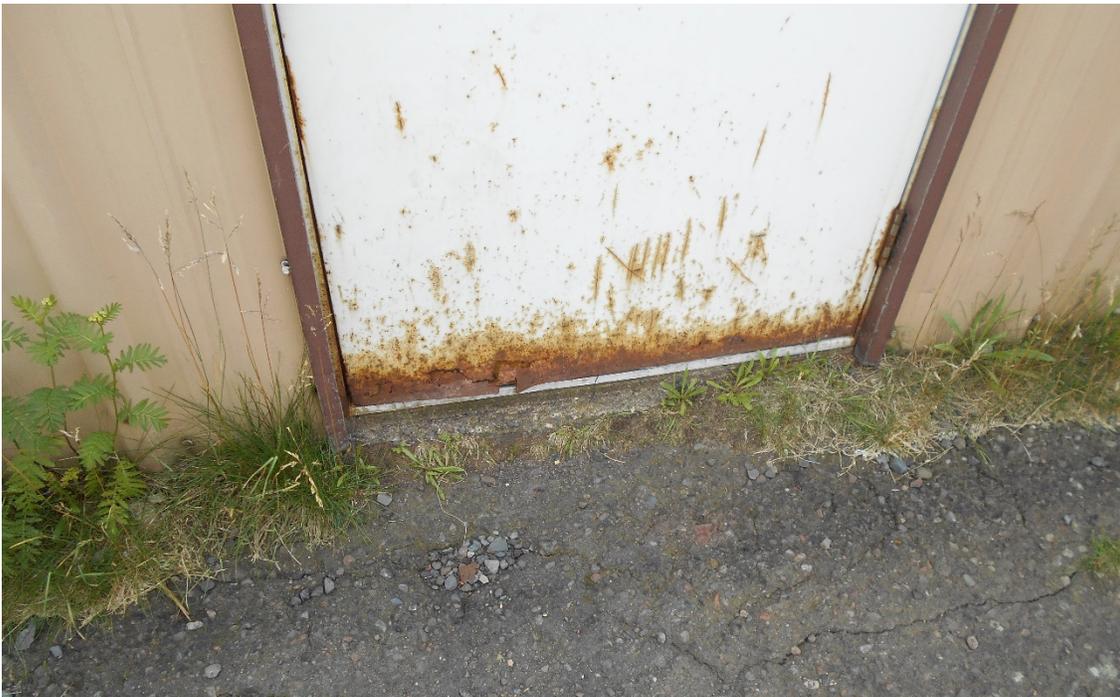
Exterior pedestrian doors consisted of painted wood frames with hollow metal doors. The doors appeared in fairly good condition, some starting to show signs of wear and deterioration beginning to form particularly near the bottom. It is recommended that exterior wood frames and hollow metal doors be cleaned and painted in the near future to prevent further deterioration.

**Photo 4** Exterior service door showing signs of deterioration (north side)

- Patch and repair any punctured or damaged exterior metal wall and hangar door panels, estimated \$30,000.
- Clean and re-paint exterior wood frames and hollow metal doors, estimated \$7,000.
- Service the existing hangar doors and operator, along with replacing bottom seals, estimated \$7,000.
- Replace existing wood framed window located on east end of building, estimated \$600.

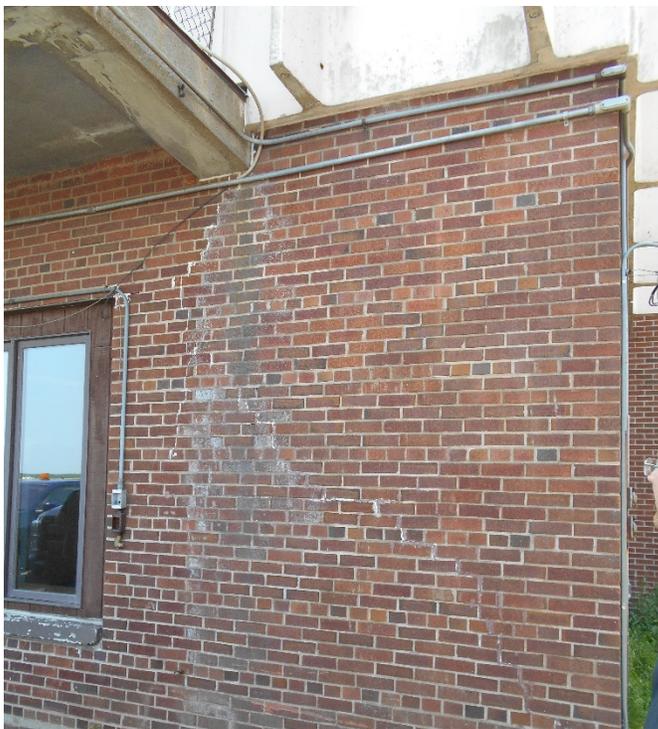
**Photo 2** Cracks in brick masonry and mortar joints in need of tuck-pointing

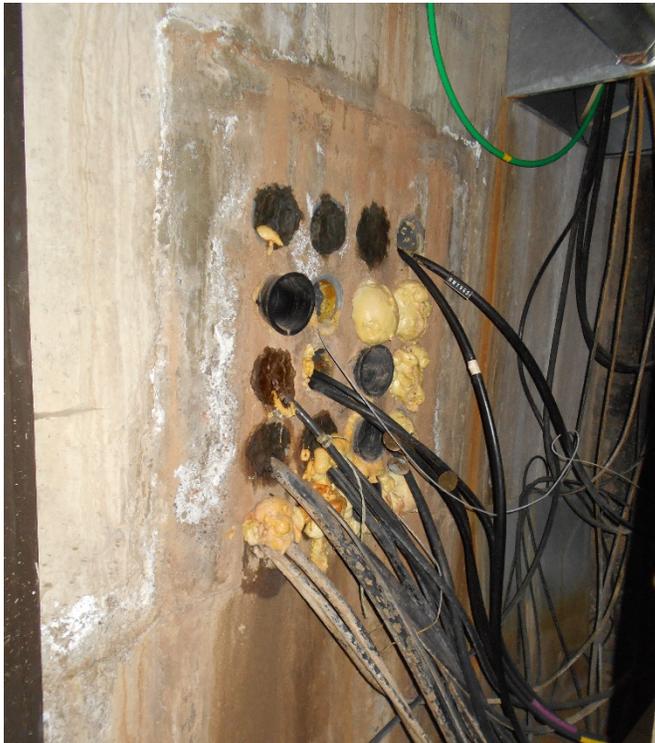
Water intrusion was noted coming in along pipe/ conduit penetrations through the concrete foundation wall in the basement mechanical room and ponding on existing concrete floor slab, more prevalent at spring/

ground thaw cycle. There is no floor drain or sump located in this room. Attempts at sealing penetrations from inside of building have been unsuccessful. Recommend cleaning and sealing penetrations from outside building where they first penetrate the exterior foundation wall, which is believed to be located beneath a manhole near northwest corner of building. The interior concrete masonry units (CMU) wall in the basement mechanical room also had signs of efflorescence, possibly due to moisture getting in through the cavity of the wall. It is unknown the exact cause, and this could possibly be resolved when the building is re-roofed. Recommend cleaning of this masonry wall to remove current efflorescence, and monitor for signs of any new efflorescence coming through.

**Photo 5** Water Intrusion coming in along pipe/ conduit penetrations in lower mechanical room

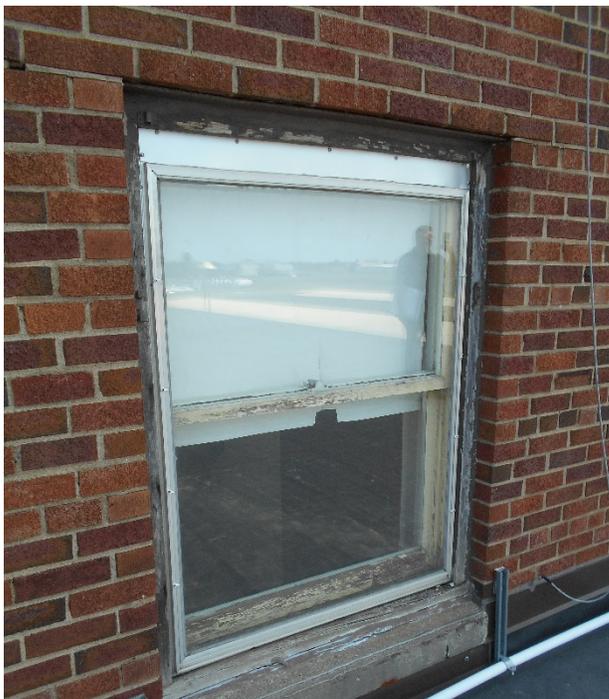
Exterior windows are painted wood units with non-insulated glazing throughout. These units are in poor condition, deteriorated and in need of replacement. It is recommended to replace existing units with an aluminum clad window with insulated glazing. Replacement windows will provide a better weather/ air tight enclosure along with an increased insulating R-value. Existing window sills consisted of either wood or pre-cast concrete. The existing wood sills were in poor shape along with the windows, and in need of replacement. The existing pre-cast concrete sill should be cleaned, repaired if needed and apply a new paint application finish.

**Photo 8** Exterior painted wood framed windows in need of replacement

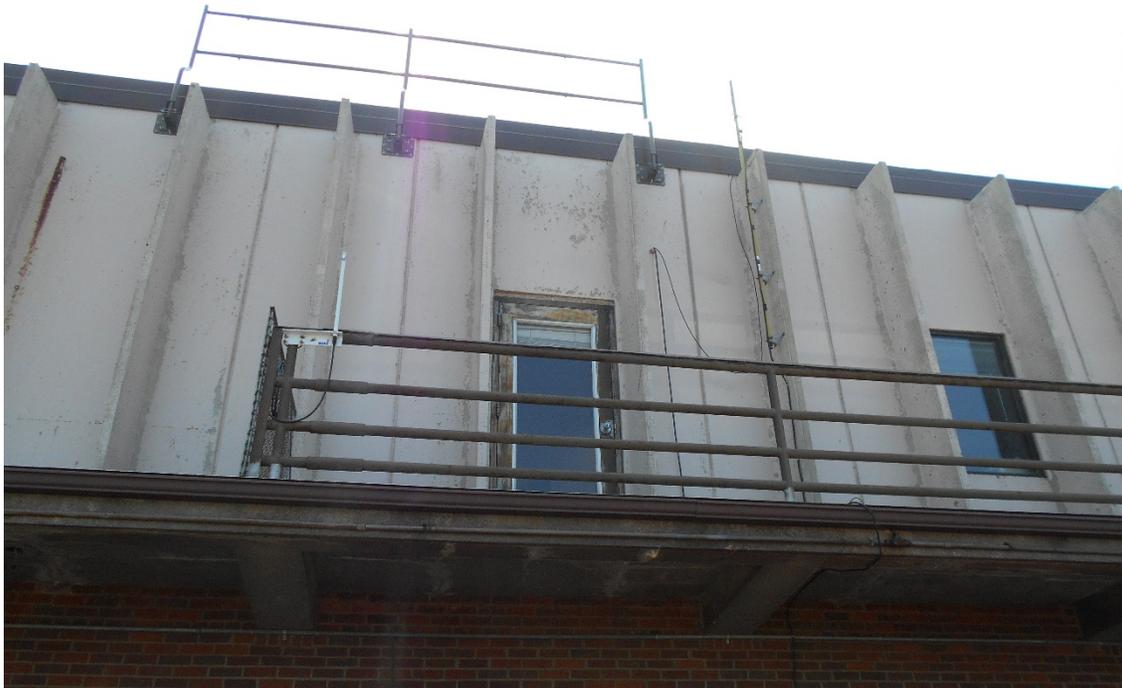
Exterior pedestrian doors are a combination of original painted wood doors and frames and replacement hollow metal doors with original wood frames at limited locations. Both the wood doors and wood frames show signs of deterioration and are in poor condition. It is recommended that existing exterior wood doors and frames be replaced with a hollow metal unit in the near future. The existing hollow metal doors previously replaced appear in good condition, and a new paint finish should be applied to prevent deterioration.

**Photo 9** Exterior painted wood door and frame in need of replacement
