# Building Assessments

Duluth Airport Authority

Duluth, Minnesota

DULAI 150733 | September 13, 2021

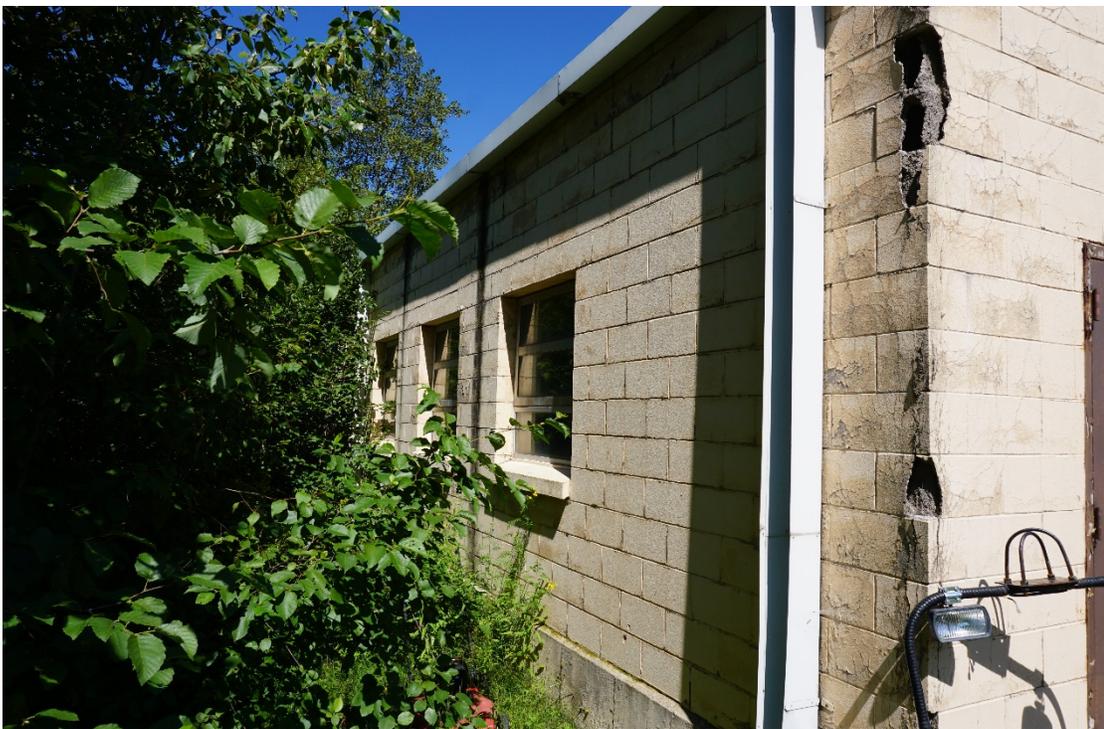
**Photo 2** Damaged concrete masonry block (CMU) / original windows

- Extensive restorative work would be required to maintain building.
- Replace damaged masonry face shells. Locations of masonry and mortar joints in need of tuck-pointing at original building.
- Replace existing doors and windows (paint), along with replacing sealant joints along exterior openings/ frames.
- Thoroughly clean and remove any peeling paint, and provide new painted finish at exterior masonry walls.
- Repair/ replace weather stripping at overhead service doors.
- Evaluate construction type and condition at post frame addition. Re-position, properly flash and secure post frame addition to original masonry building to provide weathertight enclosure (if feasible).
- Assess existing roof conditions and make necessary repairs/ replacement.

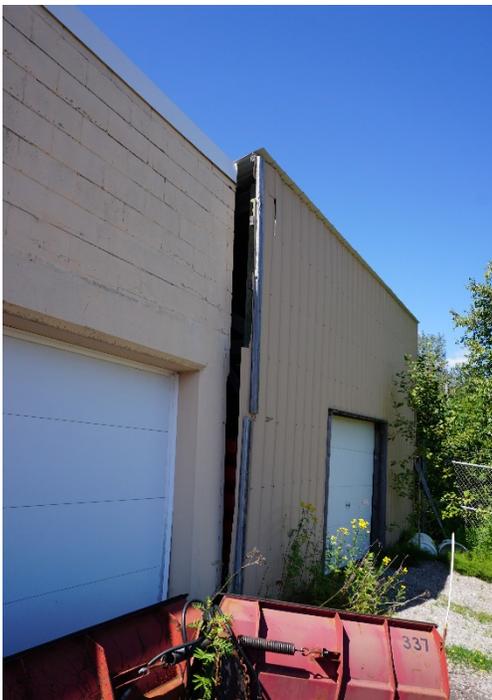
**Photo 4** Addition starting to pull away from original masonry (CMU) building

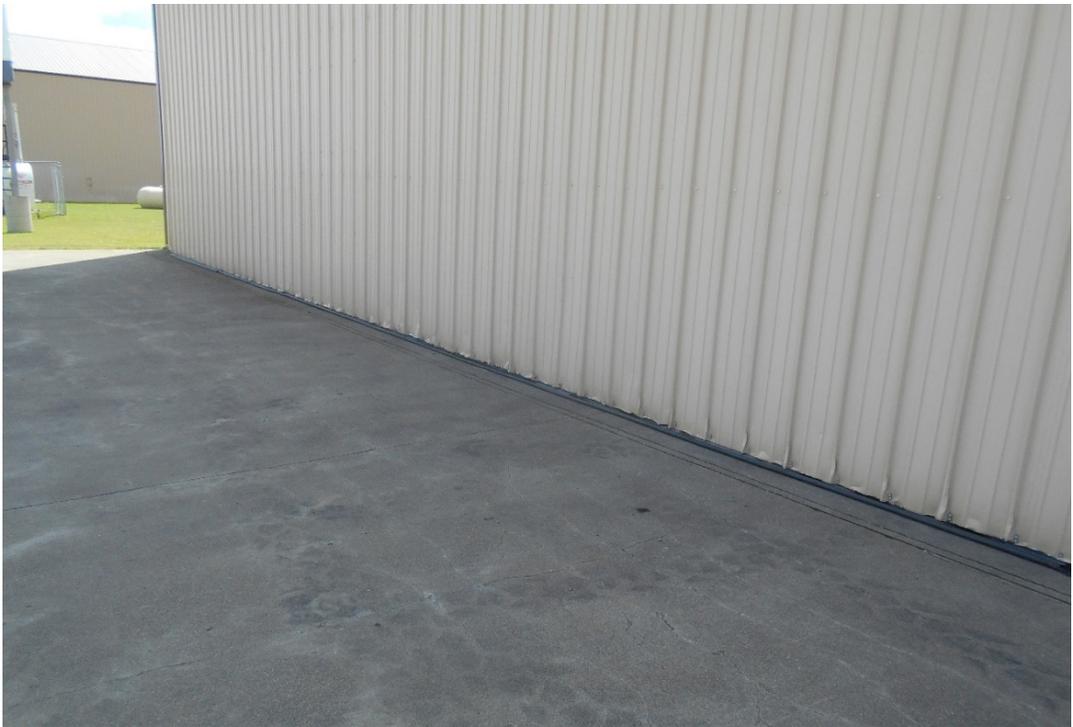
**Photo 2** Minor damage to wall panels at base of hangar door

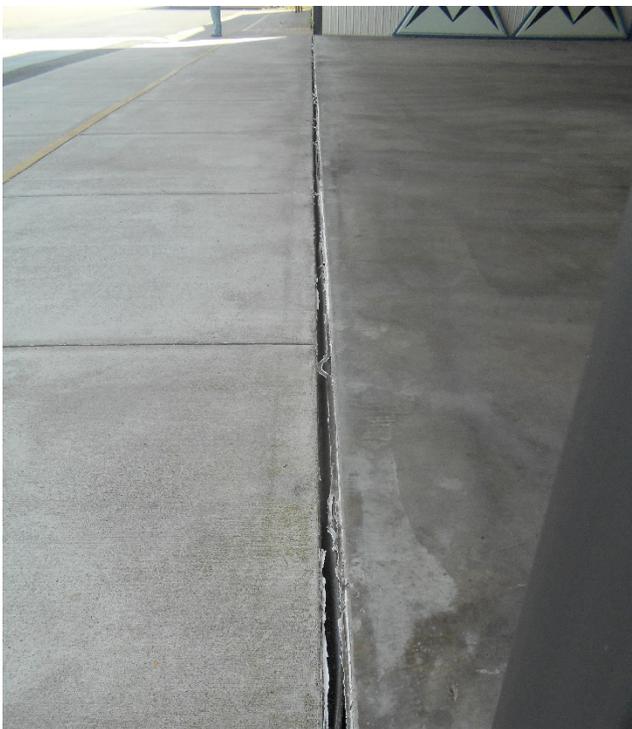
**Photo 2** Concrete apron pulling away from hangar floor slab

- Fill void space created between hangar floor slab and concrete apron with an expansion material full depth along with sealant to bridge gap and prevent further deterioration of concrete from occurring. Selection of the right expansion material and sealant along with installation is crucial to allow for further expansion/contraction deflection between the existing concrete slabs yet prevent joint material from expanding up from void getting above slab surface.

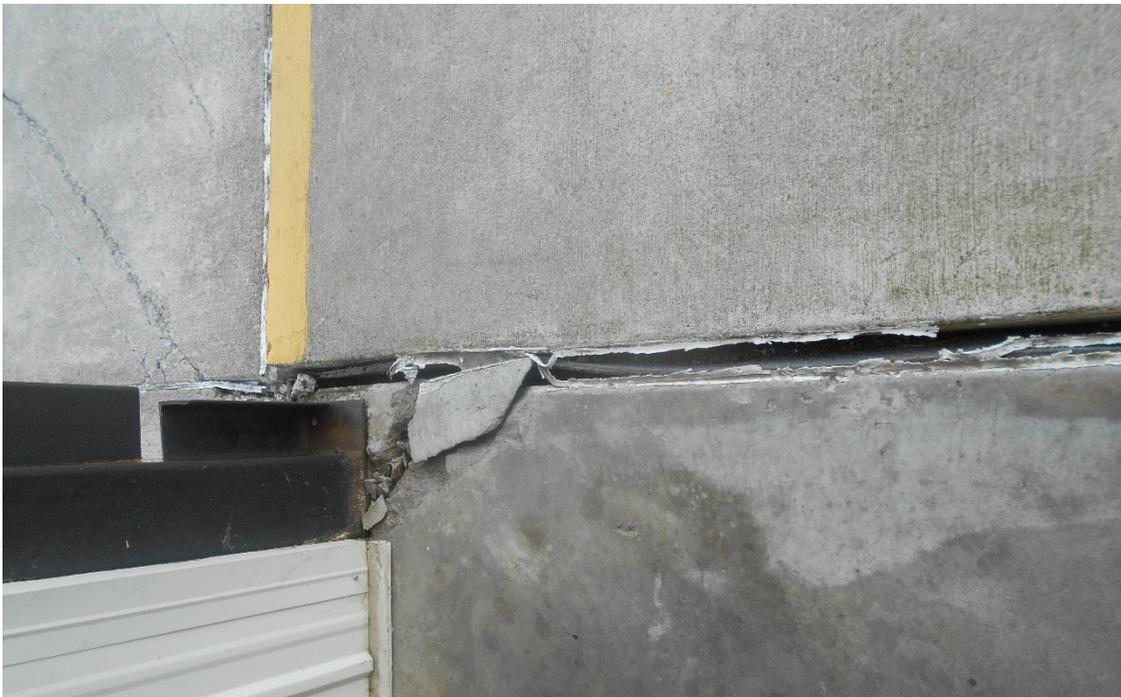
**Photo 4** Fragments of concrete broken off at corners of floor slab

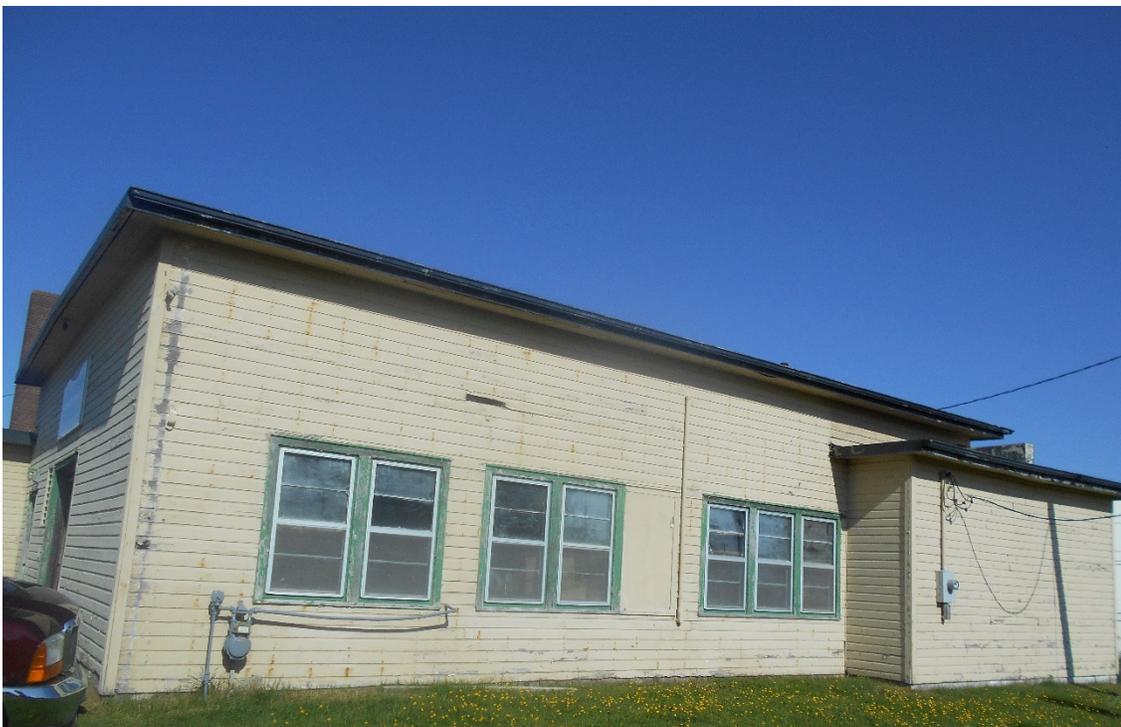
**Photo 2** Paint finish peeling/ failing on wood siding and wood framed windows (East side)

- Clean and paint existing wood siding and wood framed windows and doors to prevent further deterioration. Replace any exterior sealant that shows signs of separation, cracking, or hardening of material. Replace missing ceiling insulation/ vapor barrier in shop (multiple locations). Roof was not accessible at time of site visit, so condition of existing roof system not observed.

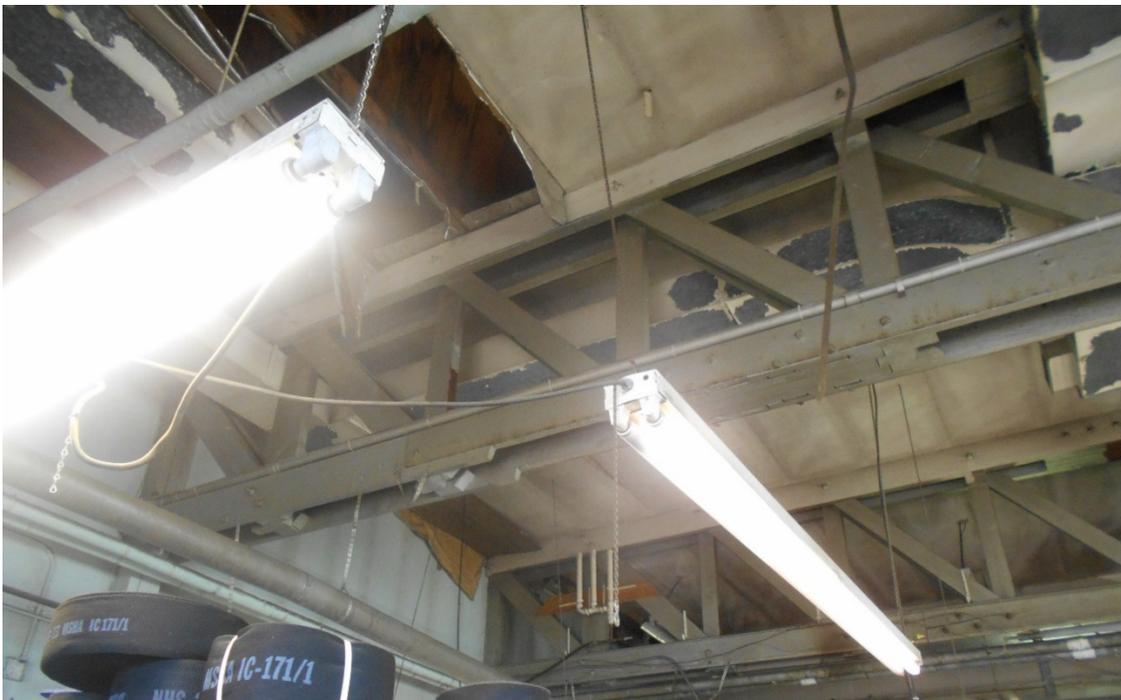
**Photo 4** Paint flaking on overhead surfaces. Ceiling insulation/ vapor barrier torn & missing (multiple locations)

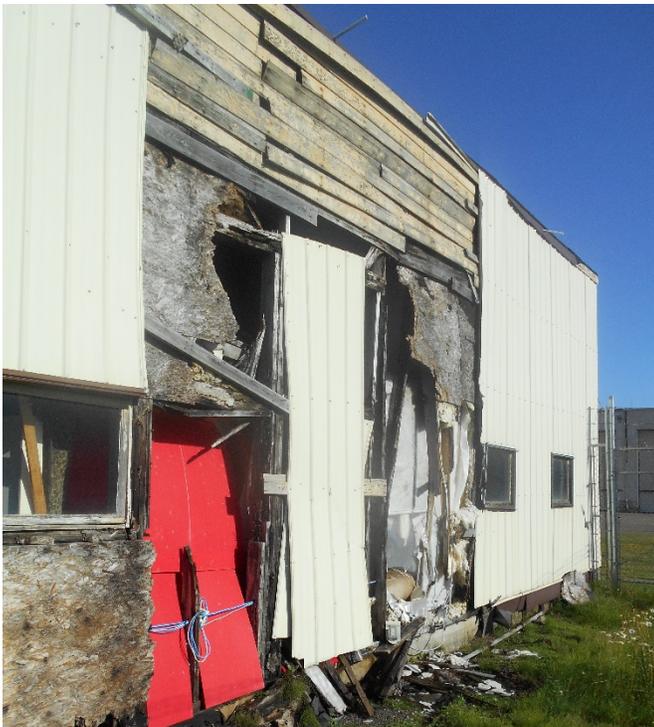
**Photo 2** Exterior damage

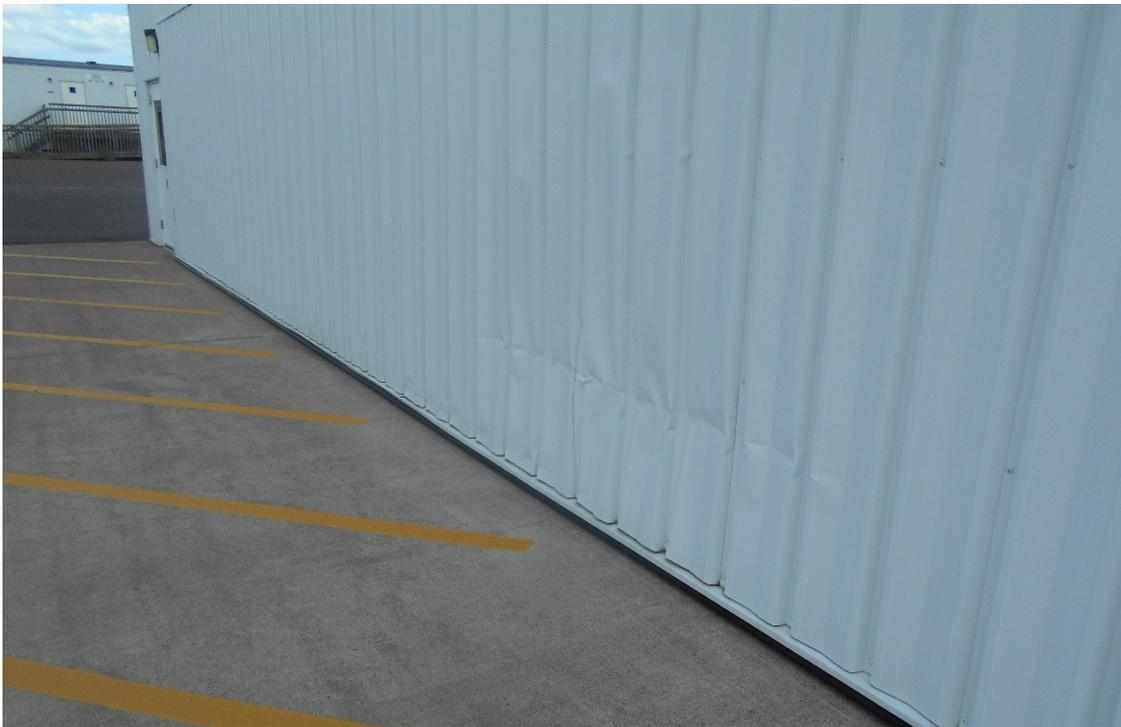
**Photo 2** Damage along bottom of prefinished metal hangar door

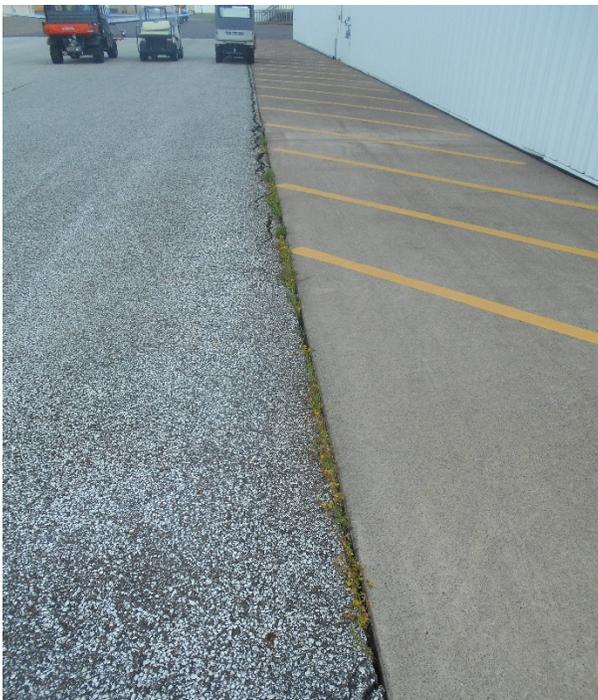
**Photo 4** Cracks in asphalt along joint with concrete apron

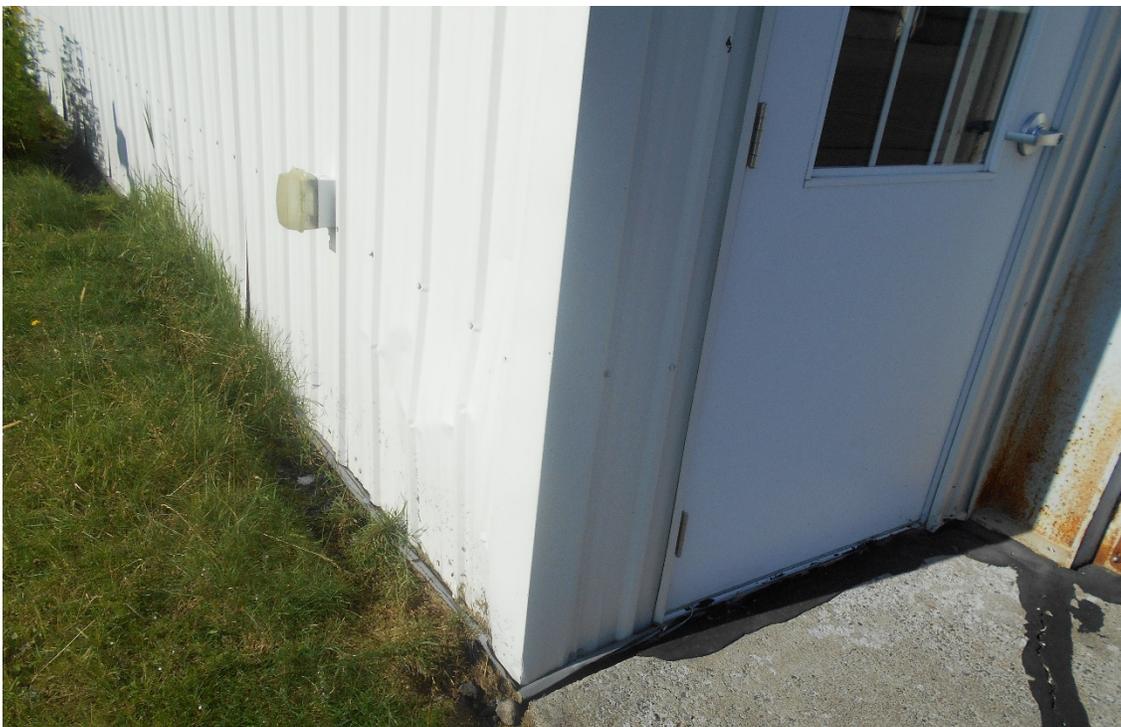
Building appeared to be in good condition overall, with no reported issues during site visit. Unable to gain access to interior space or roof at time of site visit. Some cracking in concrete apron. Minor damage to prefinished metal wall panels at limited locations.

**Photo 2** Cracks in concrete apron / minor damage to exterior metal wall panel

- Repair and fill cracks in exterior concrete apron with appropriate material to prevent further deterioration.

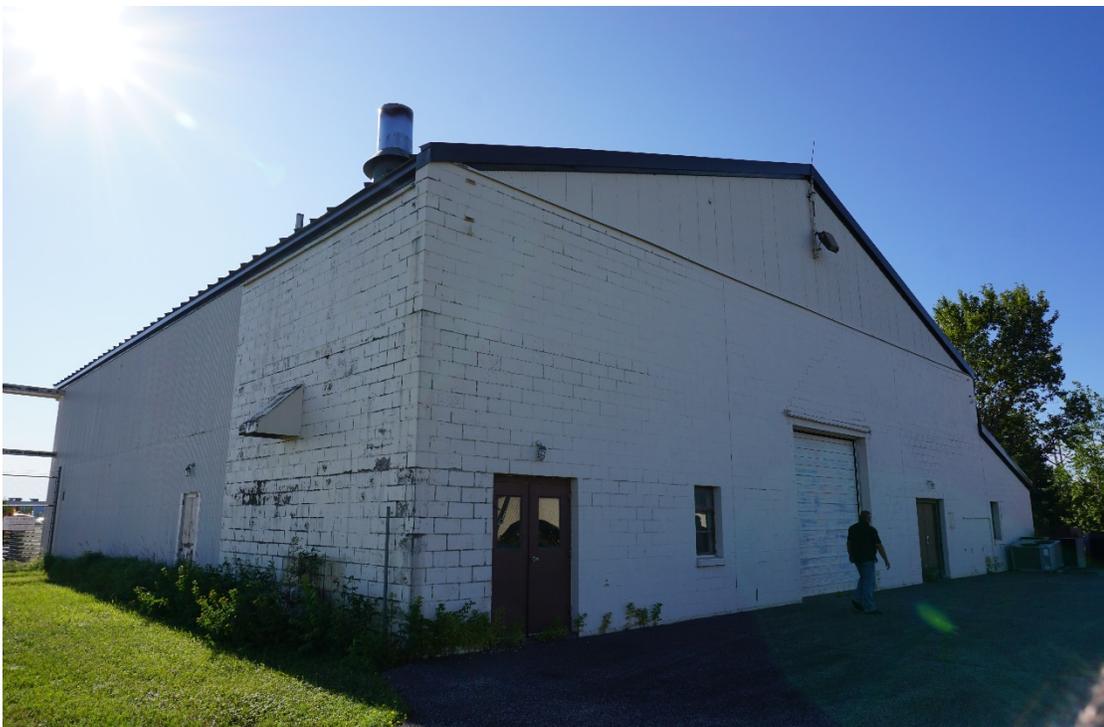
**Photo 2** Concrete masonry (CMU) along back portion of building deteriorating

- Clean off existing peeling/ flaking paint from corrugated metal siding and re-paint exterior. Clean and tuck-point damaged masonry and grout locations, and re-paint concrete masonry portion of building.
- Remove and reinstall failed sealant at joints between dissimilar material connections, door/ window frames, and at through wall penetrations.

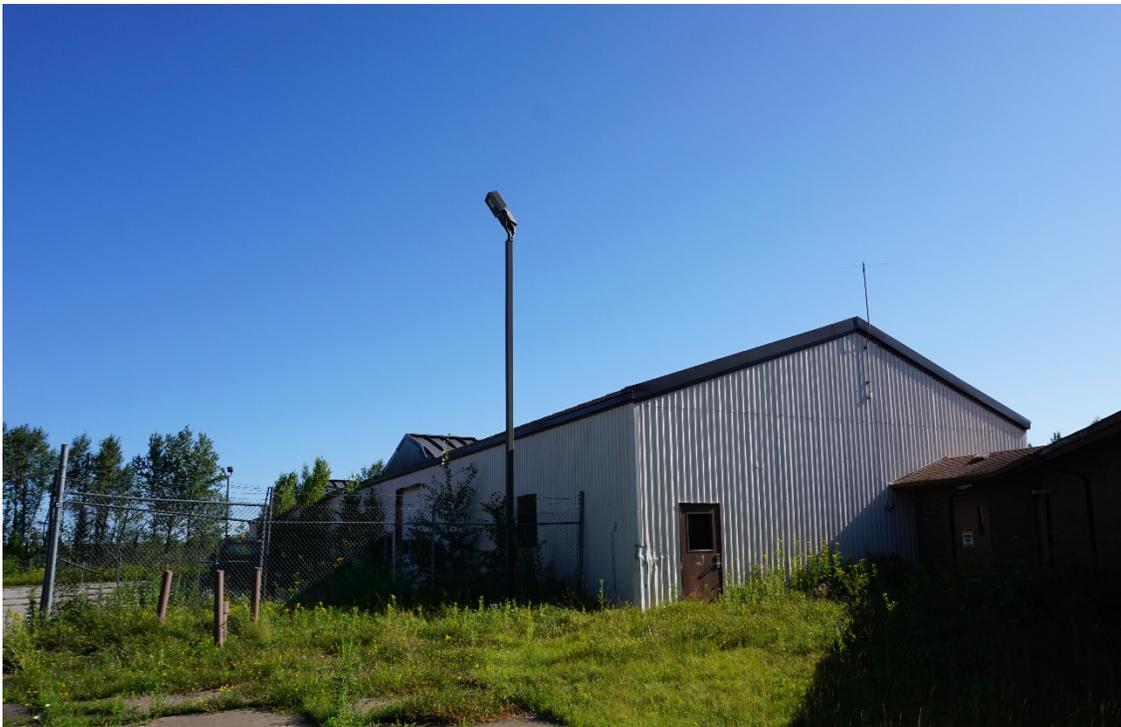
**Photo 2** Damage to prefinished metal wall panel

- Repair/ replace damaged sections of prefinished metal wall panel siding.
- Clean and paint exterior hollow metal doors and frames.
- Replace existing asphalt shingles
- Replace missing fascia wrap, and clean and paint underside of soffit at administrative addition.
- Remove and reinstall failed sealant at joints between dissimilar material connections, door/ window frames, and at through wall penetrations.

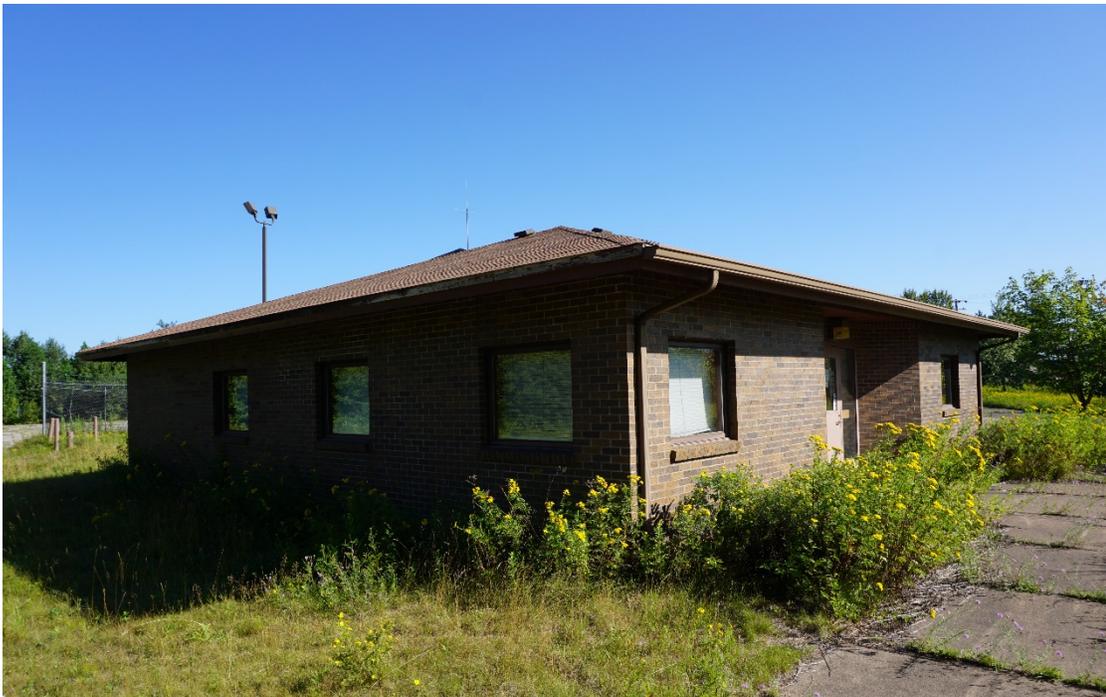
**Photo 4** Fascia wrap missing at administrative building

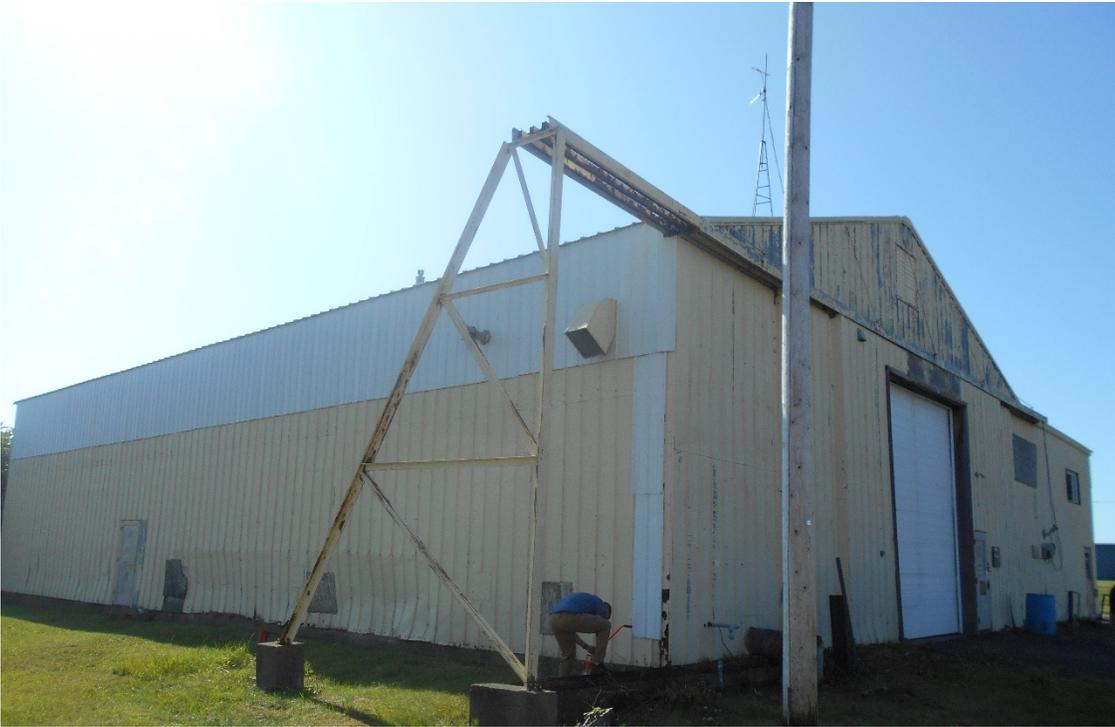
Photo 2 Damaged exterior metal wall panels

- Repair/ replace damaged sections of exterior metal wall panel siding.
- Clean and paint exterior metal wall panel siding.
- Replace existing wood and hollow metal doors and frames with new hollow metal units.
- Replace existing windows and frames at office areas with pre-finished metal units.
- Replace existing roof with new pre-finished metal roof panels and seal all through roof penetrations weather tight.
- Remove and reinstall failed sealant at all exterior joints, door/ window frames, and at through wall penetrations.
- Reconstruct second level mezzanine floor framing.

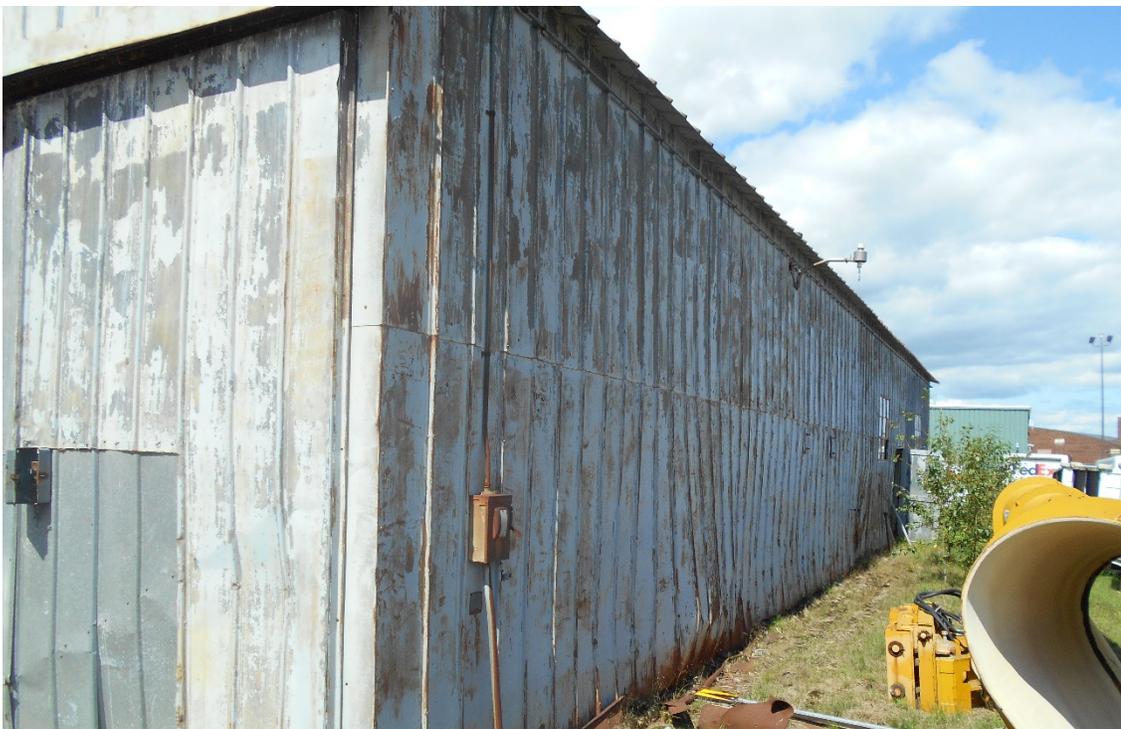
**Photo 2** Damage to exterior metal siding (multiple locations)

- Repair/ replace damaged locations of exterior metal wall panel siding.
- Clean and paint exterior metal wall panel siding.
- Remove and reinstall failed sealant at all exterior joints, door/ window frames, and at through wall penetrations.

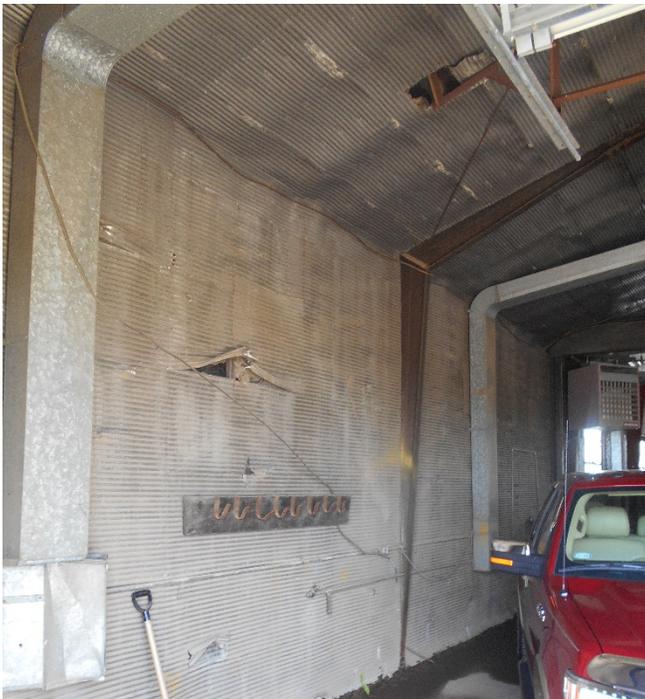
**Photo 4** Damage at interior metal wall/ ceiling liner panel

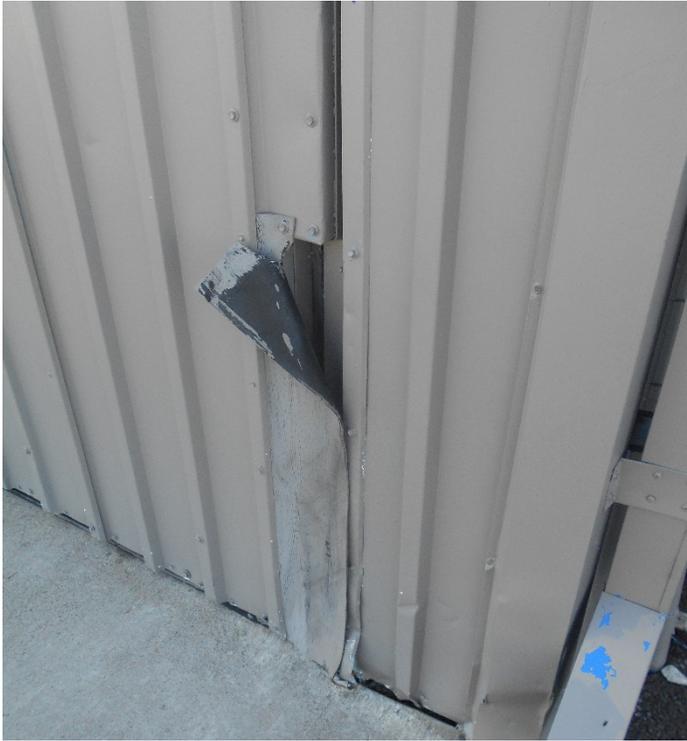
**Photo 3** Damage at lower corner of hangar door

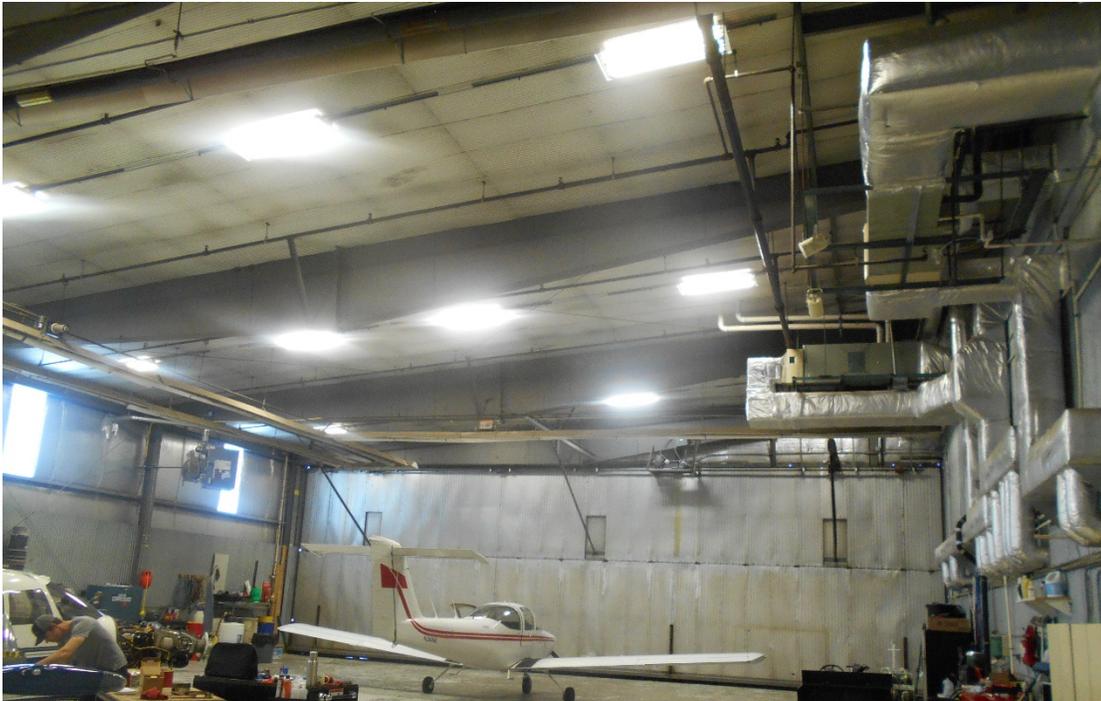
**Photo 4** Interior space / concrete slab finish worn/ flaking

- Continue with recommended maintenance schedule for building components and utilities.
- Repair/ re-apply floor slab coating to match original conditions in hangar area.

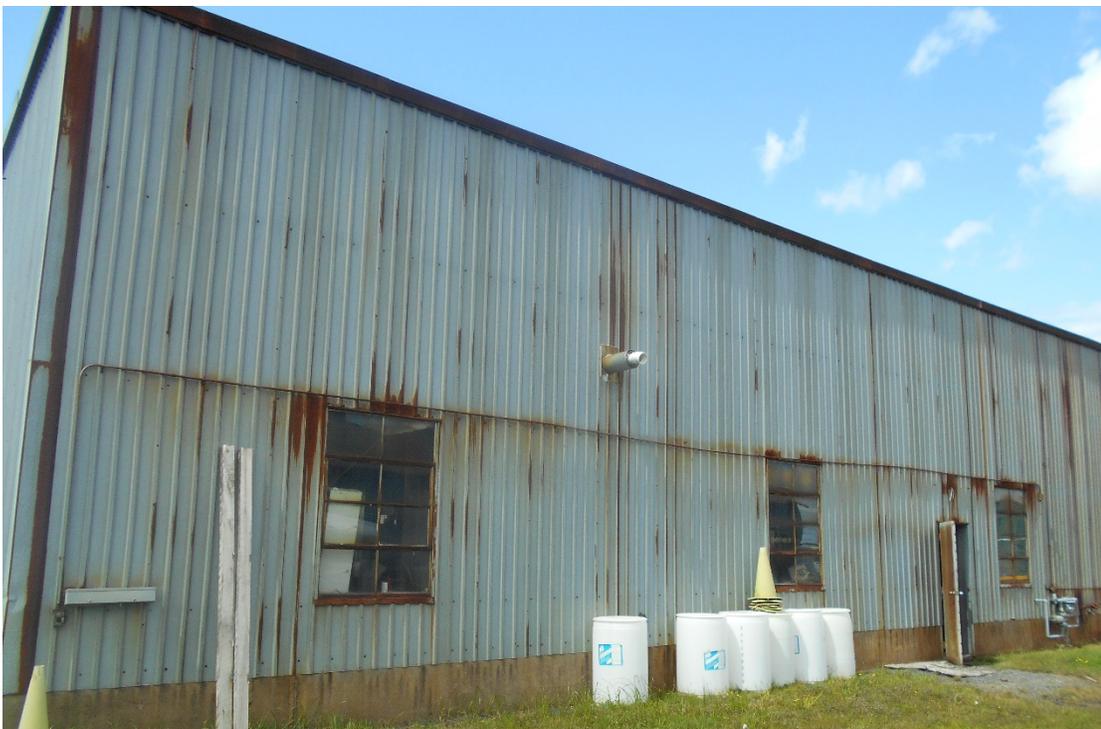
**Photo 2** Exterior siding faded, worn and rusted. Exterior windows needing replacement

- Repair/ replace damaged locations of exterior metal wall panel siding.
- Clean and paint exterior metal wall panel siding.
- Replace existing older exterior doors and frames with new hollow metal units. Replace existing vision windows and frames with new painted metal units.
- Replace existing roof with new pre-finished metal roof panels and seal all thru roof penetrations weather tight.
- Remove and reinstall failed sealant at all exterior joints, door/ window frames, and at thru wall penetrations.

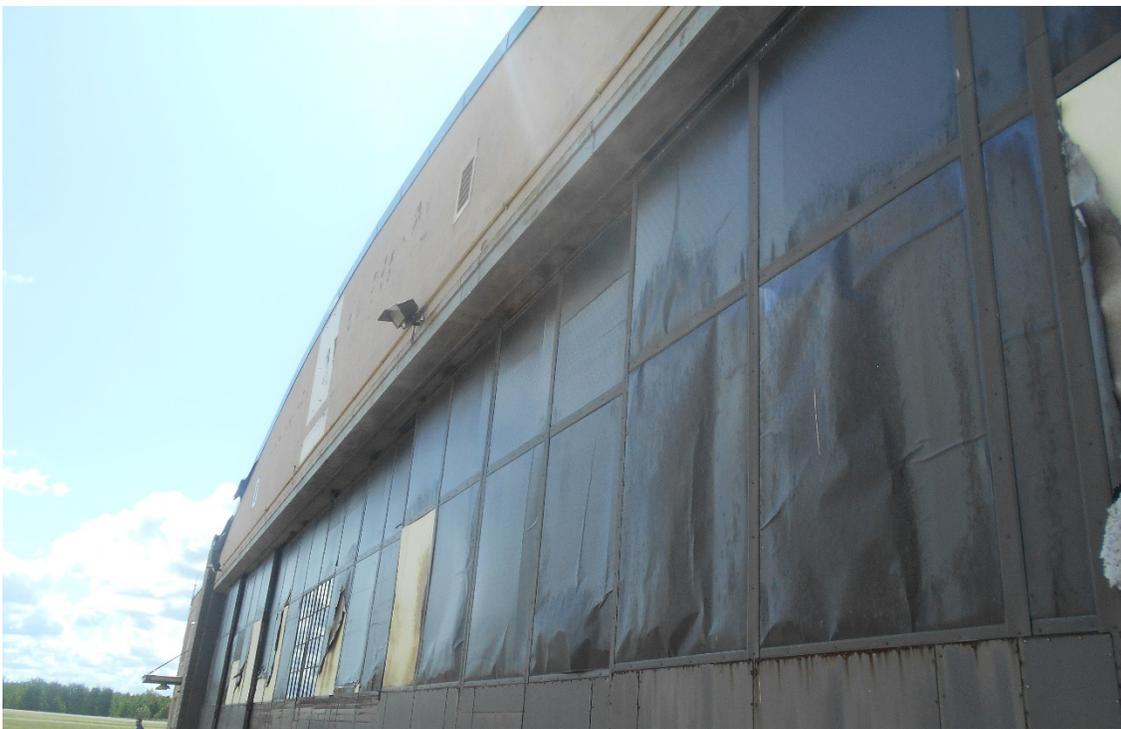
**Photo 2** Hangar door damaged, not operational

- Major restorative work would be required to office addition to be an occupiable space.
- Locations at brick and mortar joints in need of tuck-pointing at original hangar building.
- Replace existing doors, windows, hangar door and sealant joints along exterior along with new roof system at hangar to maintain weather tight building enclosure.
- Clean/ new painted finish at existing painted exterior CMU.

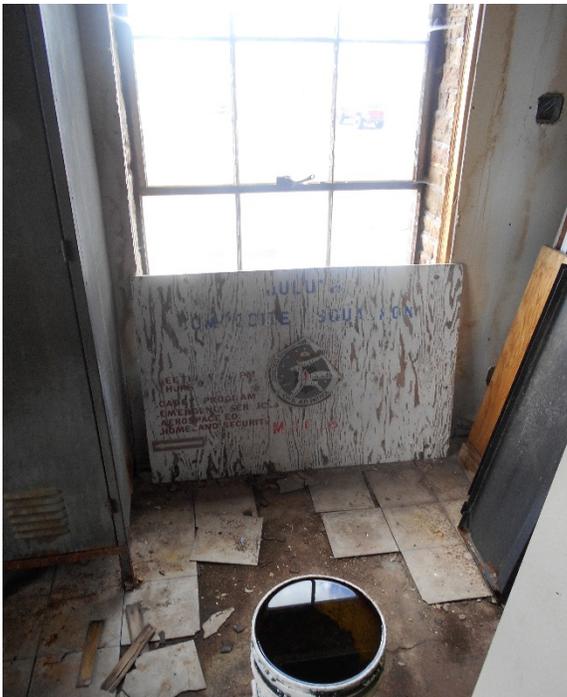
**Photo 6** Damage at interior of addition (multiple locations)

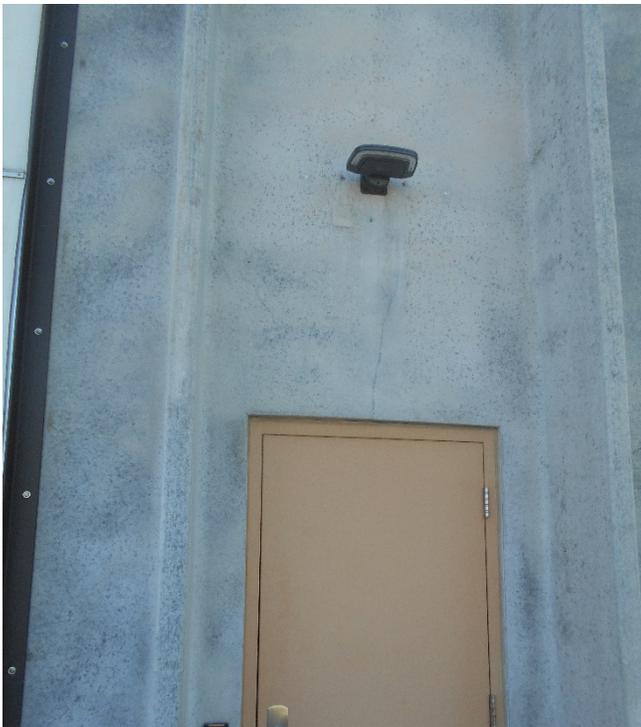
**Photo 2** Minor crack in precast wall panel

- Continue with recommended maintenance schedule for building components and utilities.
- Repair/ fill couple locations where minor cracks occurred in exterior concrete wall panels to prevent further deterioration and maintain weather tight building exterior.

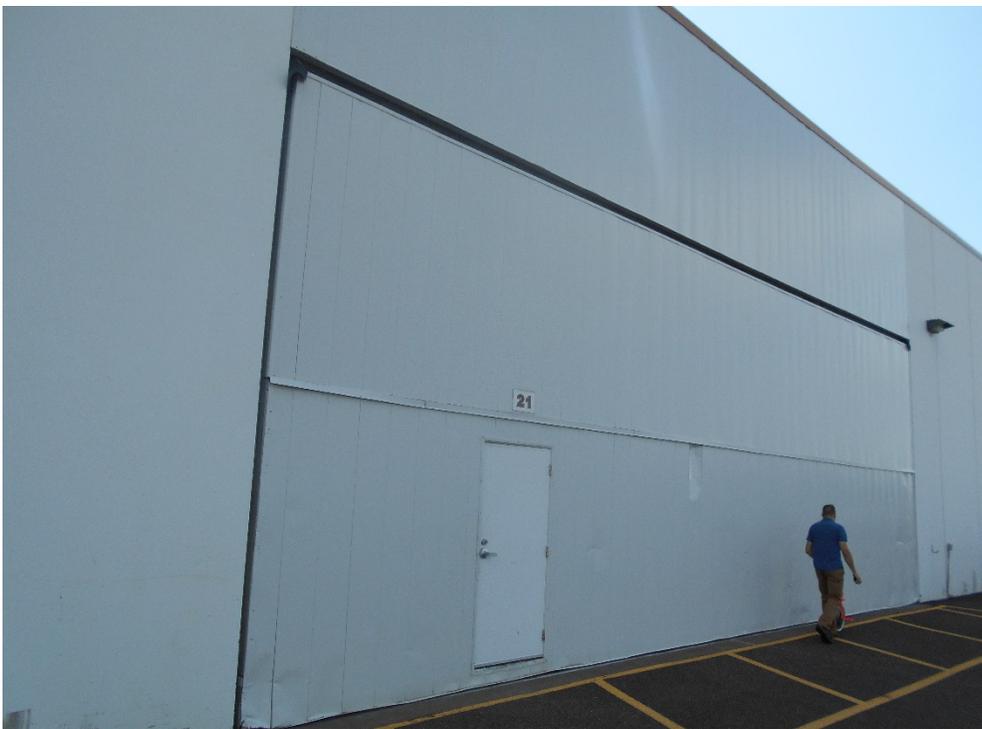
**Photo 2** Damage at hangar doors (multiple locations)

- Repair/ re-paint damaged locations of exterior precast concrete wall panels.
- Repair damaged hangar door metal paneling to prevent water infiltration and further deterioration.
- Replace sealant between pre-cast concrete wall panel to panel joints that has cracked, separated or hardened at locations along exterior of building to maintain weather tightness.

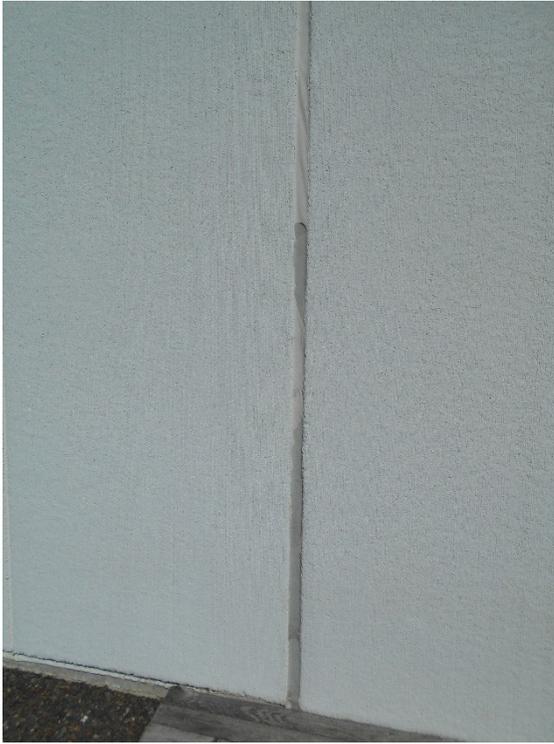
**Photo 3** Paint finish peeling at precast concrete wall panel joints (typical)

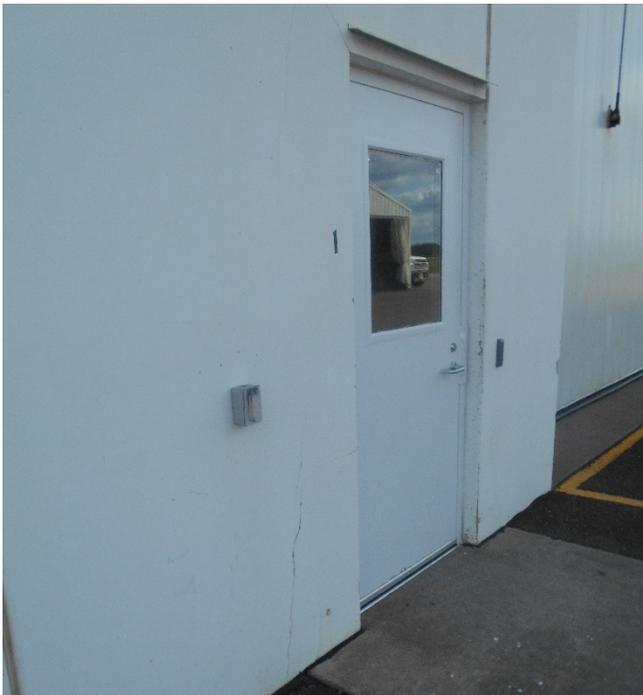
**Photo 4** Minor cracks found in precast concrete wall panels, limited locations

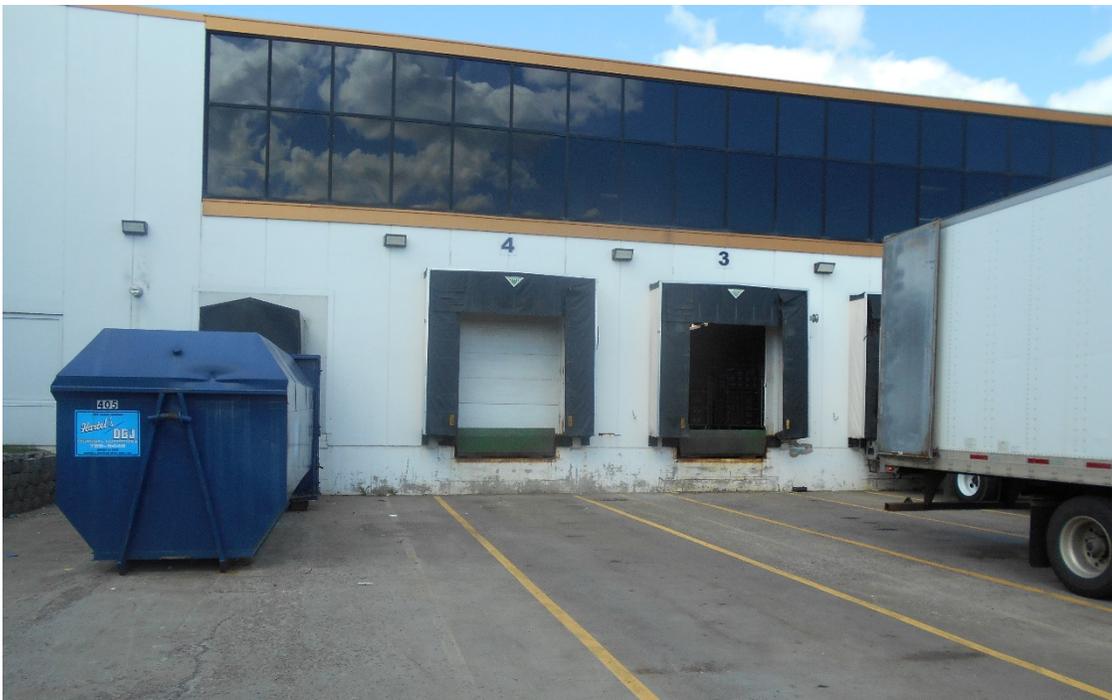
**Photo 6** Loading dock precast wall panel damage

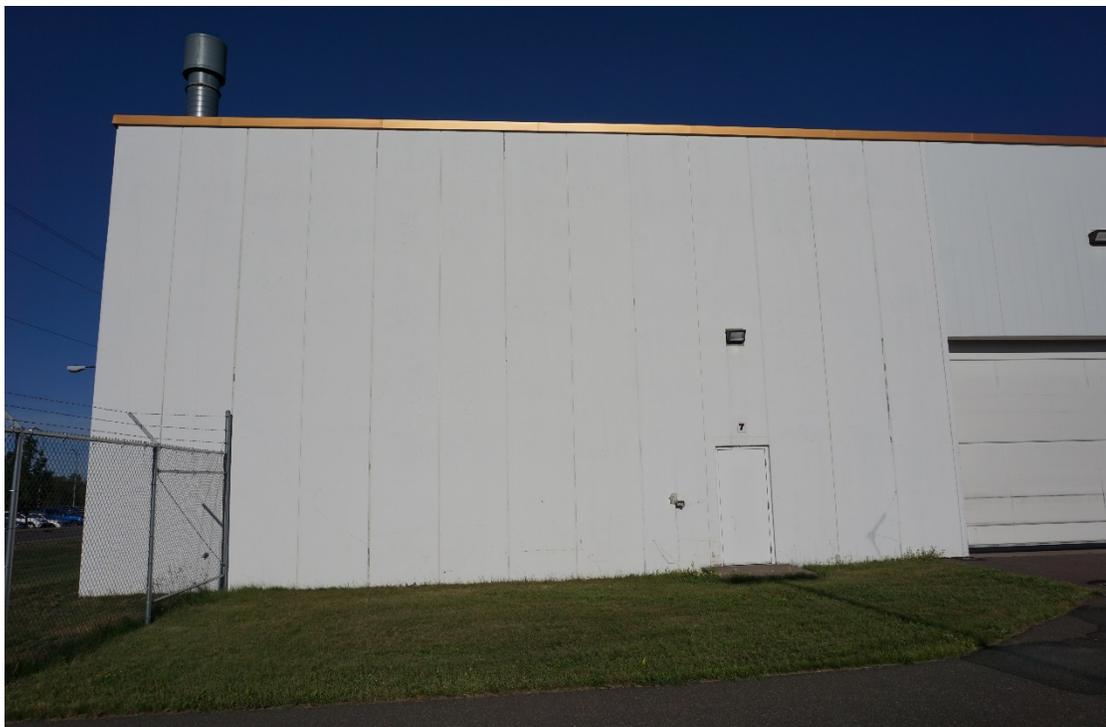
Building appears to be in overall good condition. Paint finish is peeling off sealant at precast concrete wall panel joints. No other known leaks or other issues with building. Unable to gain entry at time of site visit.

**Photo 2** Peeling paint at precast concrete wall panel joints (typical)

- Repair/ re-paint damaged locations of exterior precast concrete wall panels and sealant joints.
- Replace sealant that has cracked, separated or hardened at locations along exterior of building to maintain weather tightness.

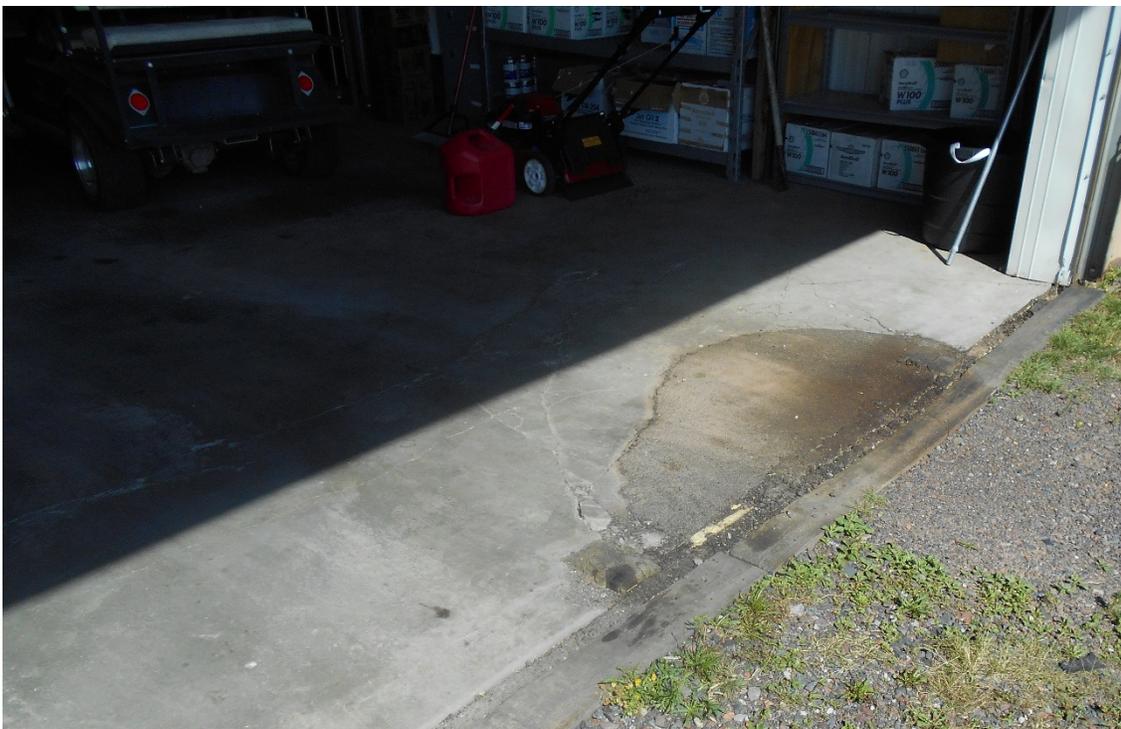
Older post frame building, refinished and modified recently for drive-thru hangar doors. Minor cracks in concrete floor slab. Building in overall good condition. Hangar doors appeared in good condition and operational.

**Photo 2** Cracks/ damage at interior concrete floor slab

- Repair/ fill minor cracks in concrete floor slab to prevent further deterioration.

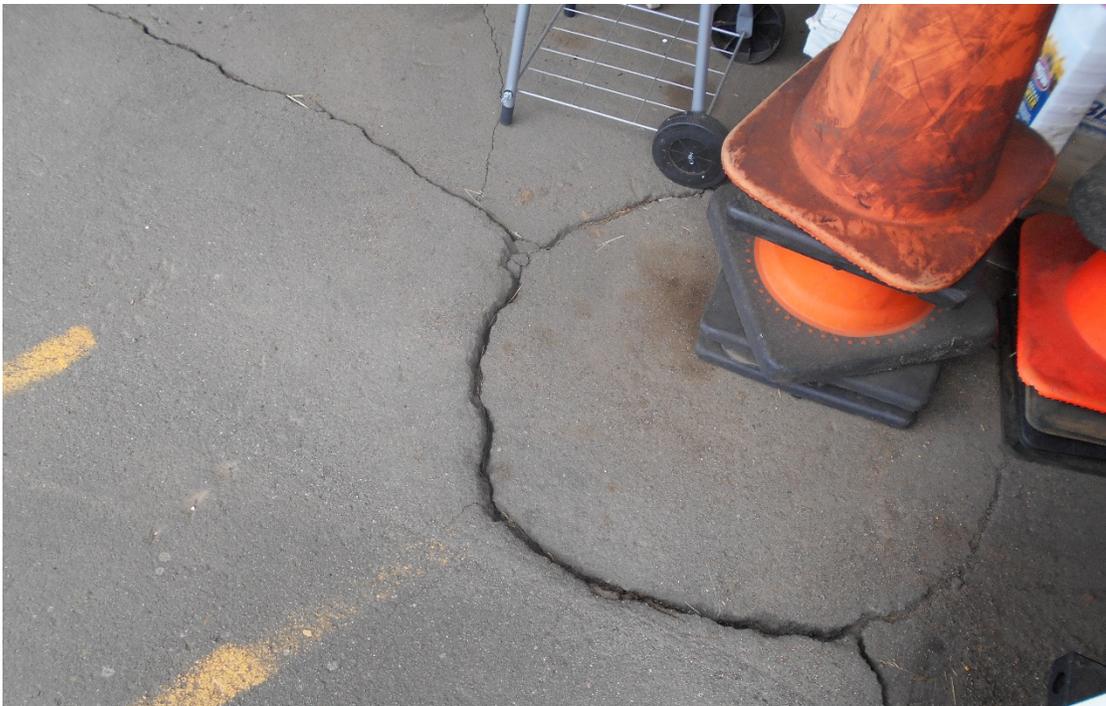
Wood framed building appeared to be set on existing bituminous pavement as no foundation was noticeable. Overall in good condition. Newer roof installed couple years ago. Slab shows heavy cracking.

**Photo 2** Cracks in bituminous floor slab

- Repair/ fill cracks in bituminous floor slab to prevent further deterioration.
- Paint exterior side of hollow metal door and frame.
